Re: Toyota Safety Recall 12V-537 –Dealer Notification Remedy Phase 1, Interim Phase 2

**Subject: Safety Recall - C0T Phase 1 Remedy Notification**  
**C2T Phase 2 Interim Notification**  
2004 to certain 2009 Model Year Prius Vehicles  
Steering Intermediate Extension Shaft

**TECHNICAL INSTRUCTIONS**  
**FOR**  
**SAFETY RECALL C0T**  
**STEERING INTERMEDIATE EXTENSION SHAFT**  
**2004 – CERTAIN 2009 MODEL YEAR PRIUS**

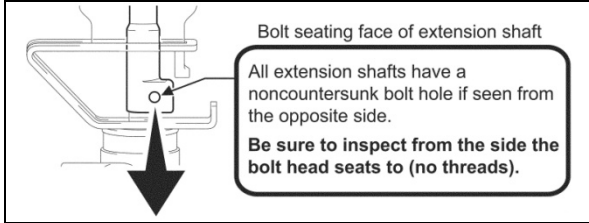
6. INSPECT THE EXTENSION SHAFT

NO Countersink	Countersink
Shaft Design		<p style="font-size: 2em; font-weight: bold; text-align: right;">OK</p>	<p style="font-size: 2em; font-weight: bold; text-align: right;">NG</p>
Action Required		<p style="font-size: 2em; font-weight: bold;">OK</p> <p>Replace the extension shaft bolt <i>ONLY</i>. Proceed to SECTION VII. EXTENSION SHAFT &amp; BOLT REPLACEMENT. Complete STEPS 24-28 and 36-37.</p>	<p style="font-size: 2em; font-weight: bold;">NG</p> <p>Replace the extension shaft and 3 bolts. Proceed to SECTION VII. EXTENSION SHAFT &amp; BOLT REPLACEMENT</p>

NOTE: The new shaft in the kit (04001-41212) is manufactured with a countersink. *DO NOT* mix the old and new shaft.

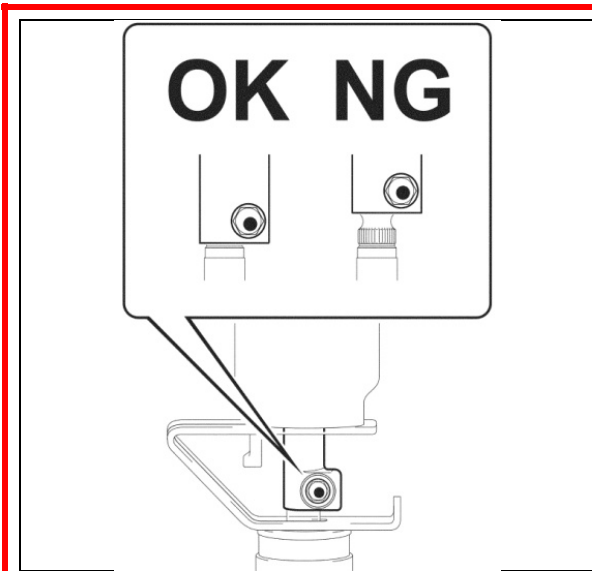
**25. INSPECT THE EXTENSION SHAFT**

- a) Confirm that a **NEW** shaft and **NEW** bolt has been installed.
- b) Confirm the lower end of the shaft has been fully seated.  
**NOTE: If only the edge of the shaft is engaged, the bolt can be tightened but the shaft may become disconnected.**
