MIL "ON" DTC P0A2D/249

Service Category Engine/Hybrid System

Section Cooling

YEAR(S)	MODEL(S)	ADDITIONAL INFORMATION
2010	Prius

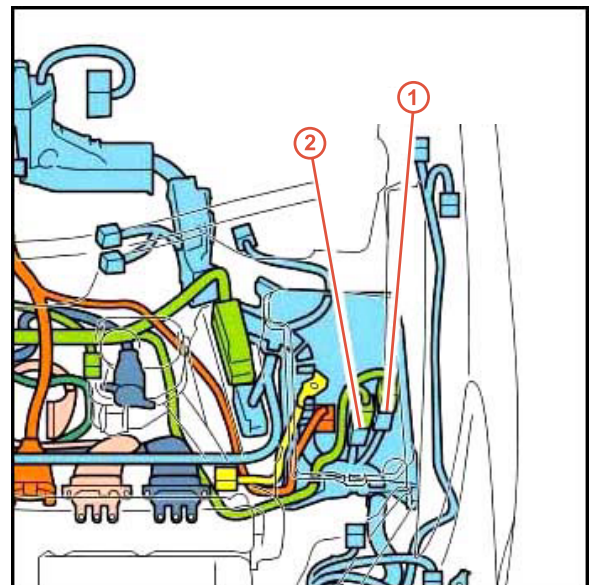
Figure 1. Location of Connector DA1

1	Connector DA1
2	Connector DA2

1. Remove the engine bay Relay Block cover and inspect inside for signs of water intrusion or contamination.
 - If water intrusion or contamination is present, proceed to step 2.
 - If no water intrusion or contamination is present, proceed to step 3.
2. If any fuses or relays show any signs of corrosion, repair or replace as necessary.
3. Disconnect and inspect connector DA1 at the Relay Block for signs of water intrusion or contamination.
 - If water intrusion or contamination is found, clean and dry as needed, then proceed to step 4.
 - If no water intrusion or contamination is found, proceed to step 4.

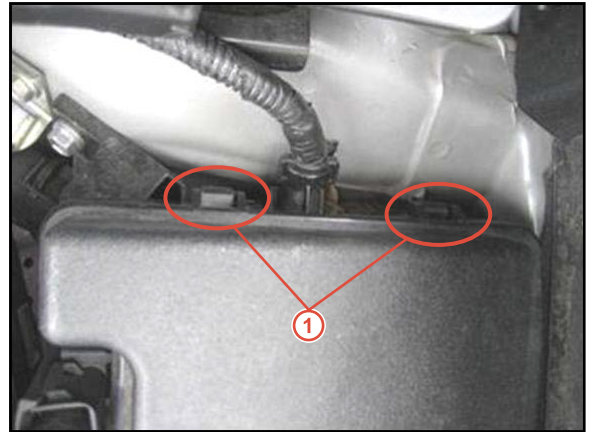
Figure 2.

1	Rear Hooks (2)
----------	-----------------------

A. Secure the rear hooks of the Relay Block cover.

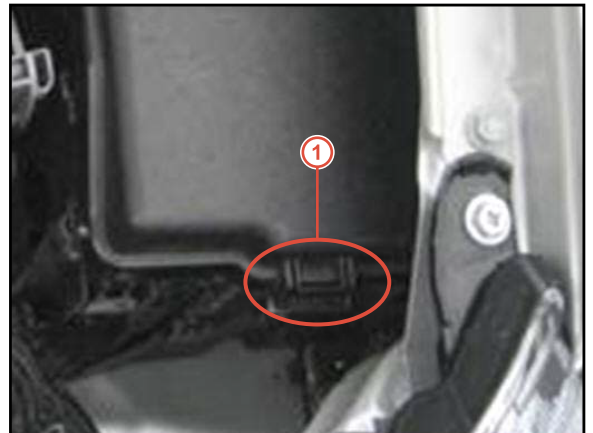
Figure 3.

1	Front Hook
----------	-------------------

B. Secure the front hook of the Relay Block cover.
