MIL "ON" DTC P0A80 due to Dust or Debris in HV Battery Cooling Fan

Service Category Engine/Hybrid System

Section Hybrid/Battery Control System

YEAR(S)	MODEL(S)	ADDITIONAL INFORMATION
2010	Prius

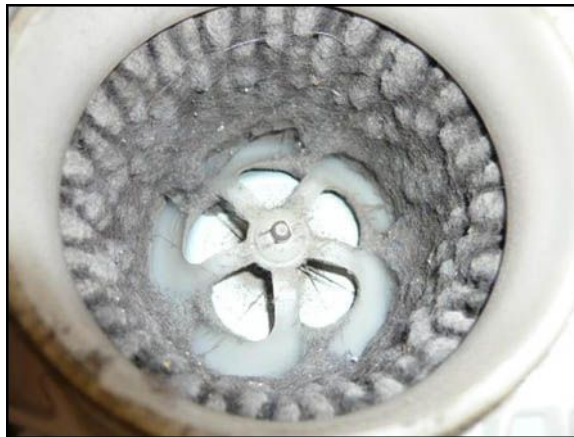
Figure 1.

Is the HV Battery Cooling Fan clogged with dust or debris build-up? Refer to Figure 1 for an example of a clogged cooling fan.

2. Clean dust and debris build-up from the HV Battery Cooling Fan with compressed air.

3. Replace the HV Battery Assembly.
