# Upper/Lower Windshield/Rear Glass Tick Noise

The information contained in this bulletin supersedes T-SB-0142-08.

## Upper/Lower Windshield/Rear Glass Tick Noise

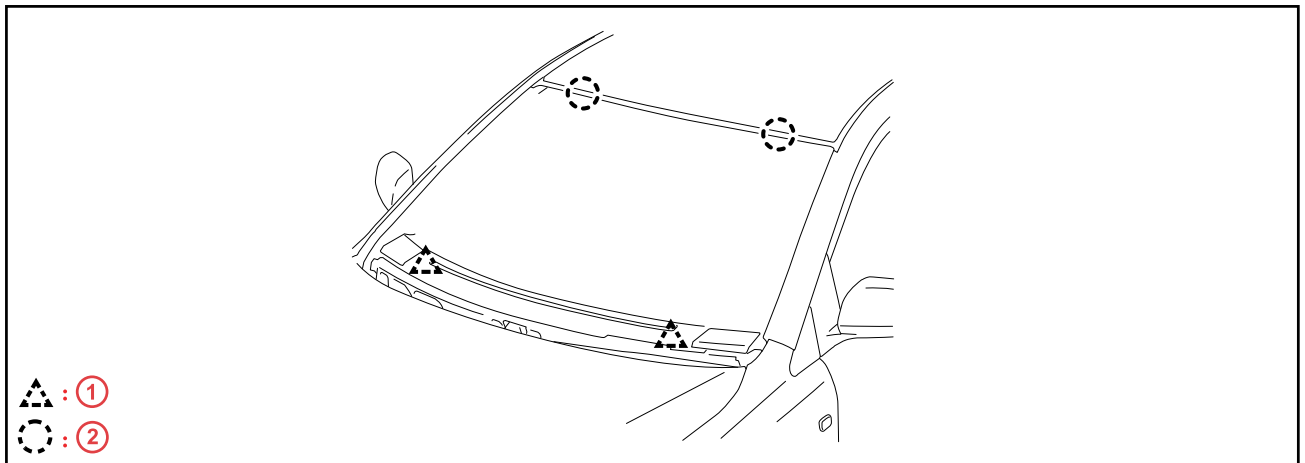
**Figure 1. Retainer and Stopper Locations**

If a creak, tick, or rattle noise is heard at the top or bottom of the windshield, or at the top of the rear glass, the source of the noise may be the two stoppers bonded to the top of the windshield/rear glass, or the windshield retainers bonded to the lower edge of the windshield. This bulletin provides the recommended repair procedure to eliminate these types of noises from the windshield/rear glass area.

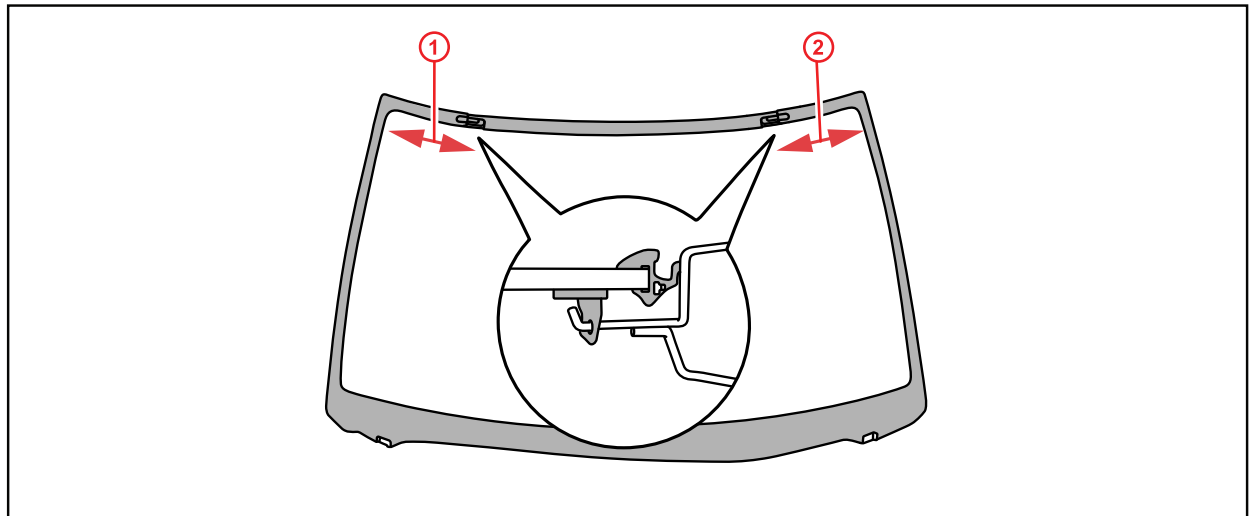
Figure 4.

The stoppers are located on the inside of the passenger compartment behind the windshield glass blackout section (near the top front edge of the metal roof opening). The stoppers are typically located 200 – 250 mm (7.9 – 9.8 in.) inboard of the top corners of the windshield glass.

1. Remove both sun visors and both A-pillar garnishes, and then carefully lower the front of the headliner to gain access to the windshield stoppers (refer to the appropriate model year Repair Manual for the proper procedure for removing and reinstalling the sun visors and headliner).

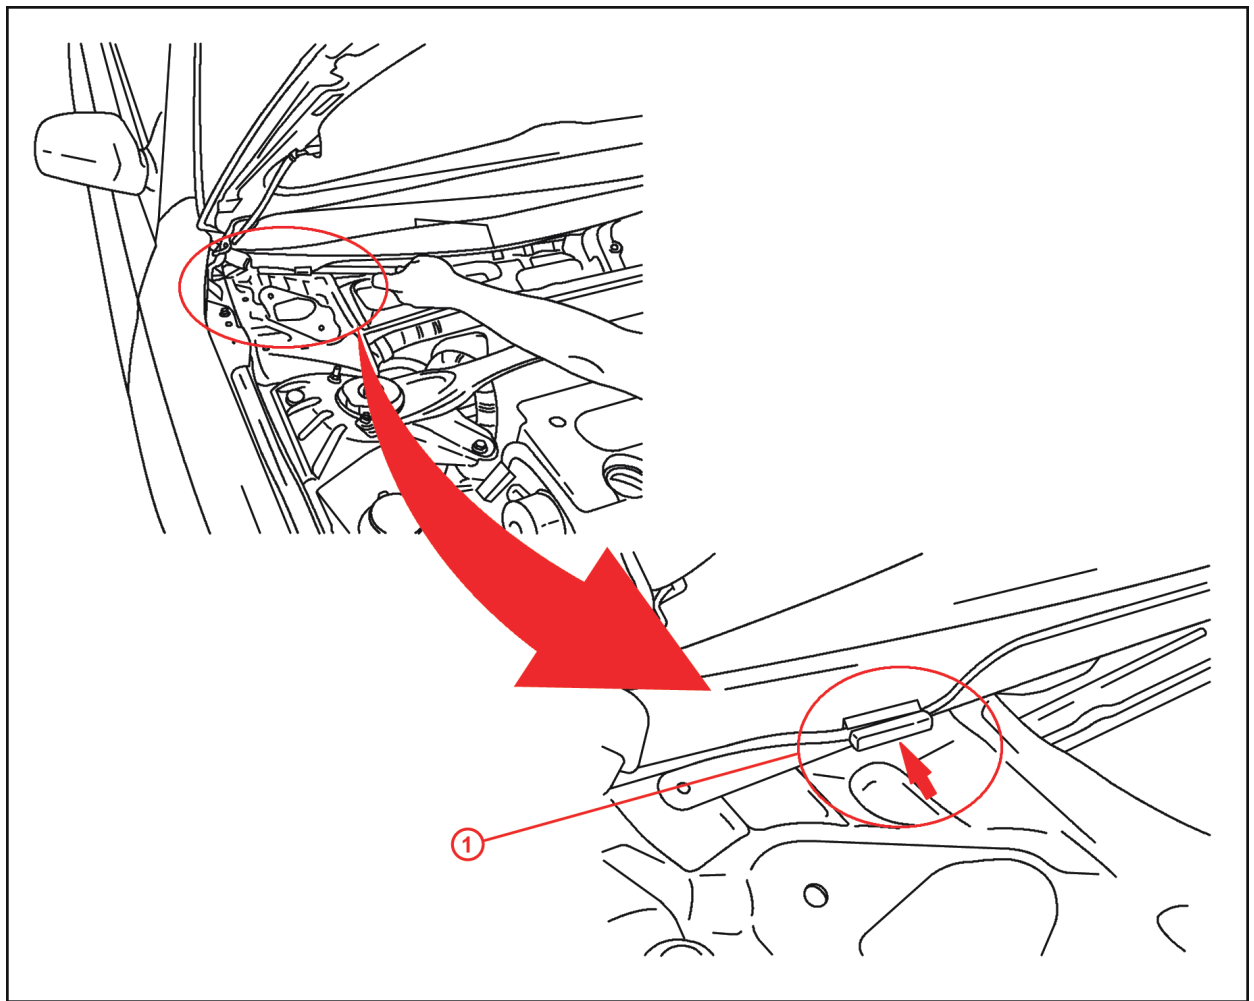
**Figure 8.**

The retainers are typically located 140 – 200 mm (5.5 – 7.9 in.) inboard of the lower corners of the windshield. The flat portion of the retainer is adhered to the backside of the windshield with double-sided, foam-backed tape.

2. Locate the lower windshield retainers.
