# Vibration from Engine after Cold Soak

**Service Category** Engine/Hybrid System

**Section** Engine Mechanical

YEAR(S)	MODEL(S)	ADDITIONAL INFORMATION
2010 – 2011	Prius

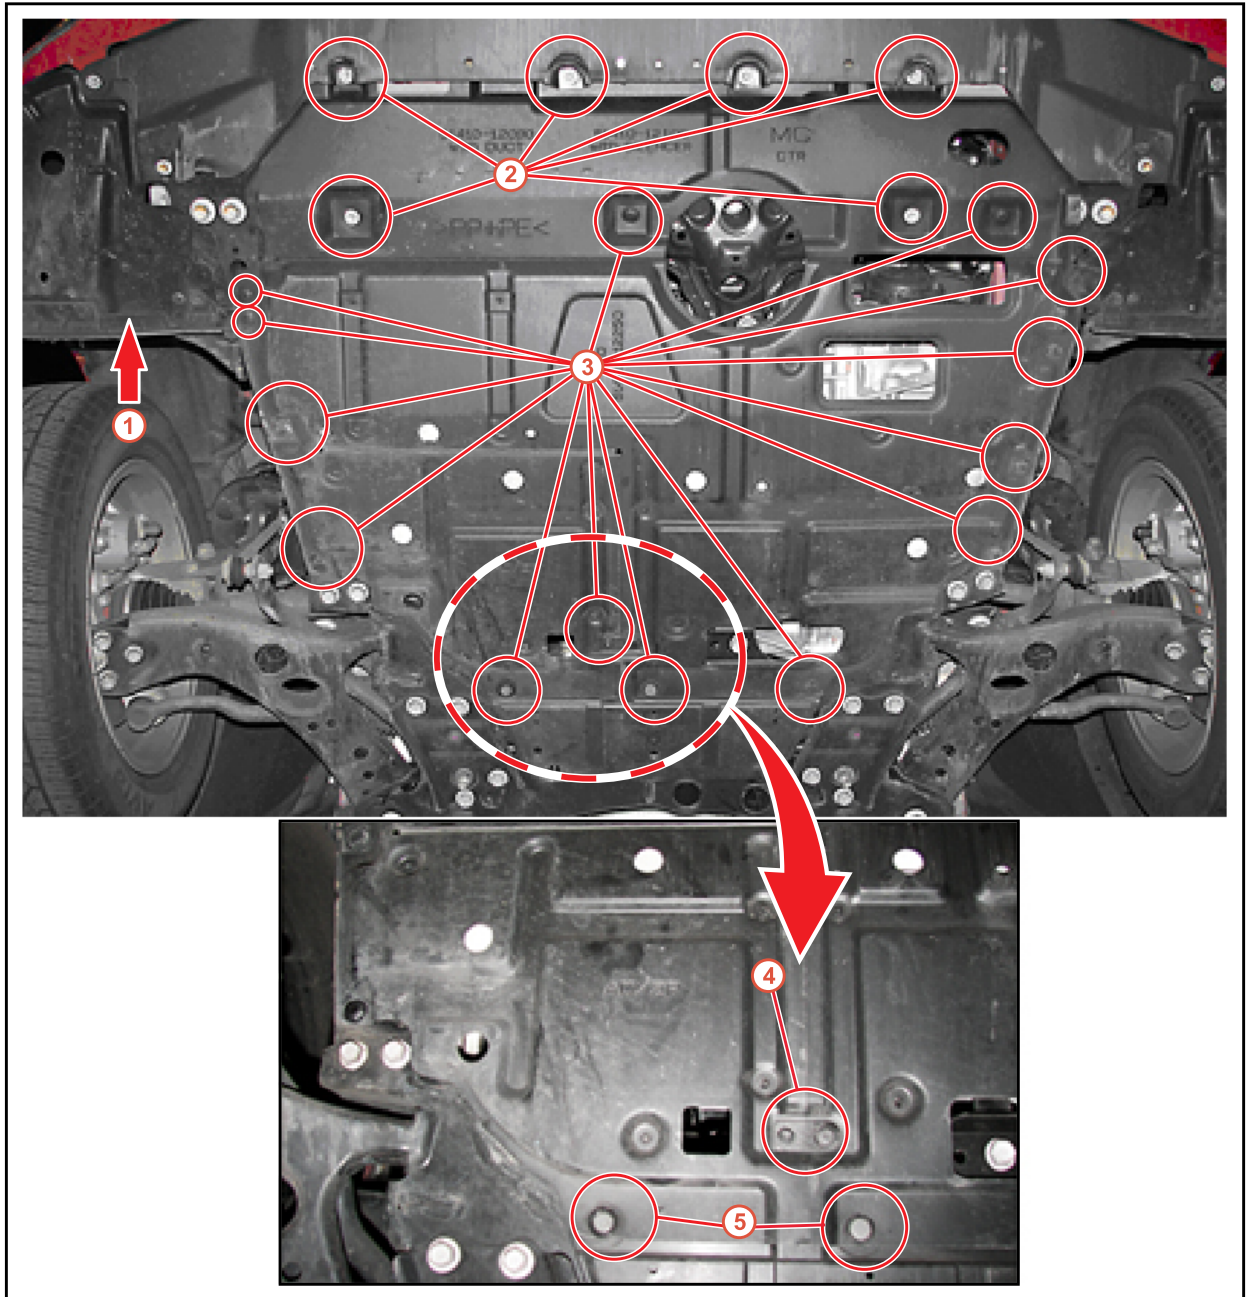
Figure 1.

Clips are not interchangeable. See Figure 1 for specific clip locations.

Remove the 6 bolts and 14 retaining clips from the engine under cover and slide toward rear of vehicle to remove cover.

5. Reposition the engine under cover into place and install the 14 retaining clips in their correct locations, then install the 6 bolts (See Figure 1).

Gently pull down on the edges of the engine under cover to ensure the clips are installed in the correct locations.
