Microscopic Analysis Report

Customer Name: ROBERT WILSON
 Reservoir Description: 2ZR-FXE ENG FILTER

Sample Date: 02/21/17
 Lab Number: 655005

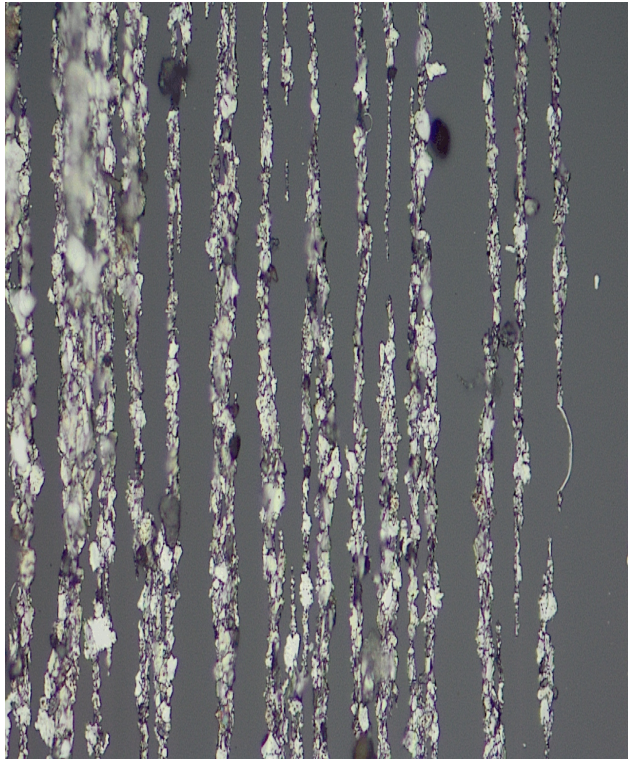
Figure 2: Ferrous Rolling Wear Platelet Particles, Ferrous Cutting Wear Particles, and Ferrous Rubbing Wear Particles at the Head of the Slide (Magnification 500X).

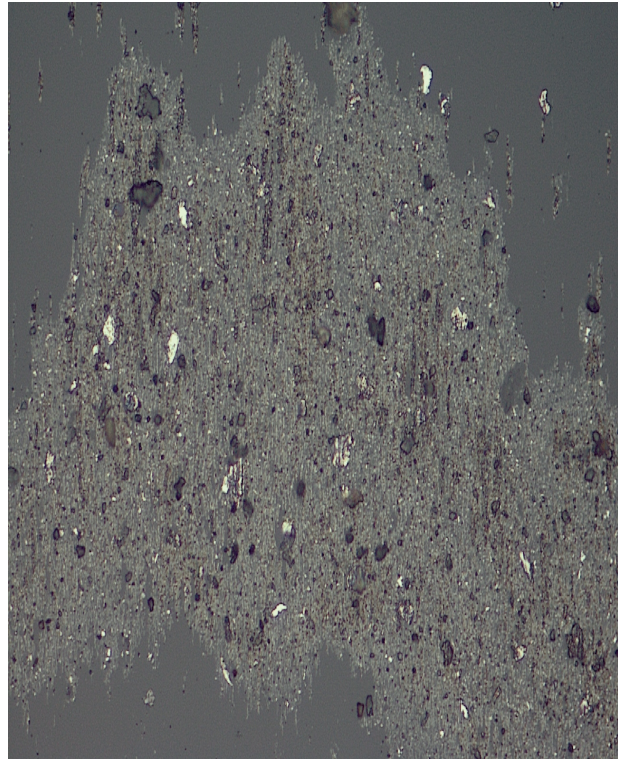
Figure 1: Nonferrous White Metal Cutting Wear Particles, Nonferrous White Metal Rubbing Wear Particles, and Abrasive/Dust/Dirt Particles at the End of the Slide (Magnification 500X).
