Headlamp Condensation

Service Category Vehicle Exterior

YEAR(S)	MODEL(S)	ADDITIONAL INFORMATION
2007 – 2009	Prius

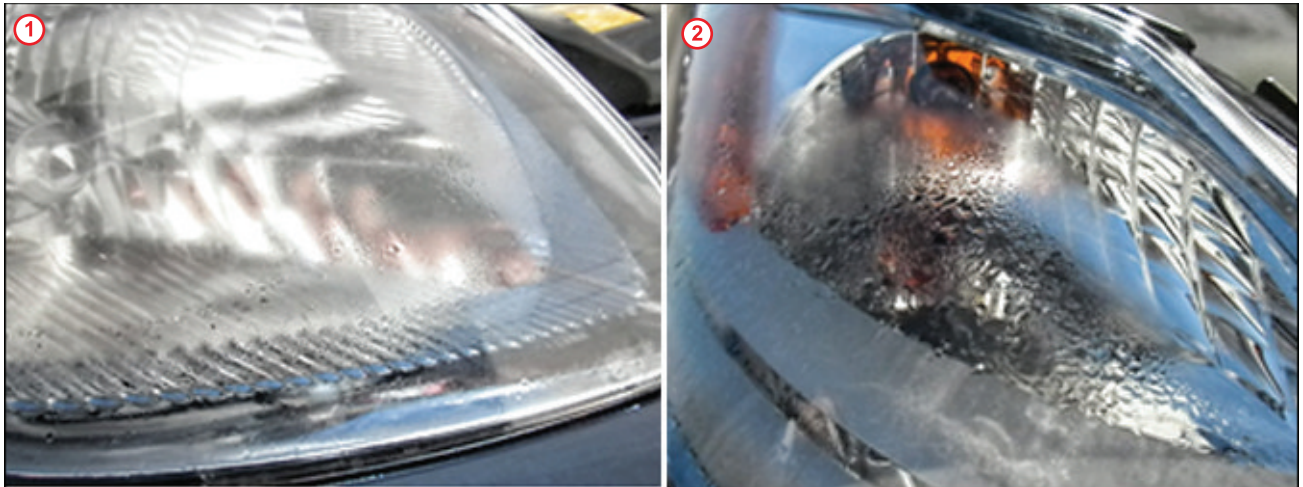
Figure 1.

1	Excessive condensation
----------	-------------------------------

2	Moisture
----------	-----------------

If headlamps have excessive condensation or moisture present, proceed with repair. If condensation or moisture is not present this TSB does NOT apply.

2. Replace the affected headlamp assembly(s).
