**PDXinspections LLC**

Portland's Used Vehicle Inspection Service

Customer	Inspection Date	Location Of Inspection	Inspection Cost
	7/16/2018		
Vehicle	Vehicle Identification Number	Manufacture Date	Exterior/Interior Color
2006 Toyota Prius Base		March 2006	Champagne/Tan
Engine type	Transmission	Drivetrain	Odometer
1.5L Inline 4 Cylinder DOHC Hybrid	CVT - Constantly Variable Transmission	Front Wheel Drive	81,794
Engine Cold Start?	Engine Temp. on Arrival	Weather/Inspection Conditions	Outside Air Temp.
No, the engine was hot on arrival	185°	Sunny	89°
License Plates/Registration			
Oregon License Plates - Current tags/registration until April 2020.

2006 Toyota Prius Inspection Prepared for

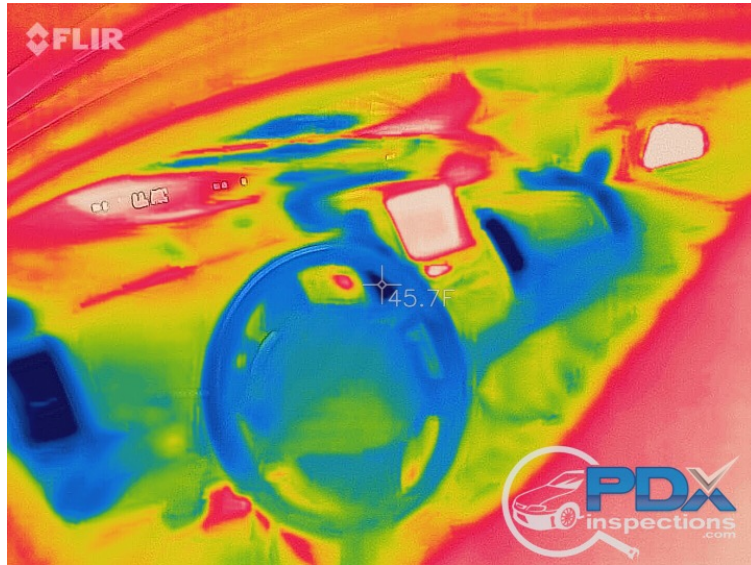
A/C performance verified with an infrared camera

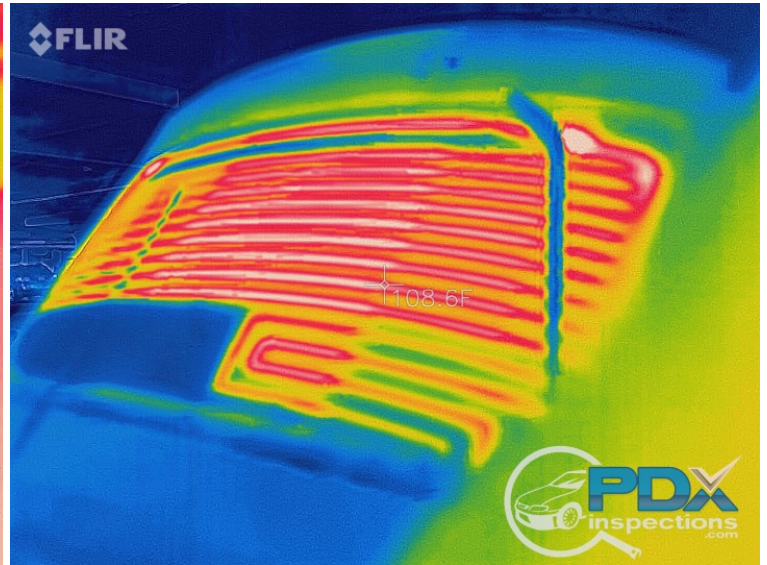
Rear defroster operation verified with an infrared camera

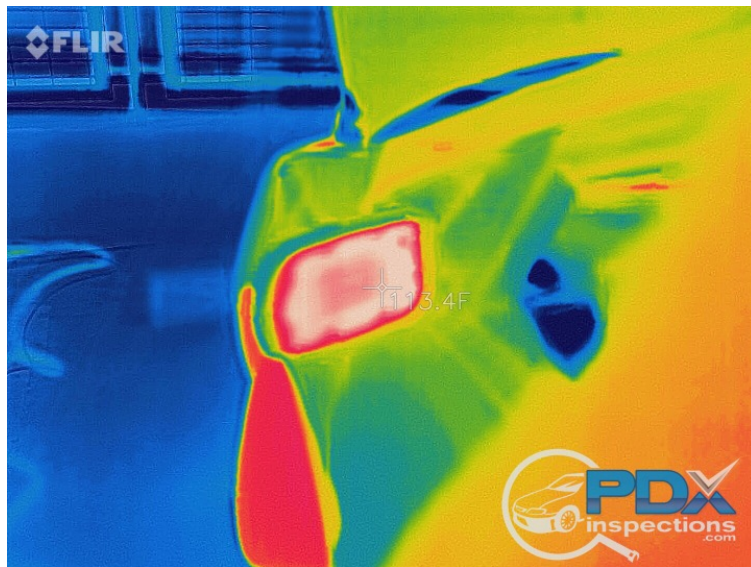
Heated mirror operation verified with an infrared camera

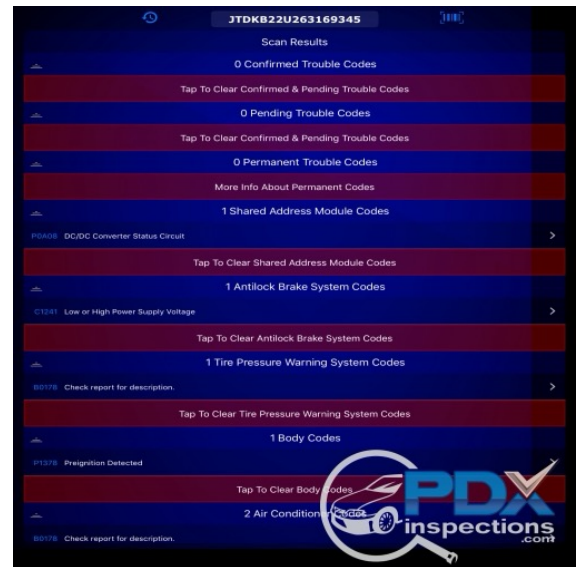
Miscellaneous history trouble codes noted. These are items that have possibly had issues in the past. They may have been addressed and/or be intermittent issues.

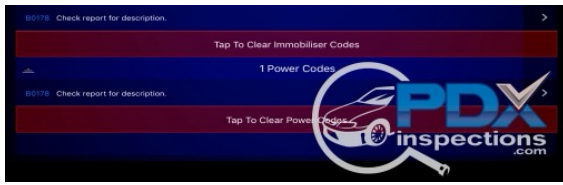
Miscellaneous history trouble codes noted. These are items that have possibly had issues in the past. They may have been addressed and/or be intermittent issues.

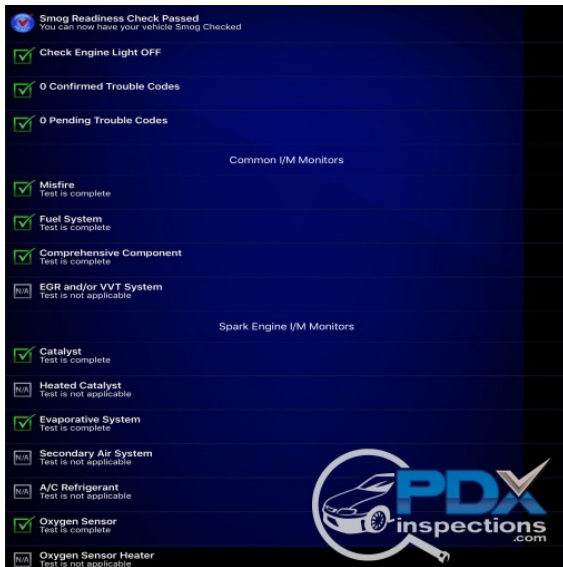
DEQ/SMOG readiness tests

Emissions Ready?	Yes, all of the I/M emission flags have successfully completed allowing vehicle to pass emissions test. This also suggests the vehicle has been driven several times without triggering any check engine lights over the recent past. It has completed/passed at least two recent back to back OBDII drive cycles (usually consisting of two separate cold start 20-30 minute drives) without failure of any emission related component.
Warning lights/Computer Codes	No current or pending codes in the engine control module. There is history code for the DC/DC converter and a C1241 low battery voltage code. This can be related to an intermittent issue or issue that has been addressed in the past - (Many times you can Google the codes to get descriptions and/or to get a better idea on possible causes). Ask for records to determine whether or not this has been fixed or addressed to rule out an intermittent condition. There are no abnormal warning lights illuminated in the instrument cluster. The engine fuel trims are within 5%, this suggests the engine control module is in full control of the engine and it is running optimally at this time. The last powertrain computer reset was 2400 miles ago. 255+ successful engine warm-ups without faults (this is the maximum number the computer keeps).
