T-TCI-5280

## Corrosion on the Back-Door Steel Reinforcement Panel Around the Switch and Rear Camera

YEAR(S)	MODEL(S)	ADDITIONAL INFORMATION
2017 - 2018	Prius Prime	Engine(s): 2ZR Drive Type(s): 2

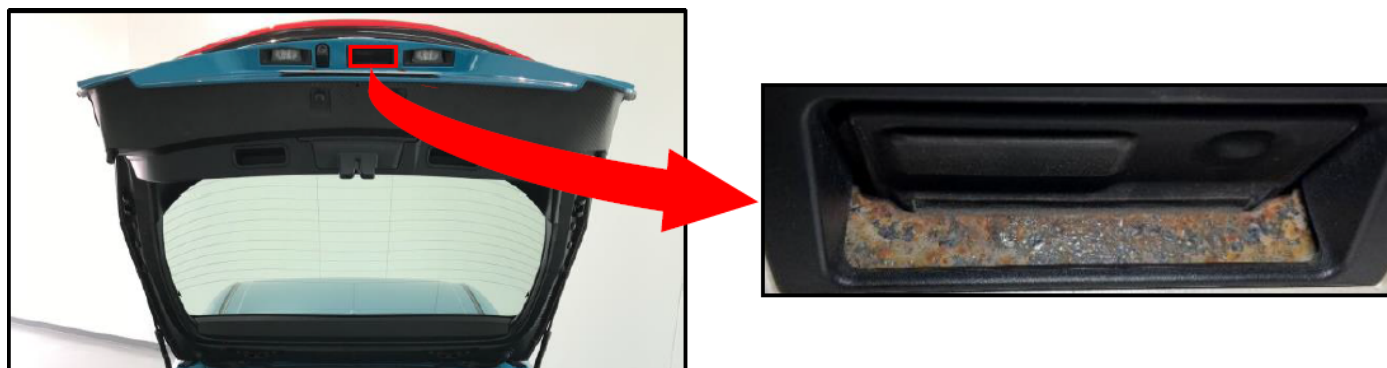
Some 2017 – 2018 model year Prius Prime vehicles may exhibit corrosion on the back door sub-assembly steel reinforcement panel visible below the opener switch and rear camera. Follow the Repair Procedure in this bulletin to address this condition.

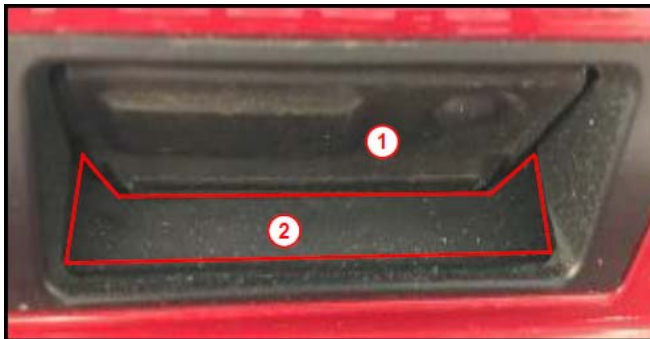
Figure 1.

- Only a small portion of the steel reinforcement panel is visible below the back-door opener switch when assembled (Figure 1).
- Coat the part of the steel reinforcement panel that is **NOT** visible with wax (Figure 2).

1	Back Door Opener Switch
2	Visible Steel Reinforcement Panel

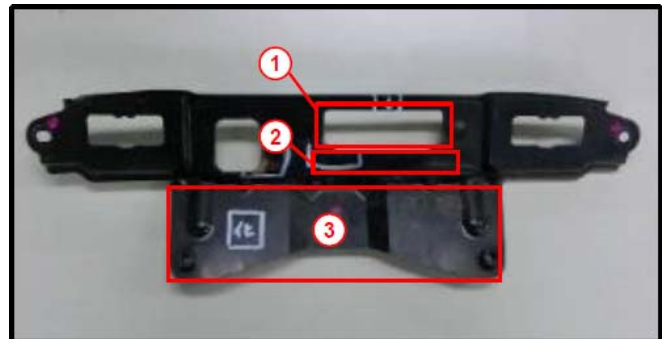
Figure 2.

1	Back Door Opener Switch Hole
2	Visible Steel Reinforcement Panel
3	Hidden Steel Reinforcement Panel

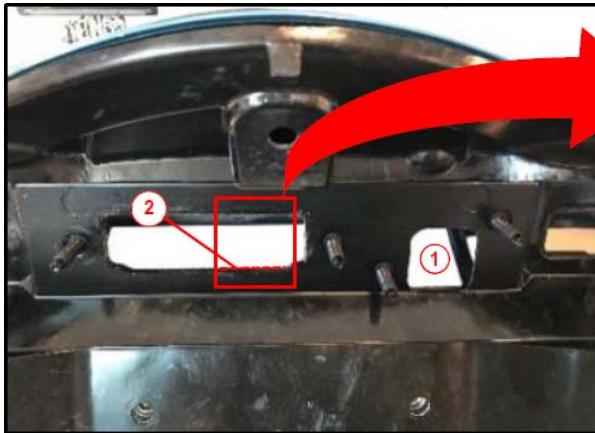
**Figure 3.**

1	Hole for Rear Camera
2	Cavity Between the Steel Reinforcement Panel and Interior CFRP Panel

- A. Lightly pry the interior CFRP and steel reinforcement panel apart with a small pry tool (Figure 4).
- B. Use an applicator wand kit to spray cavity wax in the cavity between the steel reinforcement

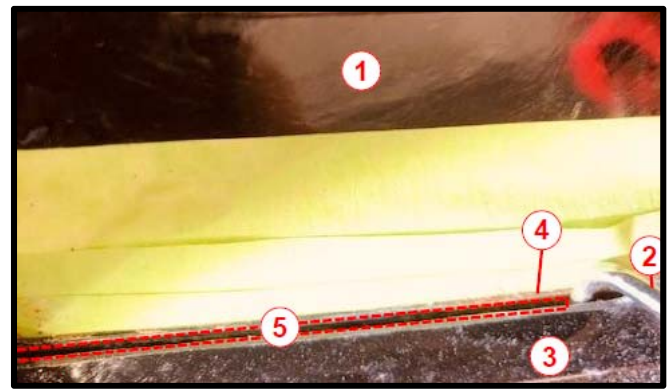
**Figure 4.**

1	Exterior CFRP Panel
2	Pry Tool
3	Interior CFRP Panel
4	Steel Reinforcement Panel
5	Cavity Between the Steel Reinforcement Panel and Interior CFRP Panel

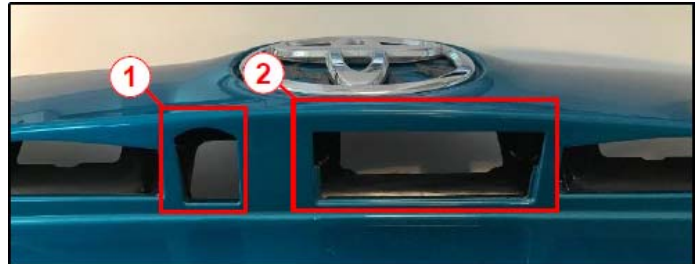
Figure 5.

1	Rear Camera Hole
2	Back-door Opener Switch Hole

- A. Use 80 – 180 grit sand paper to remove rust from the exposed steel reinforcement panel surface at the back-door opener switch and rear camera hole locations (Figure 5).

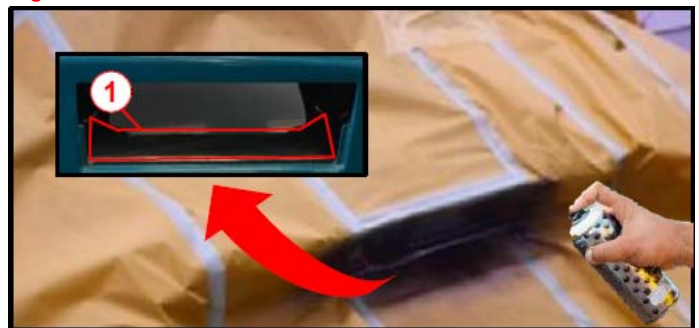
Figure 6.

1	Visible Back-door Steel Reinforcement Panel
---	---

- A. Apply spray etch primer to the exposed portions of the back-door steel reinforcement panel (Figure 6). Ensure ALL of the exposed area is coated and allow it to dry per the material manufacturer's recommendations.

7. Apply two top coats to the back-door steel reinforcement panel.
  - A. Apply two coats of black satin top coat to the visible area of the back-door steel reinforcement panel surrounding the back-door opener switch and rear camera holes (Figure 6) and allow each coat to dry according to material manufacturer recommendation. The completed repair is illustrated in Figure 8 and Figure 9.

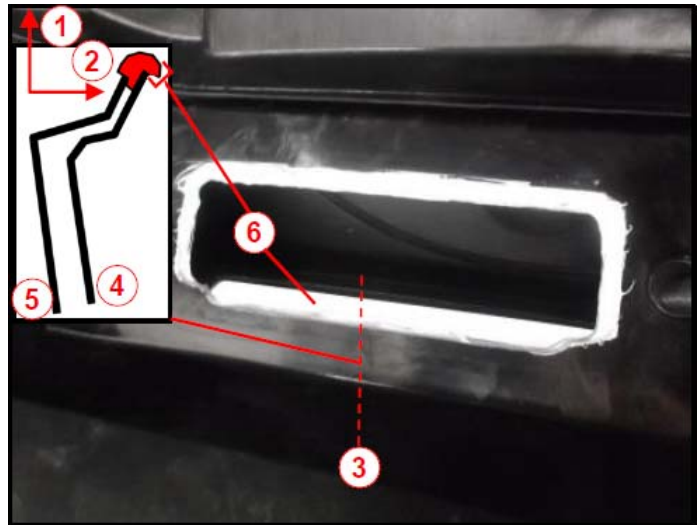
**Figure 7.**

1	Up
2	Rear
3	Cross Section
4	Interior CRFP Panel
5	Steel Reinforcement Panel
6	Sealer ≤ 1.5 mm Thick

6. Seal the gap between the back door interior CRFP panel and steel reinforcement panel.
- A. Use urethane seam sealer to fill the edge gap between the interior CFRP panel and the steel reinforcement panel (Figure 7) to prevent water entry between the two panels. Allow the sealer to dry per the manufacturer's recommendations.

To ensure proper fit of the back-door opener switch and rear camera to the reinforcement panel when reassembling, the sealer should be no more than 1.5 mm thick.

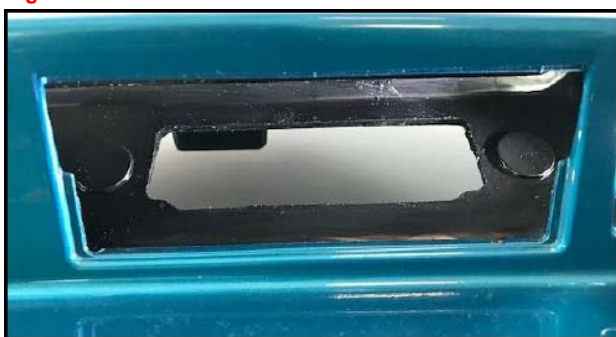
Figure 8.

Visible Front Area of Steel Reinforcement Panel Painted Black With no Visible Rust

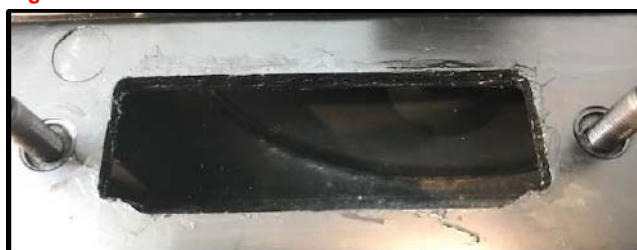
Figure 9.

Rear View of the Gap between Interior CFRP and Steel Reinforcement Panel Filled With Sealer
