2006 Toyota Tundra 4.7L Eng SR5

M.I.L. "ON" DTC P0335 AND/OR P1340: INTERMITTENT HOT SOAK NO-START

TECHNICAL SERVICE BULLETIN

Reference Number(s): EG052-06, Date of Issue: August 24, 2006

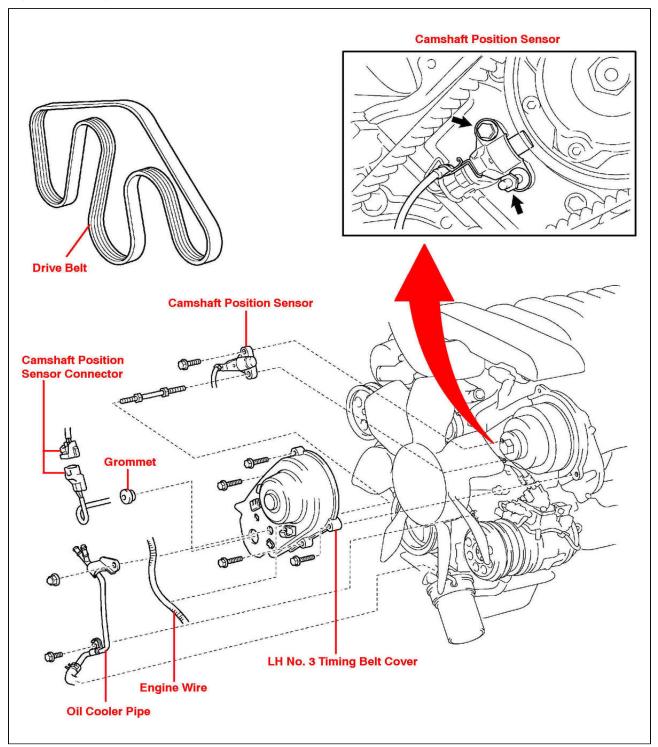
Fig 1: Identifying Camshaft Position Sensor Components

Some customers may experience a M.I.L. "ON" condition with DTCs P0335 and/or P1340 with intermittent hot soak no-start. The camshaft position sensor assembly has been improved to prevent this concern.

- 3. Replace the camshaft position sensor.
- 4. Using the Diagnostic Tester, clear the DTCs.
- 5. Test drive the vehicle for a minimum of 10 minutes. Then use the Diagnostic T ester to verify that NO pending DTCs set.
