## Gen3 Instrument Cluster Panel (ICP) Degradation – Blurry/Hazy/Greasy/Moldy/Damp Energy Monitor

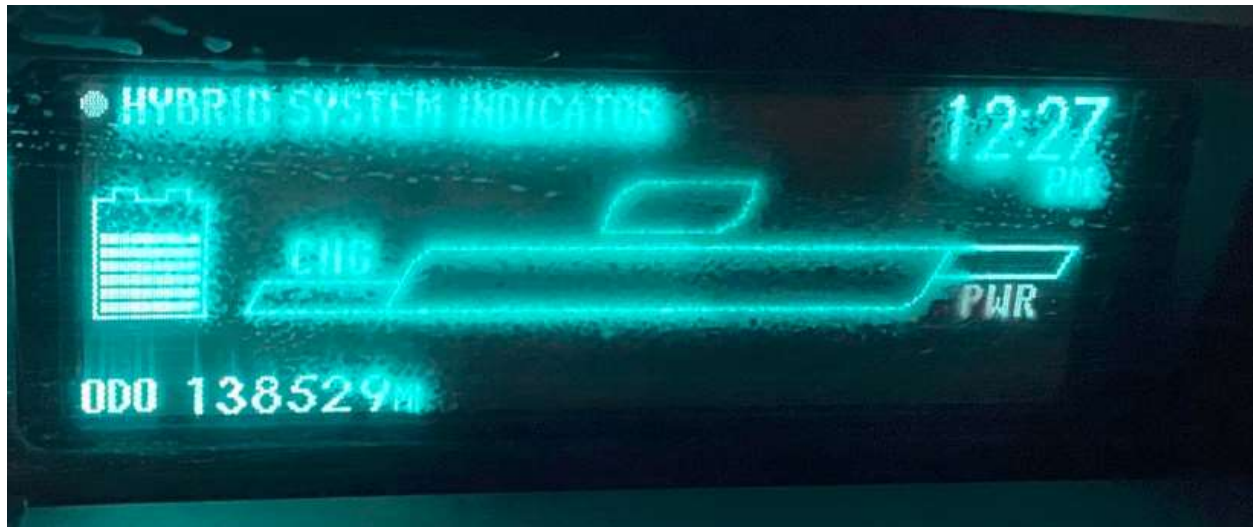
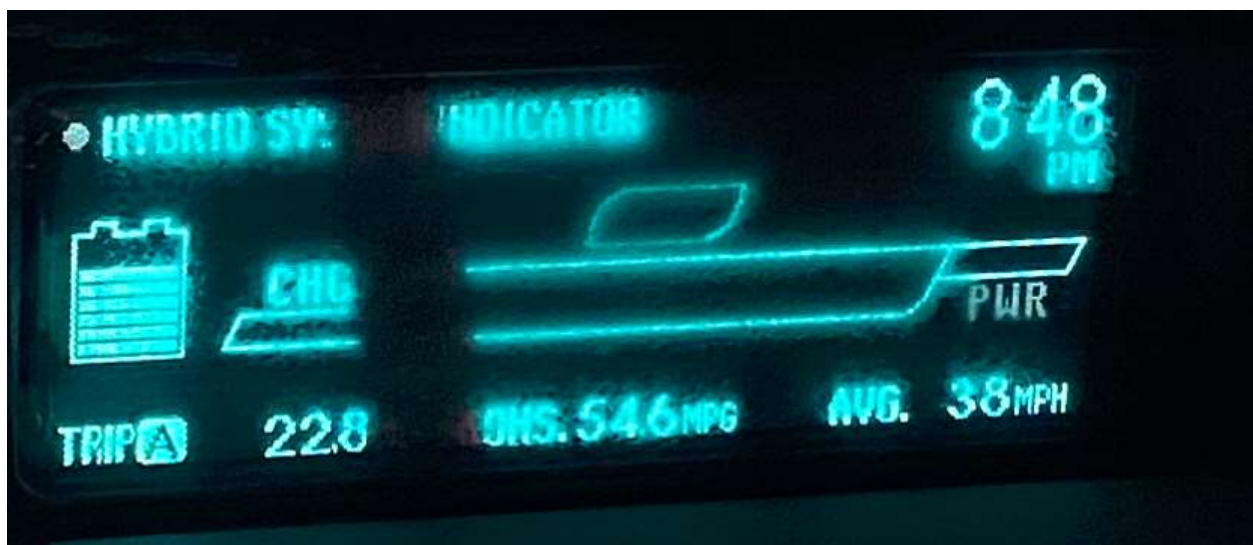
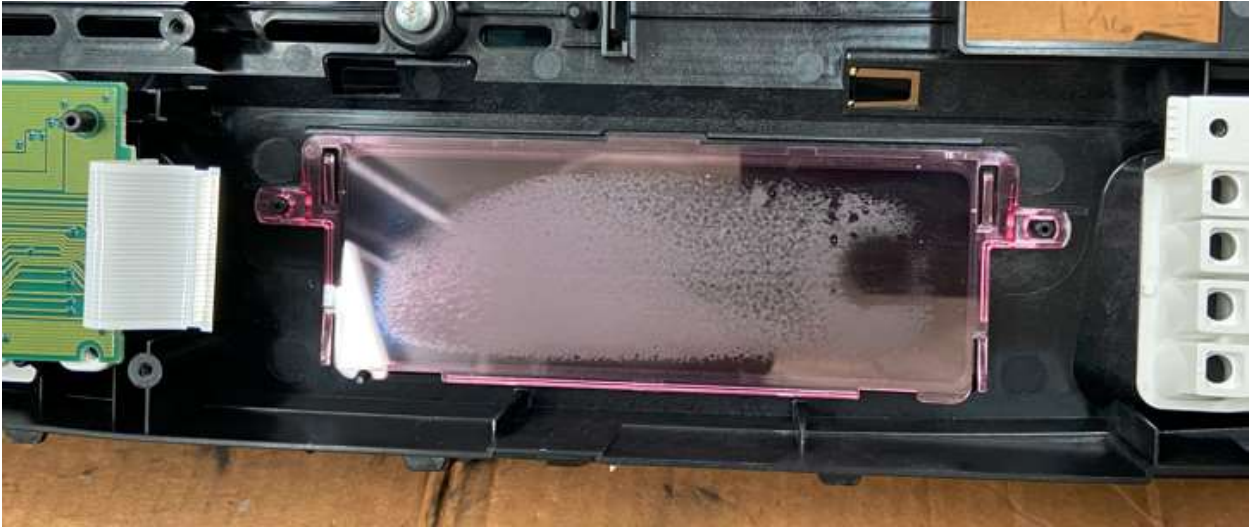
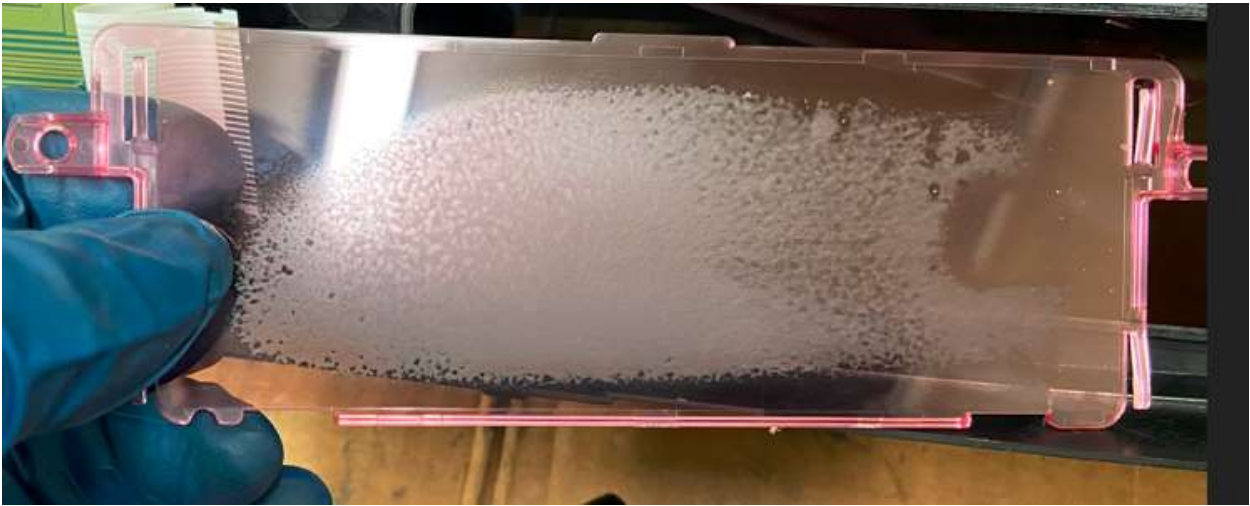
Failure Analysis: There were many theories in Prius Chat: mold, mildew, some sort of grease, or display film disintegrating; trapped moisture. Judging by the general confusion in posts, these were mostly incorrect. Upon inspecting my assembly – after removing from the car, and after disassembling the cluster itself: Blurriness develops from an overheated or over-radiated pink plastic coverplate that sits in front of the ICP energy display. The ICP display itself is a thick piece of glass sitting behind the pink plastic coverplate. It appears like this glass is too hot or too close to the coverplate. Over time, maybe display overheats due to electronics degradation; maybe it's just too close to the coverplate; or maybe the coverplate plastic material is just too weak/soft and prone to overheating; or changing from the display radiation, like how plastic degrades in sunshine. It appears like heat is the cause, and the plastic coverplate slowly liquifies and dries in repetitive cycles as you drive the car over the years. This results in a haze over the coverplate, which looks like mold/mildew/grease/moisture; but isn't. Imagine taking a heat gun to some plastic. So the finish fades and it's very similar to the haze buildup on plastic headlights over the years. This, by the way, is a clue on how to fix the problem.

1. My before pictures, showing the haze:

6. Next, the "light bulb" goes off - this problem is like hazy headlights. luckily, I had some Meguiars headlight haze polishing gel & some pads. since the plastic seemed very soft, I didn't use the two high-grit pads in the Meguiar kit. I figured this might be too much for the little piece. I went to the last step in the headlight cleaning process. I just used the gel and a microfiber cloth. this took about 5 minutes of polishing, and in the process, I could see very faint polishing scratch marks - just from the gel. The gel has a very fine suspension of grit. It was scratching the coverplate, but also clearing the problematic haze - or gooped up plastic. I figured, the very faint scratches wouldn't be visible once assembled back in the car, and this was a good trade off. You could only see these polishing marks when holding the coverplate to the light at the correct angle. Anyway, after about 4-5 applications of gel and polishing, the haze disappeared!

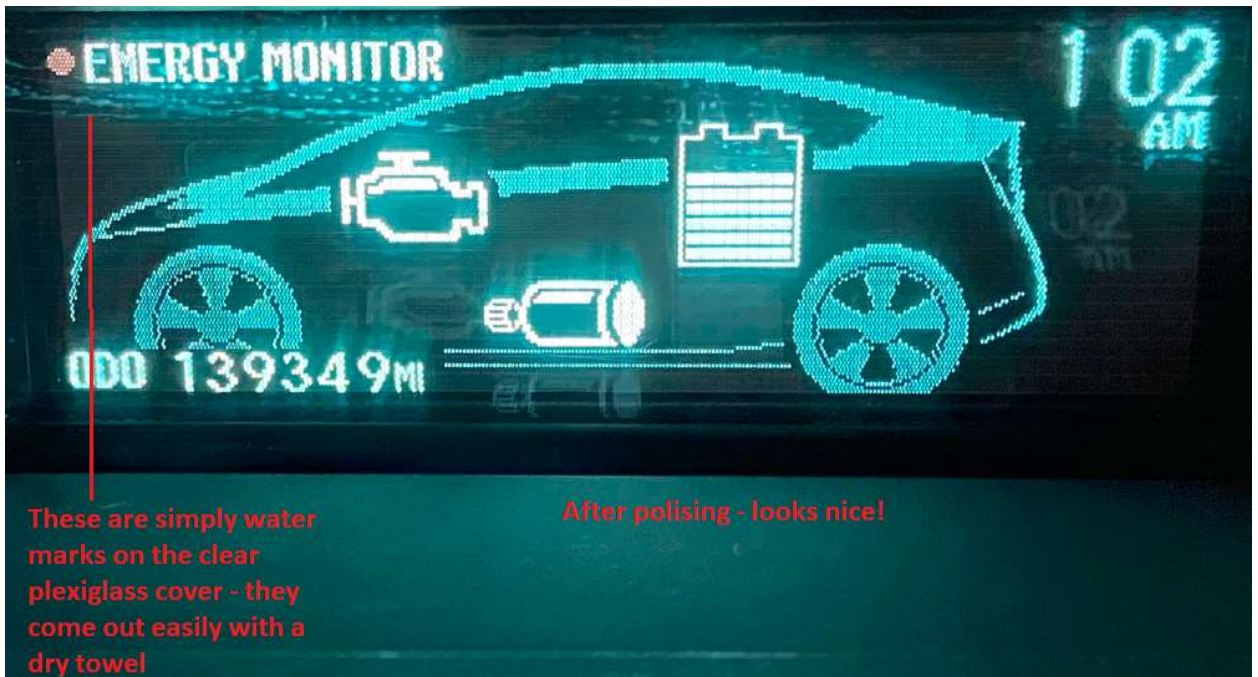
The result looks much better after polishing. I probably got the thing to almost like new. It will probably start to occur again over time, but I hope to get 10-30k on it before it goes bad. I may eventually invest in a newer ICP, but this is also a pain. See why in my additional comments below. Anyway, hope this helps!

2. My pictures, after polishing:

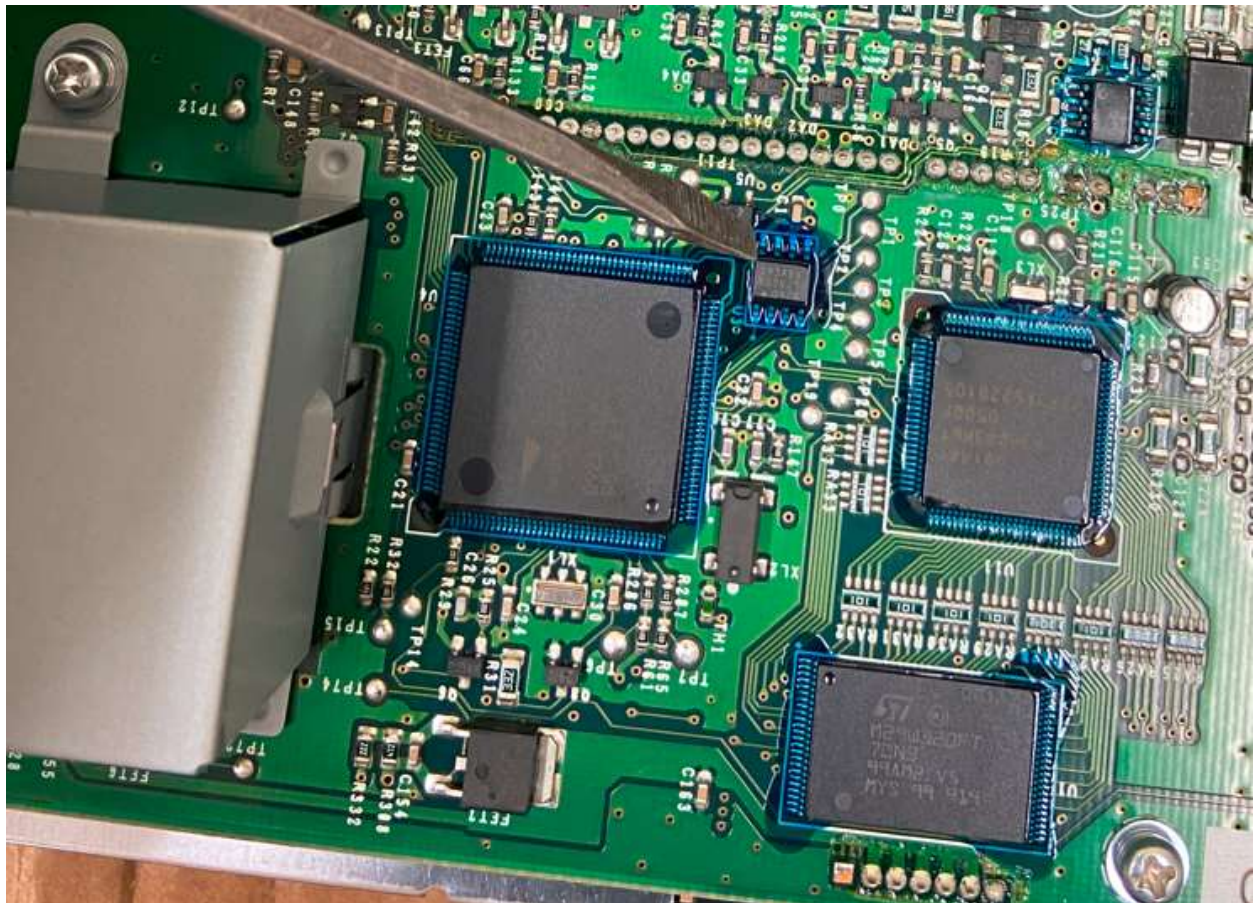
3. \*\*\* if you are thinking of getting a replacement ICP, remember that the mileage is stored on a little EPROM chip on the assembly PCB. See picture. this is a pain in the ass to re-program but can be done. To sidestep this, you could get a used ICP with whatever mileage the donor car had on it, but this would raise big red flags during a resell condition. My best thought here is to get someone/company to re-program the donor ICP before installing. Or you can do this trick: A. buy ICP with slightly more miles than your car; B. Temp Install new ICP to see its mileage; C. reinstall your old ICP; D. Drive until car is at new ICP mile marker; E, final install the new ICP. this delays gratification and is also a pain the butt. This company is Wisconsin appears to have a re-programming service: [Tanin Auto Electronix | Auto Repairs, Sales and DIY Parts](https://www.taninautoelectronix.com/) <https://www.taninautoelectronix.com/>

5. If you want to turn this into a full-time hobby, can de-solder this chip and program it – to adjust mileage on the new ICP, which you purchase from Internet. You might also consider simply swapping these chips from your old PCB to the new “used” one. Chip number is 93A86, where “A” could be different revisions. I wouldn’t try supplanting your old chip into a new PCB, unless the part numbers are exact.
