Air Conditioning System - Improved Component Inspection

USA

Toyota

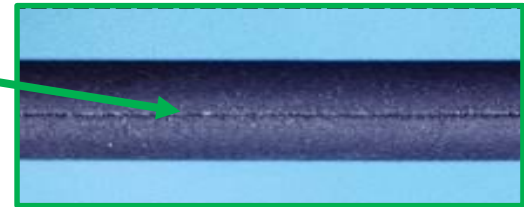
Twisted O-Ring – No Good Part
 Line at middle of O-ring is not straight.

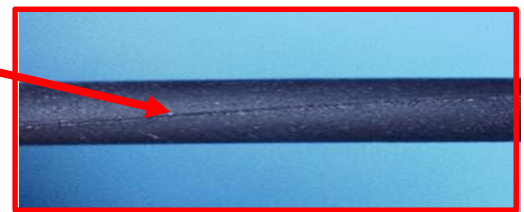
Cut/Dent/Crush – No Good Part
 O-ring damaged by another component. Replace O-ring, proceed with A/C Pipe Inspection.

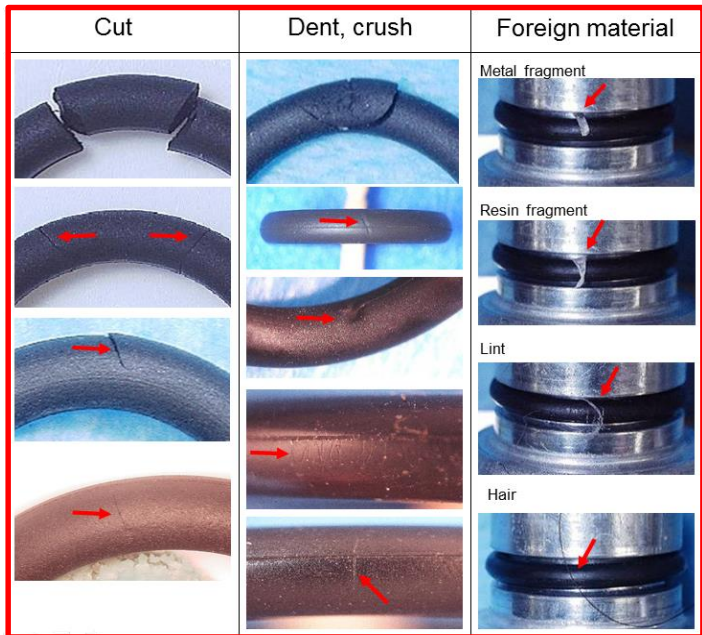
Foreign Material– No Good Part
 O-ring contaminated by material outside A/C system. Replace O-ring, proceed with A/C Pipe inspection.

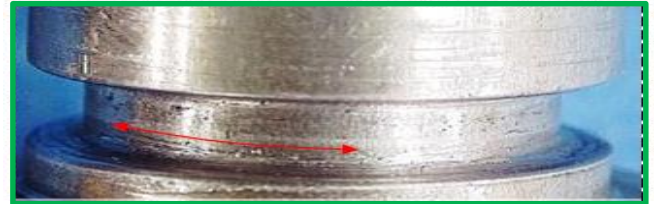
OK Part - Light scratching parallel with O-ring groove. This is caused by normal part processing. Pipe is ok to reuse.

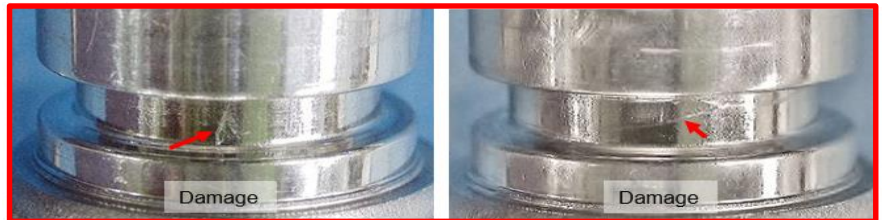
Damage – No Good Part
Pipe is damaged due to deep scratching or gouge of base metal. Pipe replacement is recommended to prevent repeat repair.

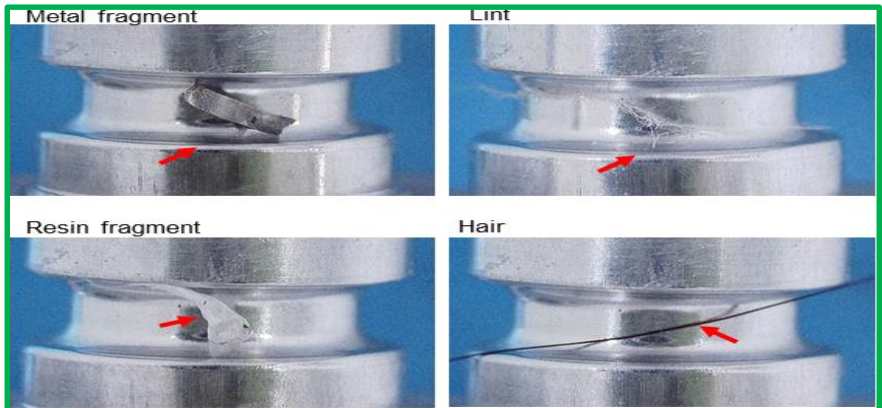
Foreign Material – OK Part
Pipe has foreign material stuck to it. Material can be cleaned off using a non-metallic tool and the pipe is ok to be reused.

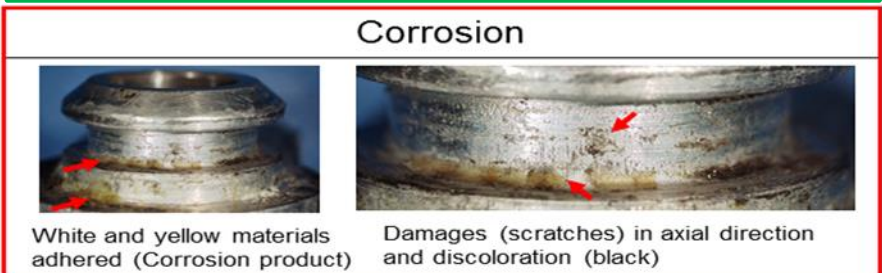
Corrosion – No Good Part
Pipe is damaged due to corrosion of base material. Pipe replacement is recommended to prevent repeat repair.

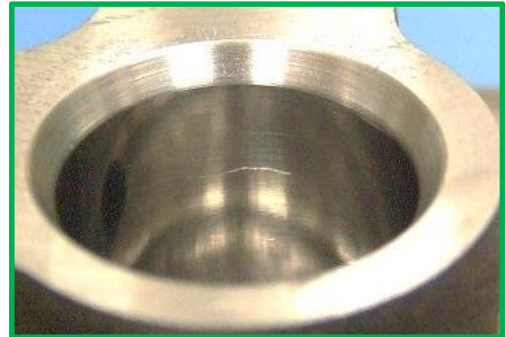
OK Part - Light scratching parallel with O-ring groove. This is caused by normal part processing. Compressor is ok to reuse.

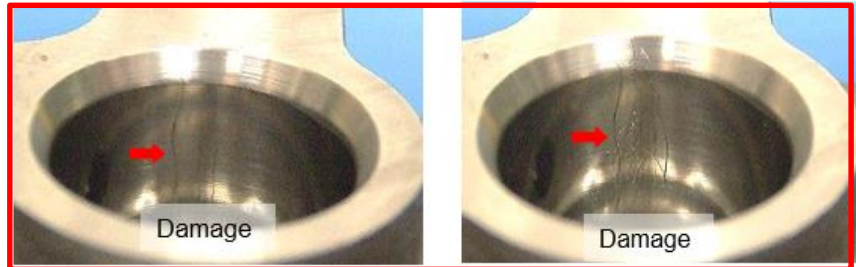
Damage – No Good Part
Compressor seal bore is damaged due to deep scratching perpendicular to O-ring groove.

Compressor replacement is recommended to prevent repeat repair.

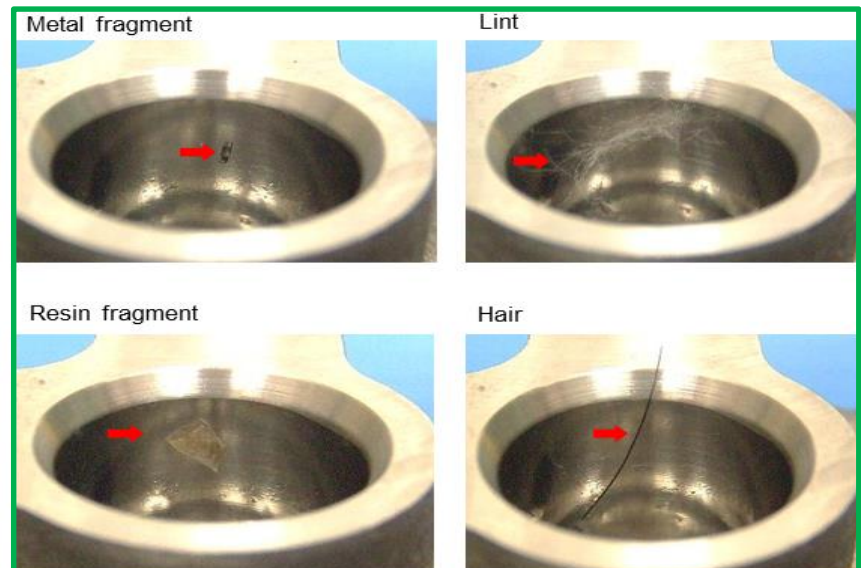
Foreign Material – OK Part
Compressor has foreign material stuck to seal bore.

Material can be **carefully** cleaned off using a non-metallic tool and the compressor is ok to be reused.

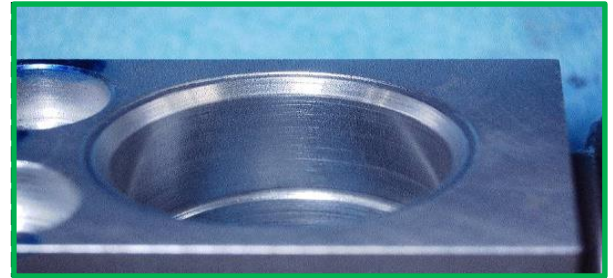
OK Part - Light scratching parallel with O-ring groove. This is caused by normal part processing. Expansion valve is ok to reuse.

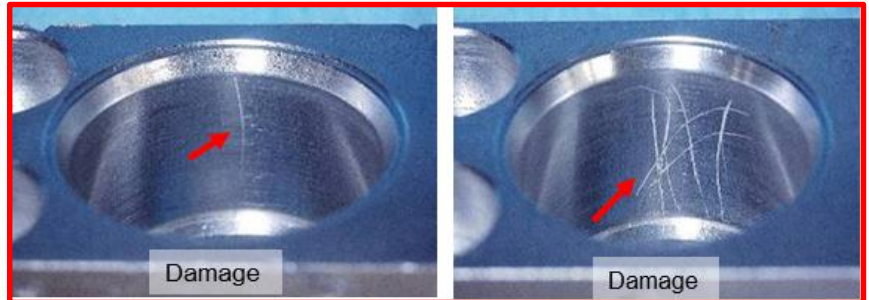
Damage – No Good Part
Expansion valve seal bore is damaged due to deep scratching perpendicular to O-ring groove.

Expansion valve replacement is recommended to prevent repeat repair.

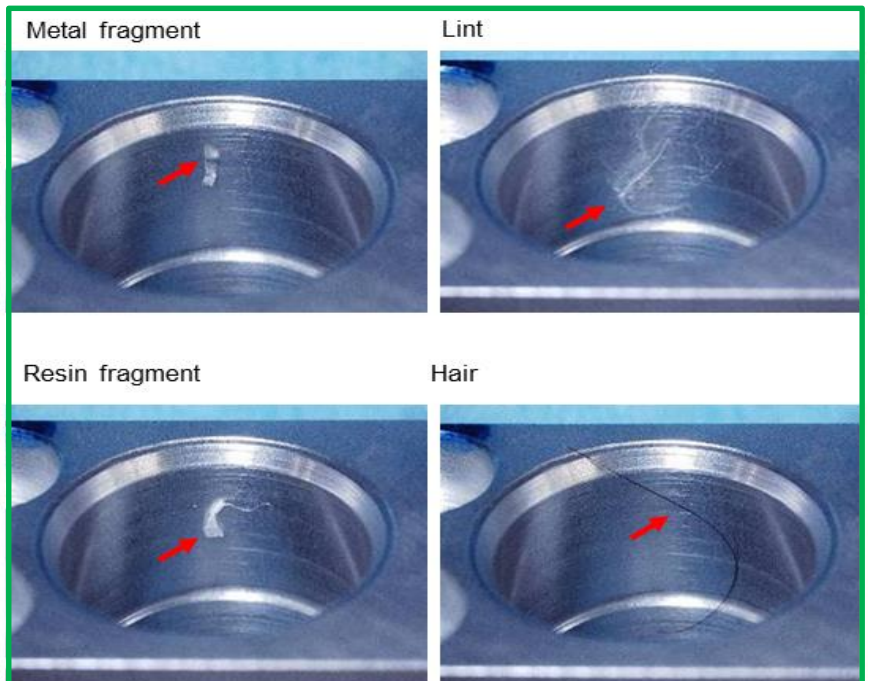
Foreign Material – OK Part
Expansion Valve has foreign material stuck to seal bore.

Material can be **carefully** cleaned off using a non-metallic tool and the expansion valve is ok to be reused.

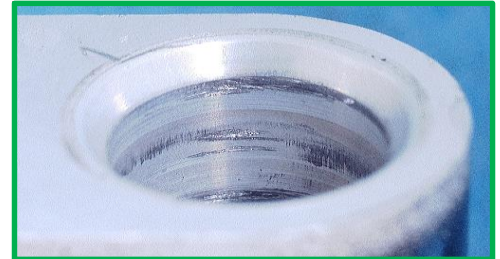
OK Part - Light scratching parallel with O-ring groove. This is caused by normal part processing. Condenser is ok to reuse.

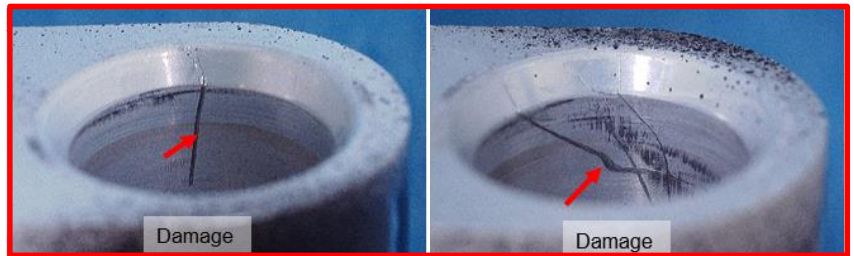
Damage – No Good Part
Condenser seal bore is damaged due to deep scratching perpendicular to O-ring groove.

Condenser replacement is recommended to prevent repeat repair.

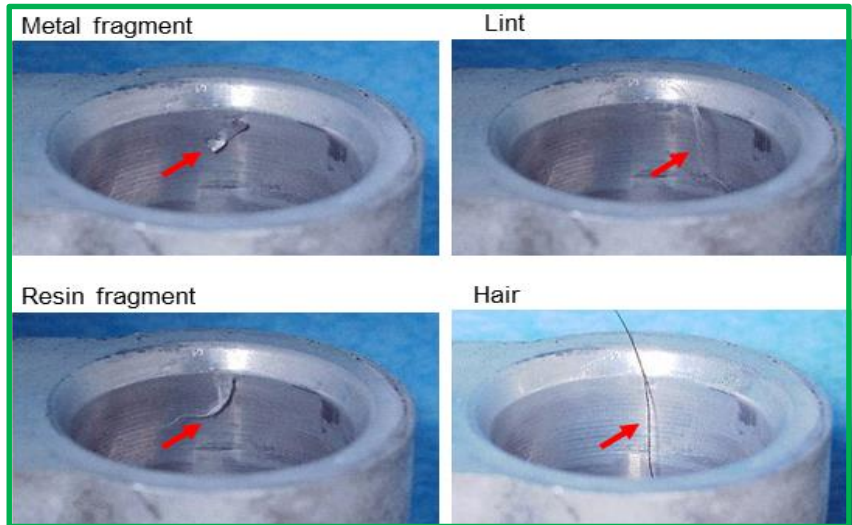
Foreign Material – OK Part
Condenser has foreign material stuck to seal bore.

Material can be **carefully** cleaned off using a non-metallic tool and the condenser is ok to be reused.

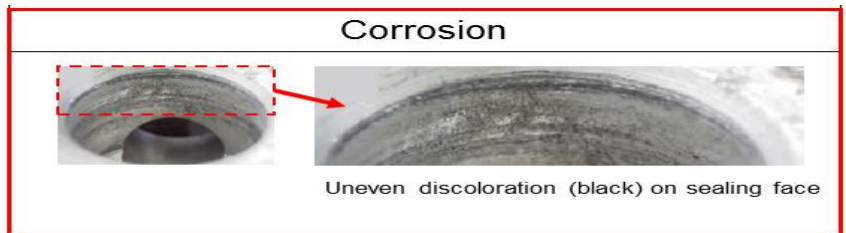
Corrosion – No Good Part
Seal bore is damaged due to corrosion of base material.

Condenser replacement is recommended to prevent repeat repair.
