Tire Pressure Monitoring System (TPMS) Tire Registration "Lost Communication With ECU"

Service Category Suspension

Section Tire Pressure Monitoring

The purpose of this bulletin is to provide procedures on Tire Pressure Monitoring System sensor registration when Lost Communication With ECU appears on the Techstream display.

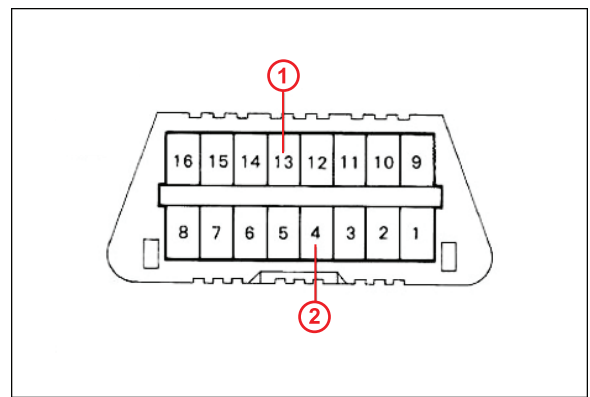
Figure 1.

1	TC
2	CG

If "Lost Communication With ECU" appears during the registration process, then terminals TC and CG were not connected properly or the key was cycled during this process.

1. Connect TIS Techstream to the vehicle
2. Turn the ignition switch to the "IG-ON" position.
3. Select the datalist for the Tire Pressure Monitoring System.
4. Check and set all tire pressures to specification with an accurate tire pressure gauge and compare the information to what is displayed on the datalist.
5. After checking the tire pressure, record the TPMS sensors ID numbers.
6. With the vehicle set to "IG-ON" mode, disconnect the TIS Techstream.
7. Using Jumper wire or equivalent, connect terminals TC and CG at the DL3 connector for at least 30 seconds. Do not cycle the ignition switch to "OFF" position during this step. (Landcruiser use TC and E1 at DLC1)

8. Once 30 seconds have passed, with the vehicle still in "IG-ON" mode, remove the jumper wire.
9. Connect TIS Techstream and begin the registration process.
