TMS-NTC-13178
July 23, 2013

Re: Toyota Safety Recall 13V-235 Dealer Notification - Remedy

Subject: Safety Recall D0H – **Remedy Available**
Certain 2010 Model Year Prius
Brake Booster Pump Assembly (Accumulator)

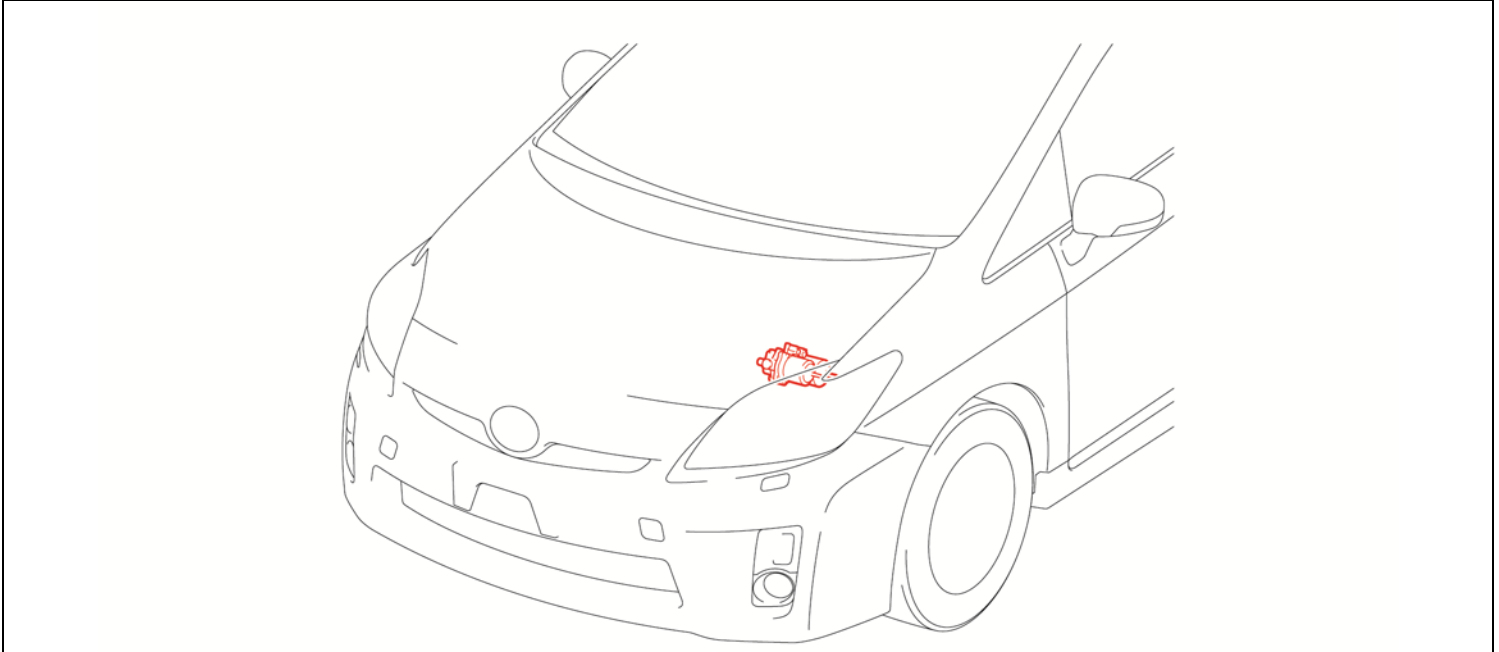
II. BACKGROUND

The subject vehicles are equipped with brake pressure accumulators consisting of a metal plunger containing brake fluid encased in a metal housing. The plunger is designed with metal pleated bellows to allow for motion. Nitrogen gas is sealed between the plunger and housing. There is a possibility that a fatigue crack could develop in the bellows due to the vertical vibration of the plunger while driving. If this occurs, nitrogen gas could leak into the brake fluid and gradually cause the brake pedal stroke to become longer, resulting in decreased hydraulic pressure. Under certain circumstances, this condition could affect stopping distance and increase the risk of a crash.

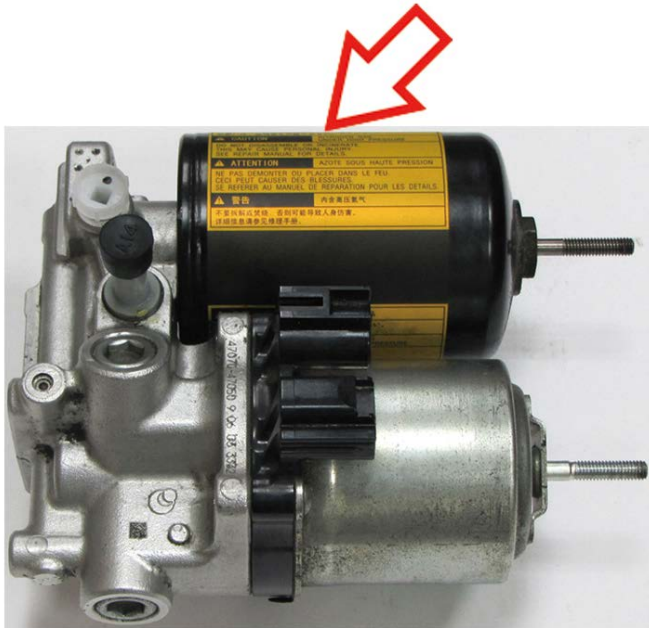
CONDITION 1

Label is **HORIZONTAL** on accumulator
Accumulator replacement **REQUIRED**

The accumulator is affected and replacement is required. Proceed to **STEP 3**. To determine if additional parts require replacement.

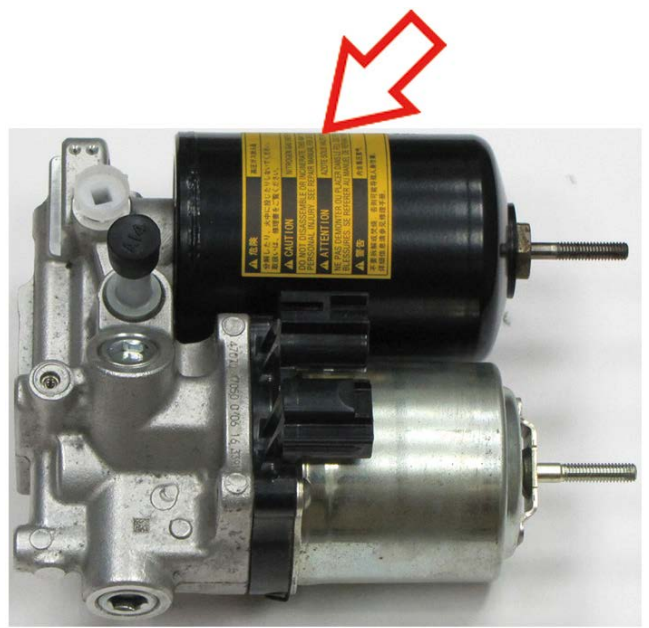
CONDITION 2

Label is **VERTICAL** on accumulator
NO NEED to replace accumulator

The accumulator **IS NOT** affected and **DOES NOT** need to be replaced. Reassemble the vehicle. Campaign complete.
