L-SB-0061-12

# MIL "ON" DTC P2111 and P0A0F After Cold Soak

YEAR(S)	MODEL(S)	ADDITIONAL INFORMATION	
2011 – 2016	CT200H

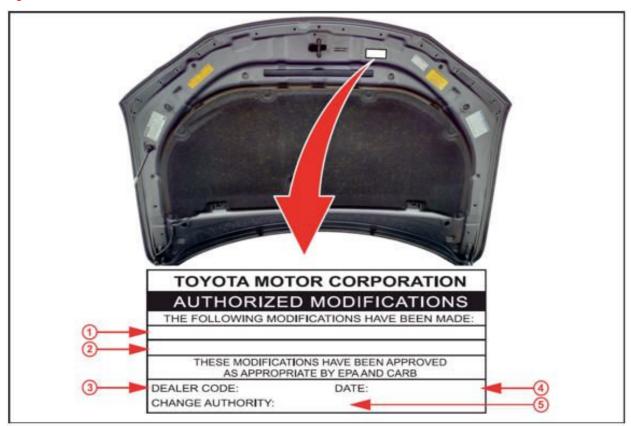
Figure 1. Location of Authorized Modification Label for CT200h

3. Check for the Authorized Modifications Label affixed to the vehicle in the location shown in Figure 1 below.

- 5. Install the Authorized Modifications Label.
  - A. Using a permanent marker, enter the following information on the label:
    - ECM Part number (Refer to the Parts Information section for the NEW PART NUMBER)
    - Calibration ID(s) (Refer to the Calibration Information section for the NEW CALIBRATION ID)
    - Dealer Code
    - Repair Date
    - Change Authority (This bulletin number)
  - B. Affix the Authorized Modification Label to the vehicle at the location shown in Figure 1. The Authorized Modifications Label is available through the MDC, P/N 00451-00001-LBL.
- 6. Confirm the Repair.
  - A. Confirm P2111 and P0A0F are not present after cold soak.
  - B. Test Drive the vehicle to confirm proper vehicle operation.
