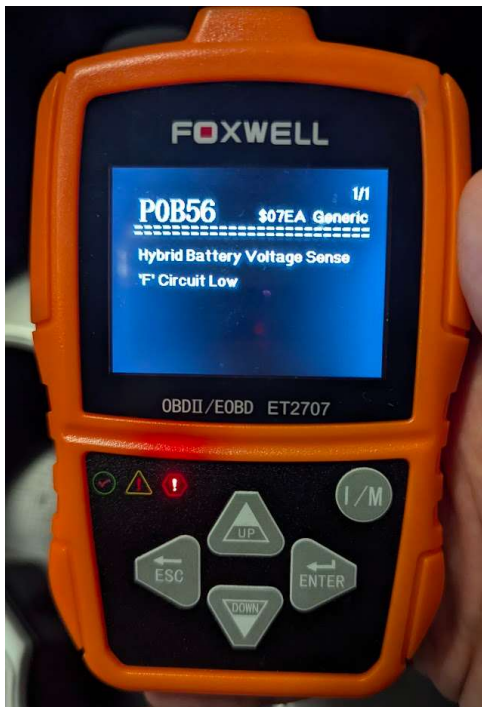
OBD reader returns code P0B56, 'Hybrid Battery Voltage Sense 'F' Circuit Low. Code was cleared but returned upon cycling ignition power.

*Figure 2 - OBD Reader codes returned*

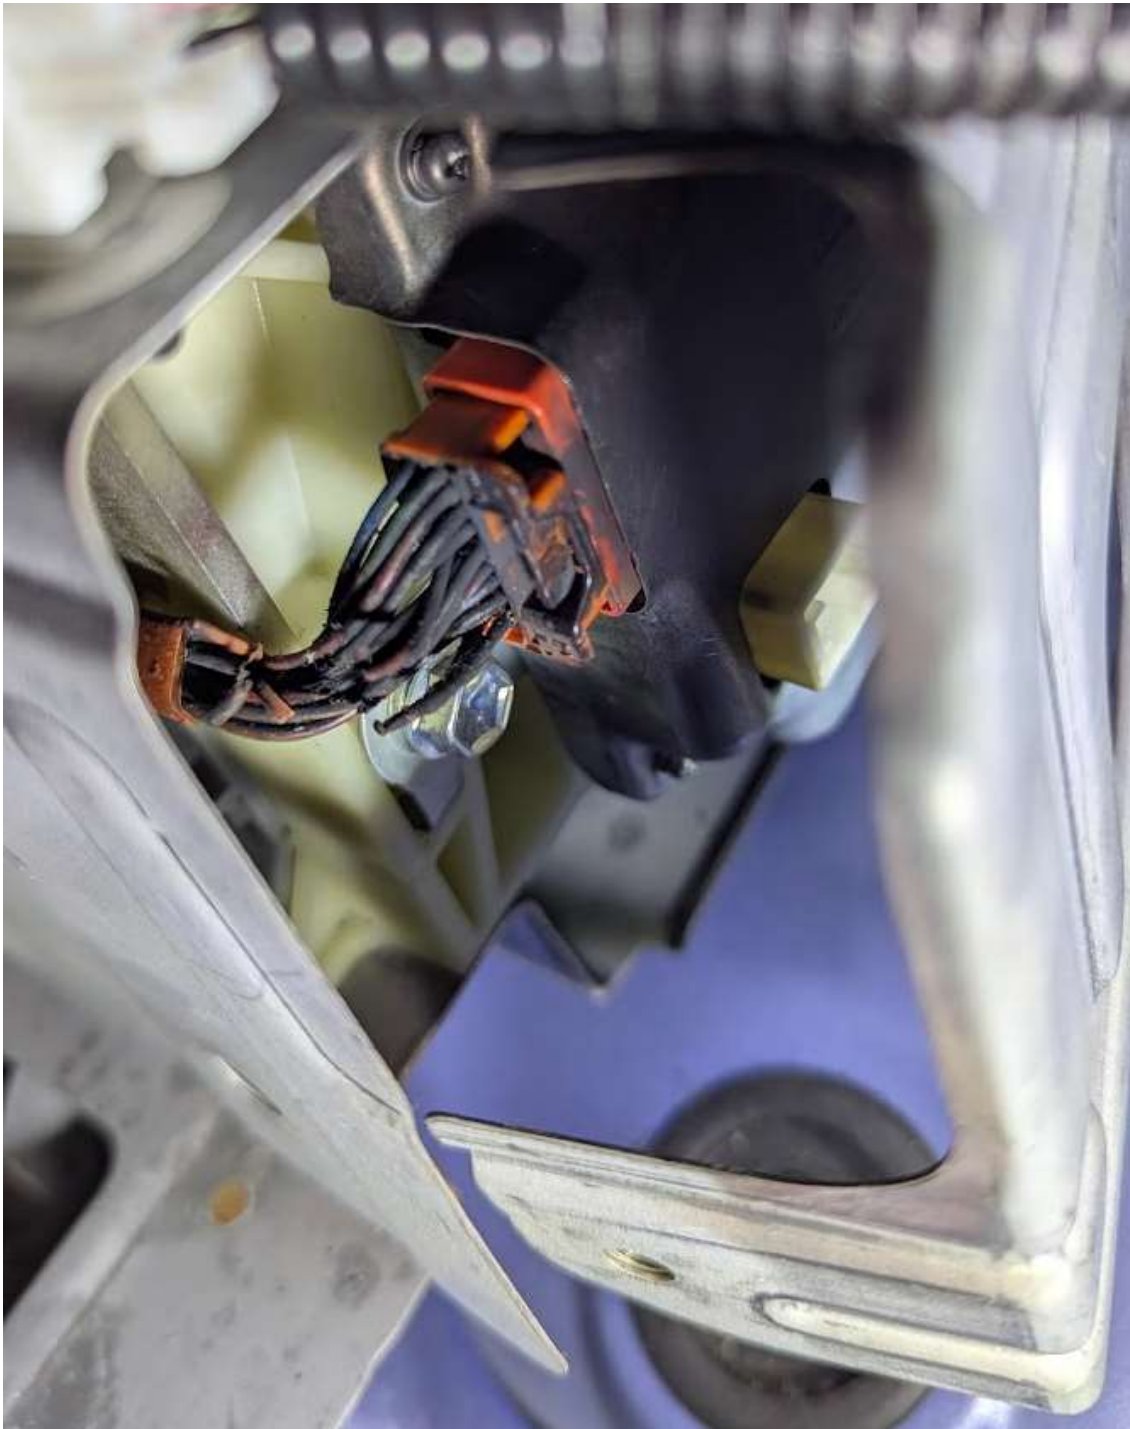
Subsequently, the HV battery pack service plug was removed and the sense voltage connector was accessed for further testing. Connector, module casing and surrounding shielding shows carbon deposits consistent with high heat, smoke, and/or fire. Several wires appear melted and are disconnected. The voltage sense plug is also corroded/melted and unable to be disconnected safely – will require removal and further disassembly of HV to assess comprehensively.

*Figure 3 - Voltage sensor connector showing carbon deposits from smoke and/or fire*

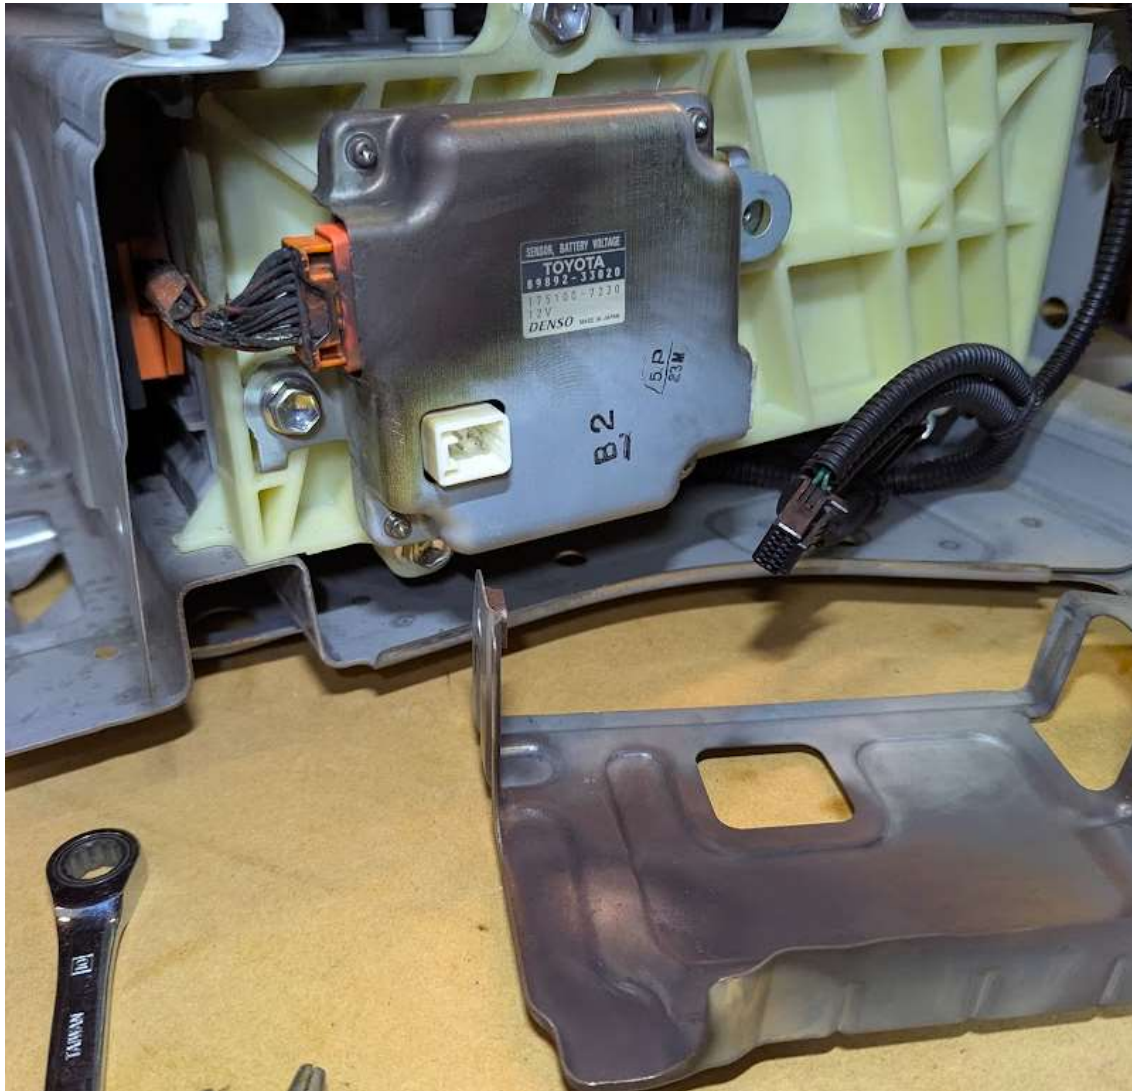
The HV Battery pack was removed from vehicle and assessed for further damage. No evidence of external causes were located.

Figure 4 - Heat/carbon damage to module and cover plates

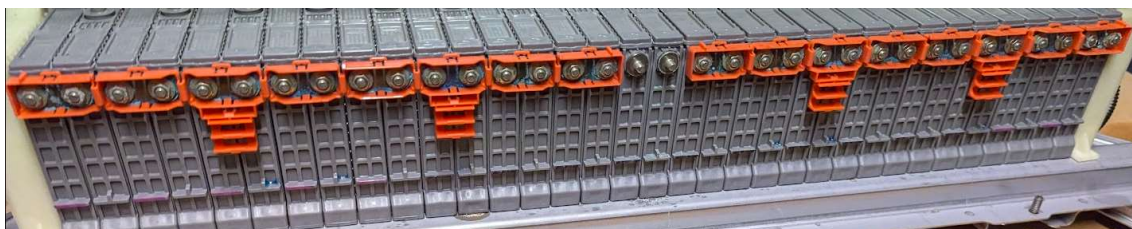
Superficial corrosion was observed on busbars and sense connectors.

Figure 5 - HV battery rear cell interface w. busbars

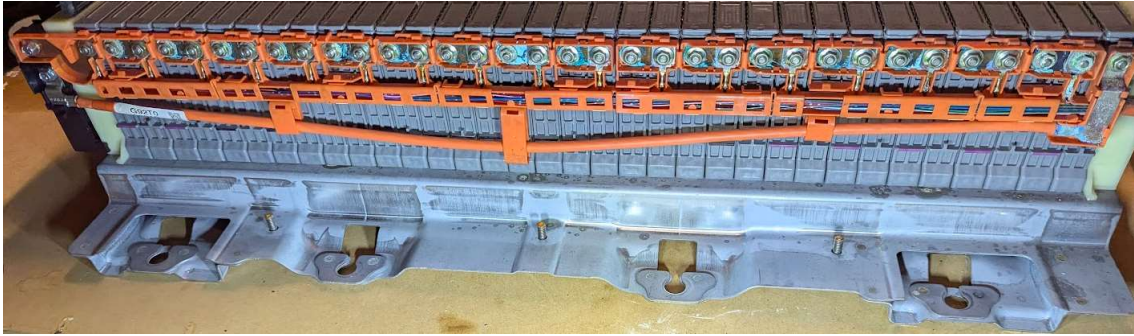
*Figure 6 - HV battery front cell interface w. busbars*

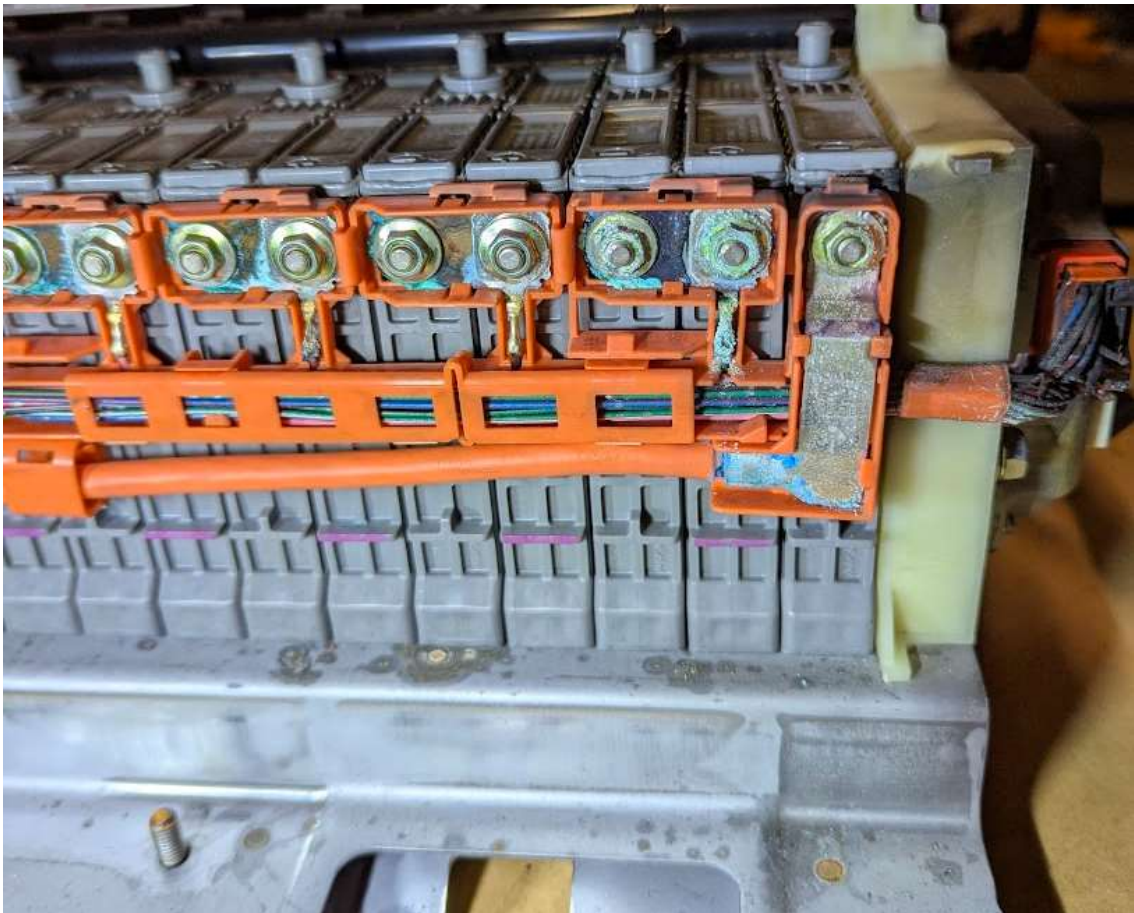
*Figure 7 - Corrosion on HV battery connections – right rear of back with melted sense wires far right*

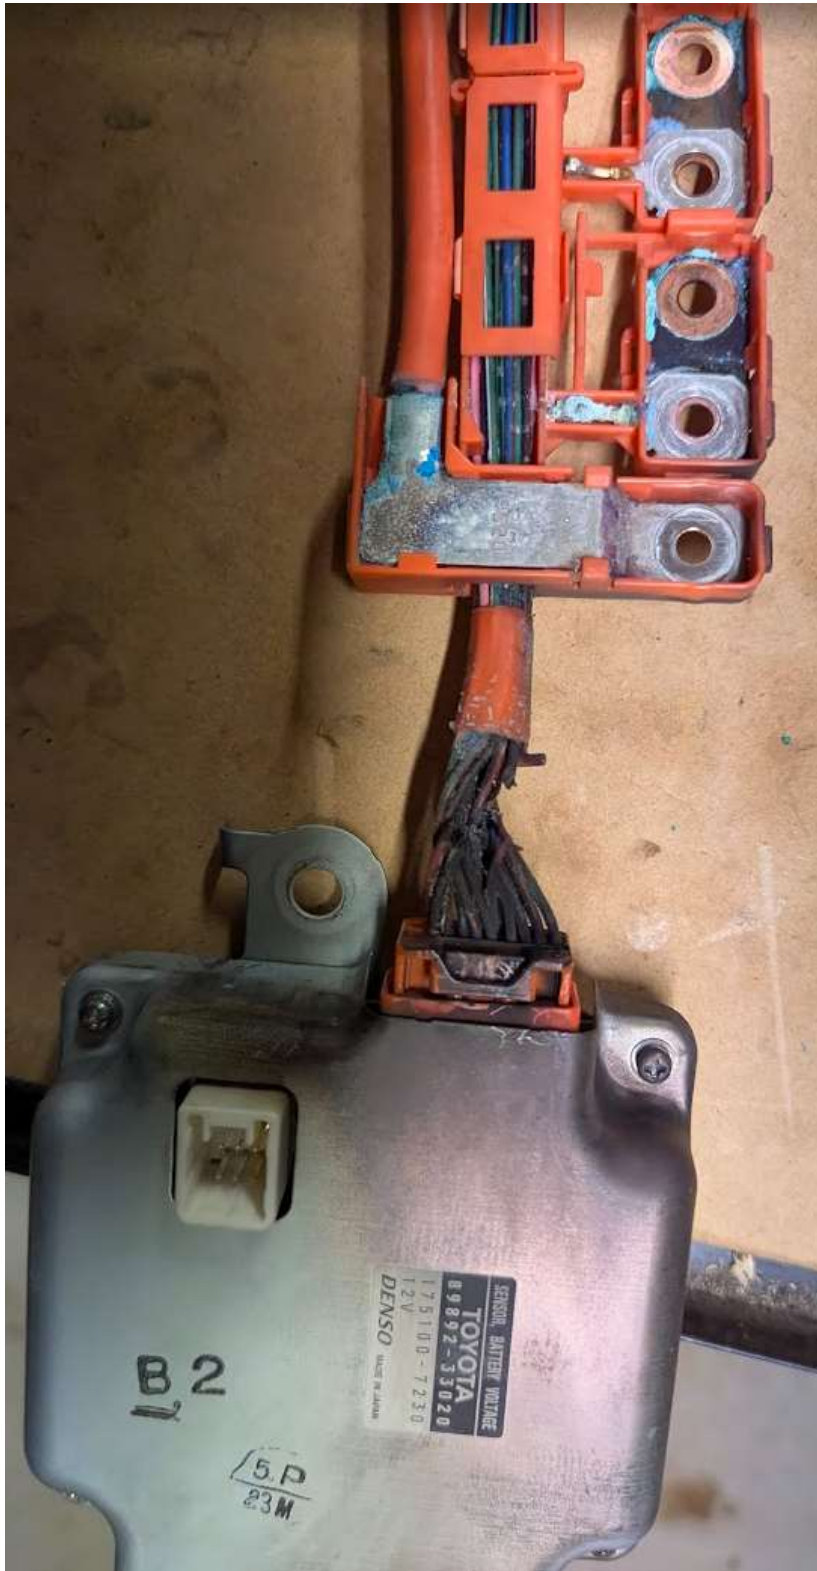
Figure 8 - 6 of 18 wires in sense harness have melted

It appears the interface between the battery voltage sensor module and wiring harness may have developed a high resistance join resulting in excessive heating, melting and smoke and/or fire.

Items requiring replacement include the voltage sensor module and battery voltage sensor harness.

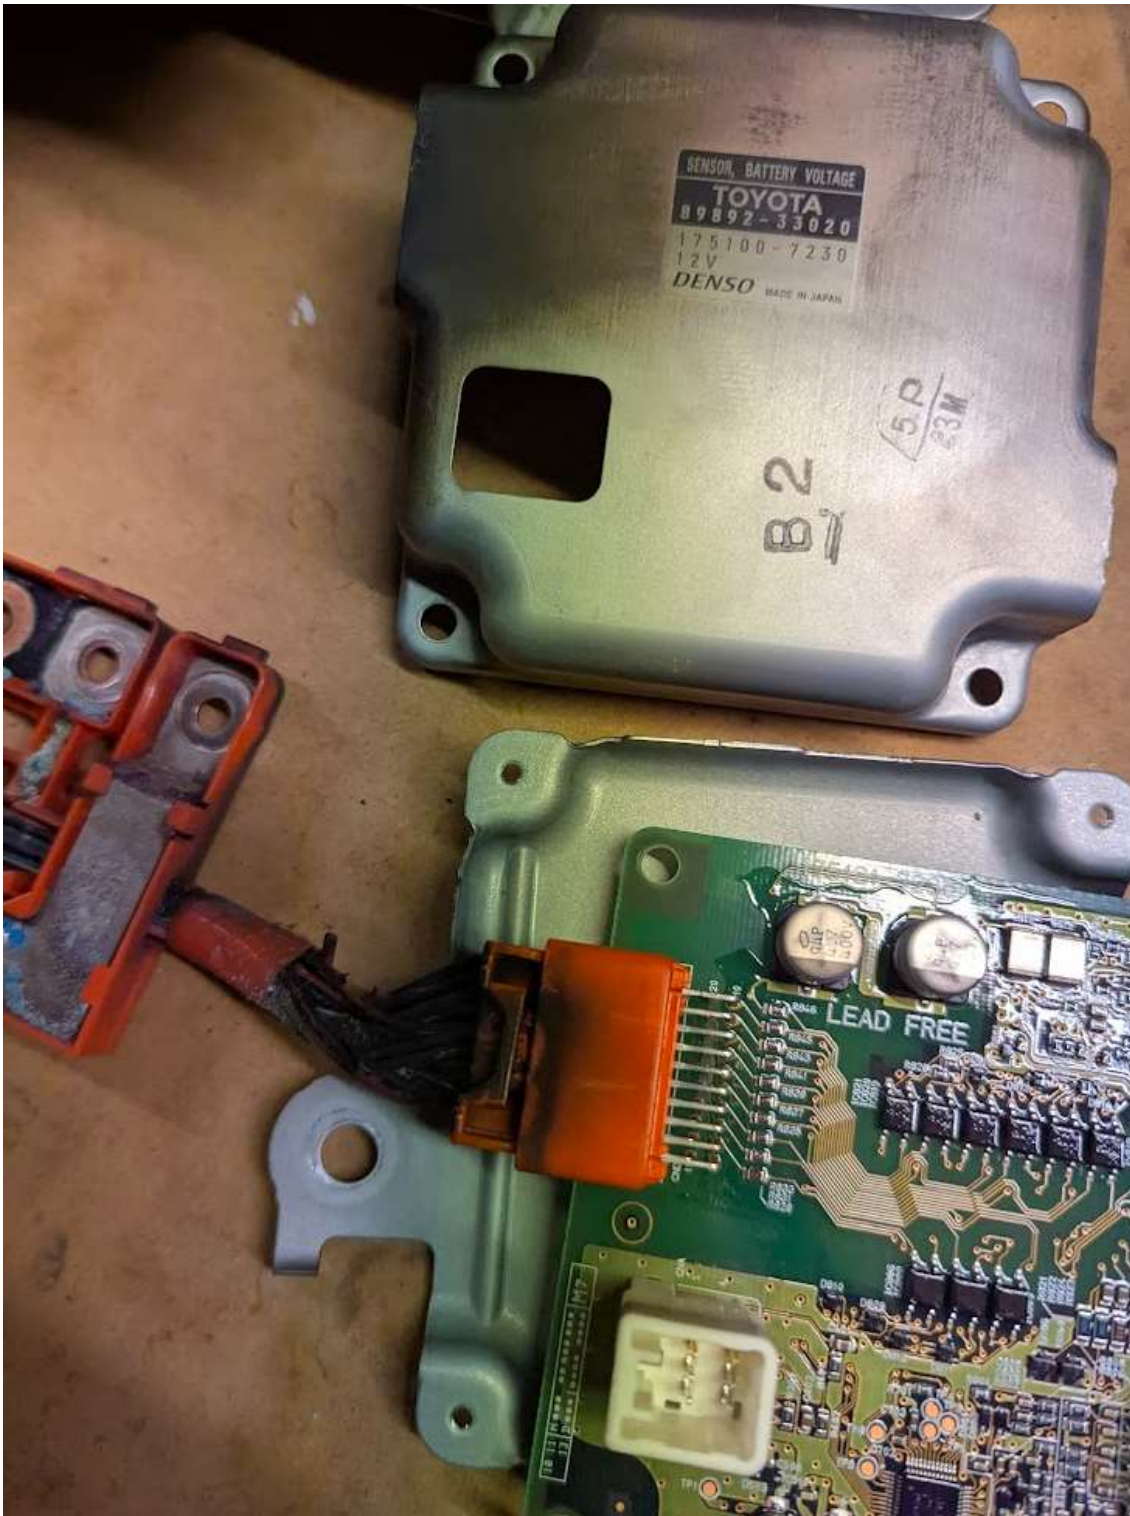
Battery voltage sensor board internally appears ok, including soldered pins to board. Connector itself has sustained damage.

Figure 9 - Battery voltage sensor module board and connector

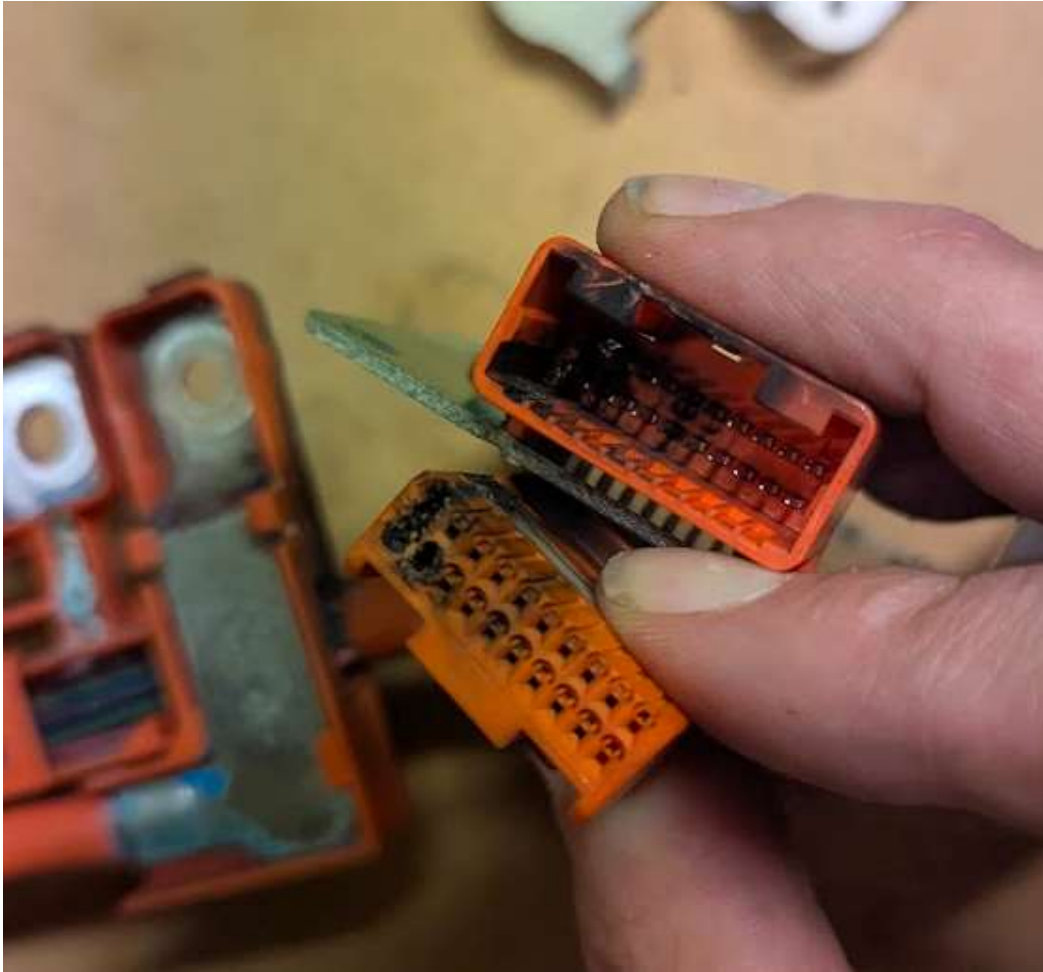
Plug is burnt/melted and required significant effort to remove, noting 2 of 18 connected male pins have the female terminal melted onto them.

*Figure 10 - Melted/burned connector.*

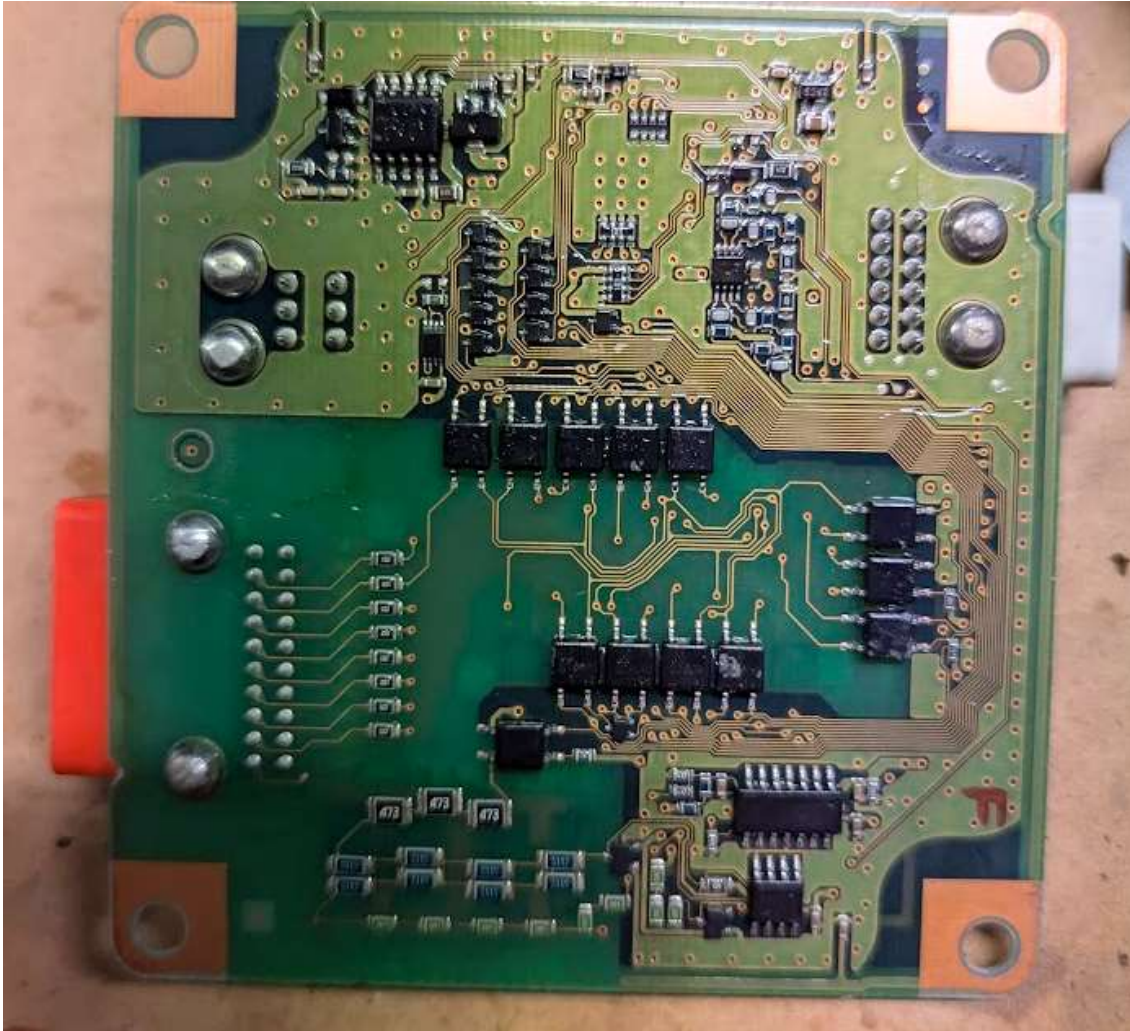
Underside of voltage sensor board also shows no visible issue, including sense harness connector

*Figure 11 - Underside of battery voltage sensor board*

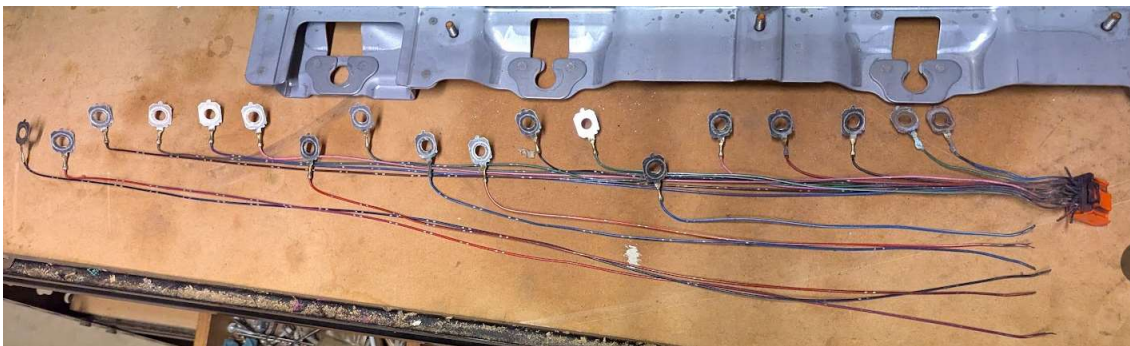
The sense harness was disassembled, confirming that out of 18 wires, 6 had been completely melted and disconnected and a further 2 were partially damaged.

*Figure 12 - battery voltage sensor harness*
