# TOYOTAtech

## How to Find Toyota Ignition System Faults Fast! Dotting the IGFs and Crossing the IGTs

July 2021

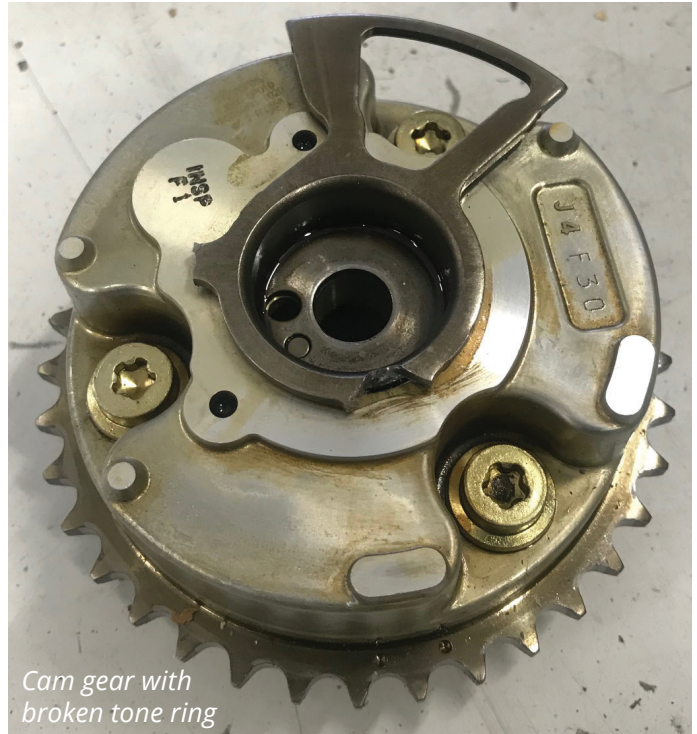
The magnet on the camshaft sprocket originally had three protrusions. Two had broken off (see “Cam gear with broken tone ring” on previous page), which explained the two missing pulses in the waveform. This signal is used for injector timing and ignition timing. The truck was able to start without a proper signal, but it caused an extended crank while the ECU searched for the expected sensor output, and of course a trouble code once it realized the sensor output was incorrect.

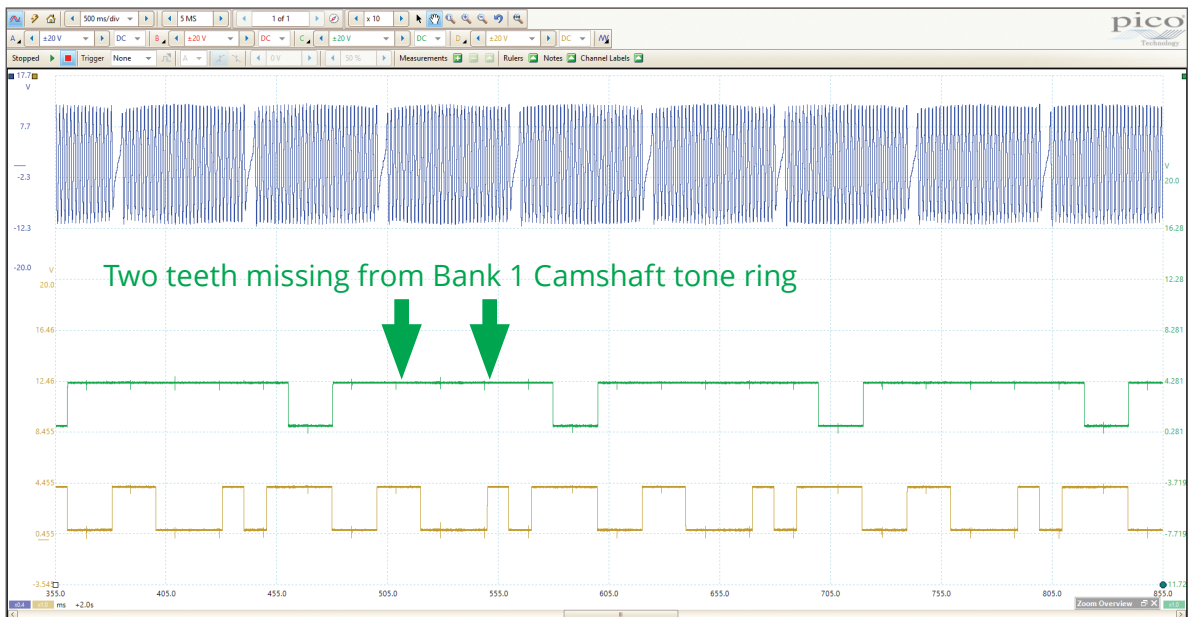
2009 Tacoma Cam - Crank Waveform

symptoms for this truck were the check engine light being illuminated and an extended cranking time. Hooking up a lab scope to the crankshaft sensor and both camshaft sensors resulted in the “2009 Tacoma Cam - Crank Waveform” shown on the previous page.

The variable reluctance crankshaft sensor is shown with the blue trace and the Hall effect camshaft sensors are shown by the green and gold traces. The capture clearly shows two missing pulses from the green camshaft sensor trace.

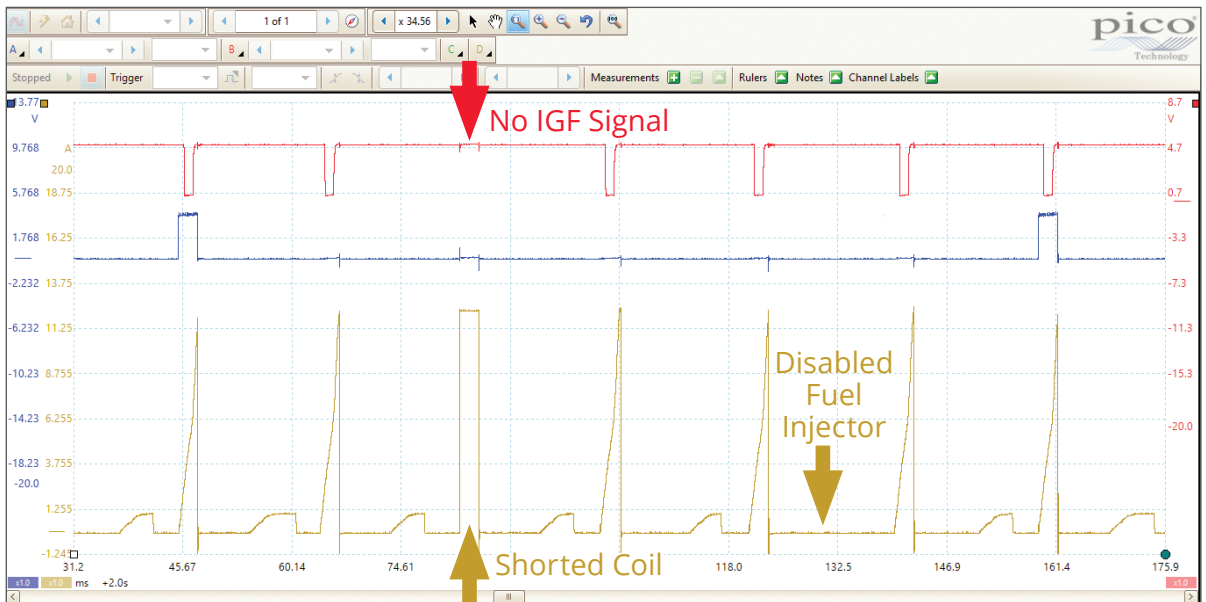
Sienna 3MZ-FE Shorted Ignition Coil

This first vehicle study is taken from a 2006 Sienna with a 3.3L V6 3MZ-FE engine. This vehicle had a single cylinder misfire and the check engine light was flashing. The faults present were a P0305 and

P0355 for a Cylinder 5 Misfire and Cylinder 5 Primary/Secondary Circuit. In this transversely mounted V6 engine, cylinder 5 is on the rear bank covered by the intake plenum.

With the preferred testing method of using three channels of a lab scope the problem can quickly and easily be identified. There is no need to swap components to a different cylinder to see if the fault will follow. The waveform clearly shows that Cylinder 5 ignition coil is completely shorted, with no gradual ramp up to the current flow. The shorted coil has resulted in no IGF confirmation signal. The ECM then sets the P0355 Primary fault and shuts down fuel injector operation for that cylinder.

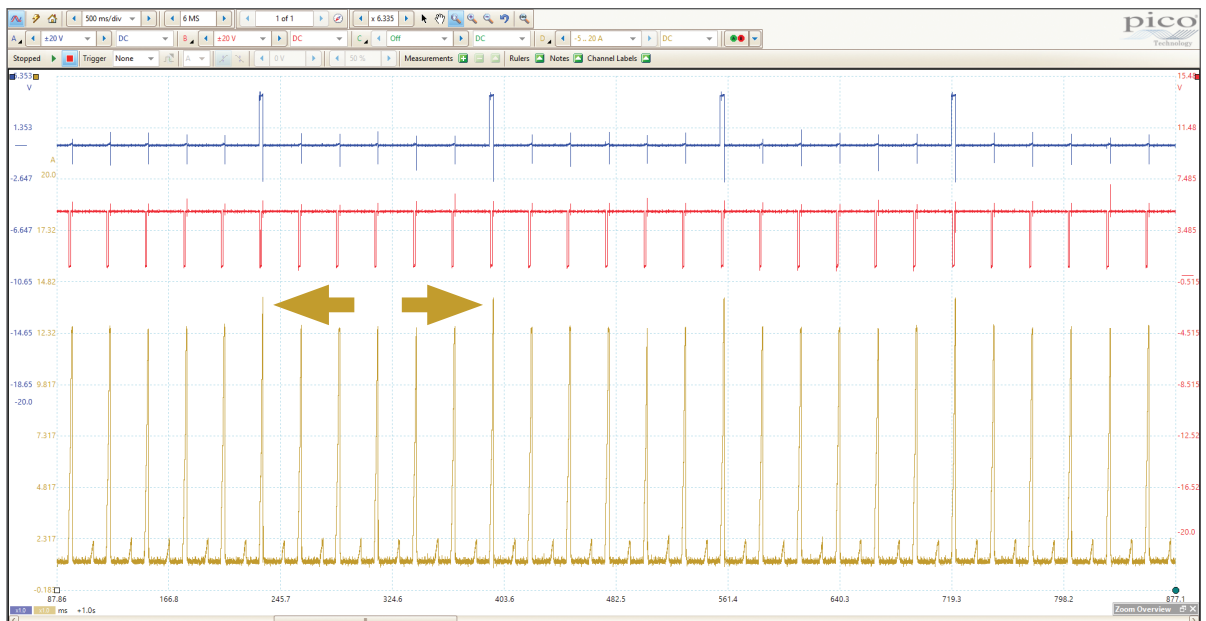
Ignition Coil with Excessive Current

Using the same testing method of an amp clamp on the ignition coil fuse and two channels on the IGT and IGF signal wires, the following waveform was captured. The image shows the cylinder 4 ignition coil current-limiting ability has failed. The coil is drawing 14 amps of current, when all the others are at 12 amps or less. This excessive current affects the IGF

confirmation signal for this coil, keeping in mind that the IGF signal is created by circuitry inside the ignition coil.

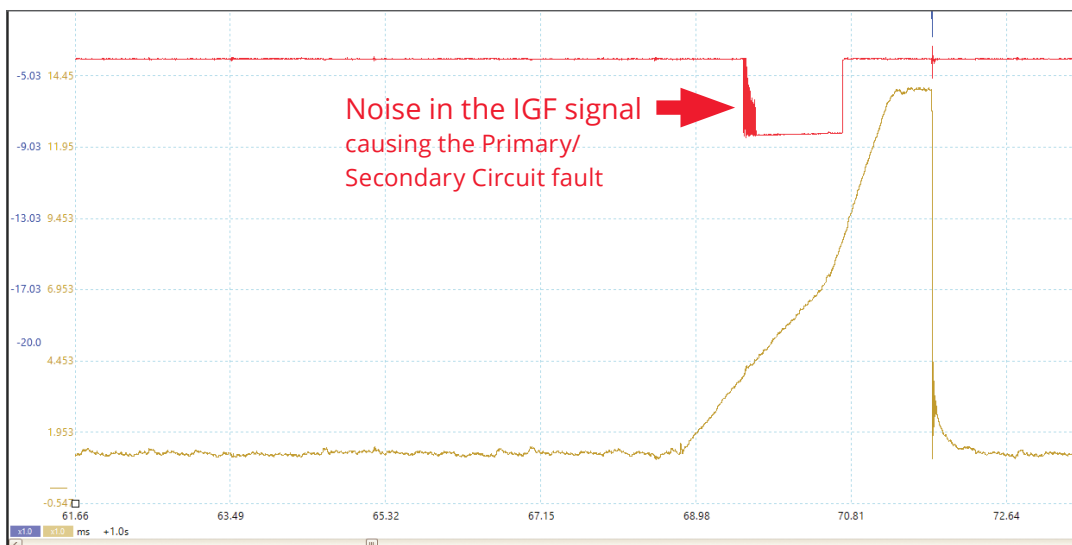
Faulty IGF Signal

Zooming in on one of the Cylinder 4 ignition event shows the IGF signal breaking down. Ultimately, the real cause of the misfire on this vehicle was the IGF circuit inside the cylinder 4 ignition coil. The excessive coil current caused the

IGF signal to break down which the ECM interpreted as an ignition failure and disabled the fuel injector resulting in the intermittent rough running this RAV4 was experiencing.

The misfire detection system often flags misfires for several cylinders, or even all the cylinders, when a primary circuit fault code is present. The best practice in this situation is to focus testing and repair efforts toward the cylinder with the primary fault code. In most cases,

the remaining misfires were sympathetic faults flagged incorrectly and will not return.
