GenIII Prius Intake Manifold

Example #1: Prius.1 2010 with clogged Intake Manifold. Generating P0304 misfire codes.

Example #2: Prius.2 (Different Car, Same Issue)

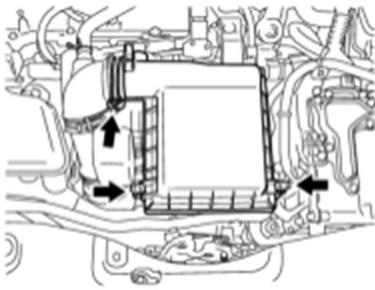
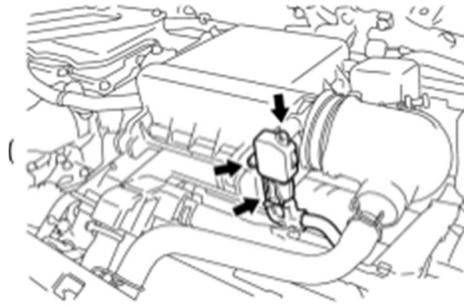
Air Filter Cap + Mass Air Flow Connector

- * Remove air filter cap.
 - Loosen the top 4" hose clamp as it connects to the cover.
 - Unclip mass air flow meter connector (from the back left side of the cover).
 - Release the 2 clamps and slide off the air filter top cover.

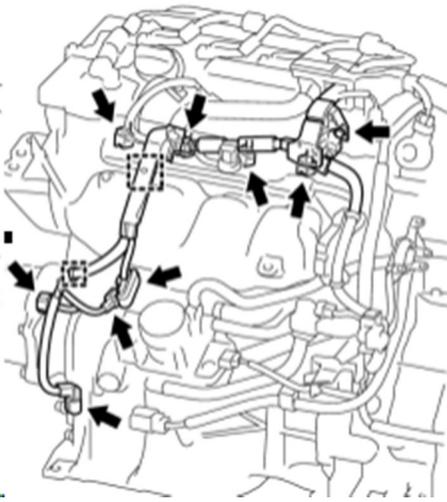
Engine Harness / Connectors

- * Disconnect the associated wiring from the sensors, etc.

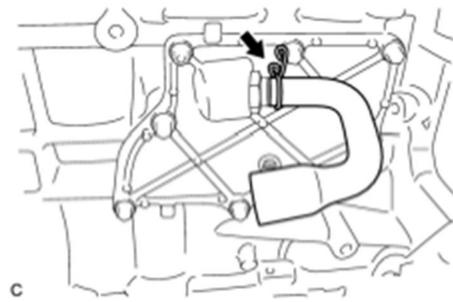
PVC / Ventilation Hose

- * Release the bottom hose clamp and separate the ventilation hose.

- * Disconnect the PVC hose.

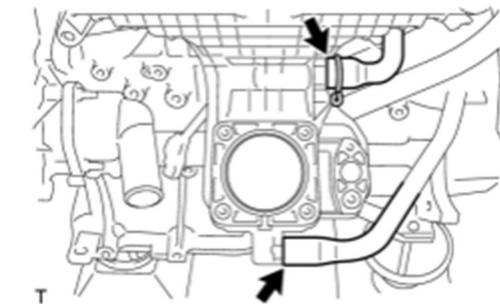
Disconnect the fuel vapor feed hose and ventilation hose.

- * Disconnect the fuel vapor hose.

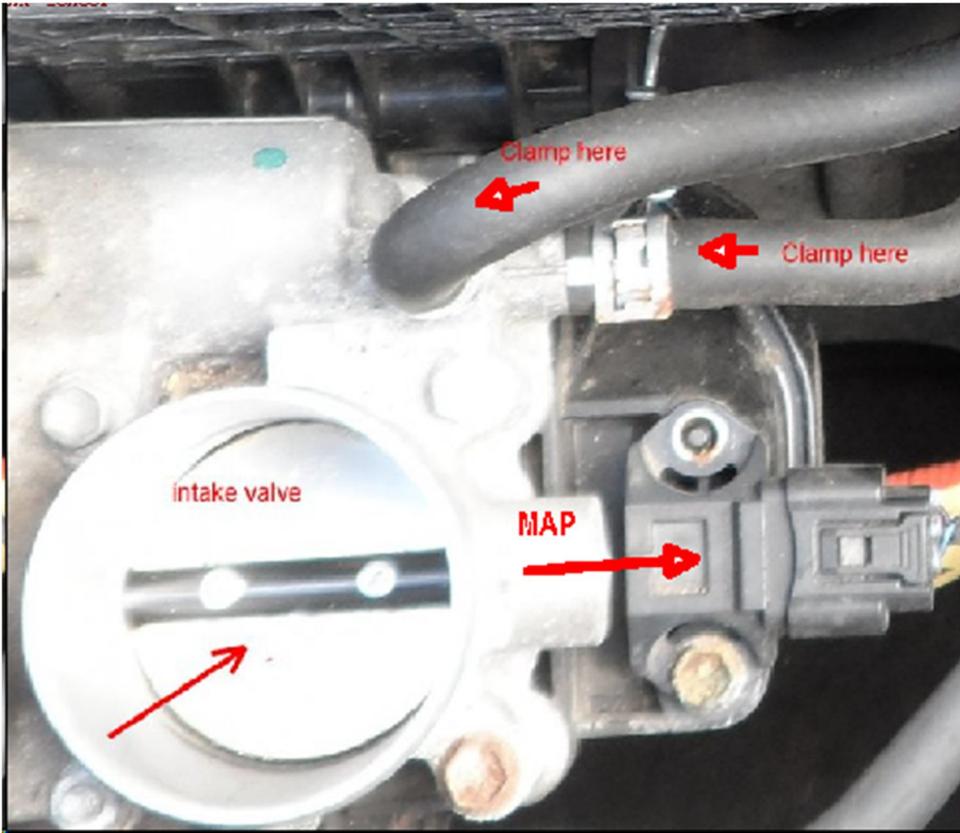
Clamp off Coolant Hoses before removing from the throttle body.

- * Clamp off and remove the (2) coolant hoses that connect to the top rear of the throttle body.
 - I used large hemostats.
 - One enters from the top, the other from the driver's side.
 - They were still under pressure and gave me a blast of coolant.
 - Try unscrewing the engine coolant tank lid to release any coolant pressure.

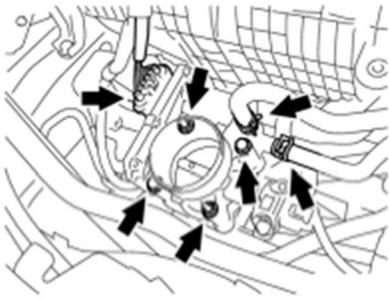
Throttle Body

- * Remove the (4) 10mm bolts that secures the throttle body.

- * Separate the throttle body and remove the intake manifold.

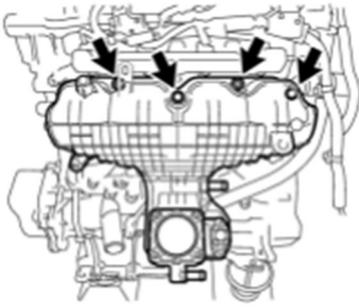
Intake Manifold Bolts

- * Unbolt the (5) 12mm bolts / nuts holding the intake manifold to the head. (3) bolts (2) nuts

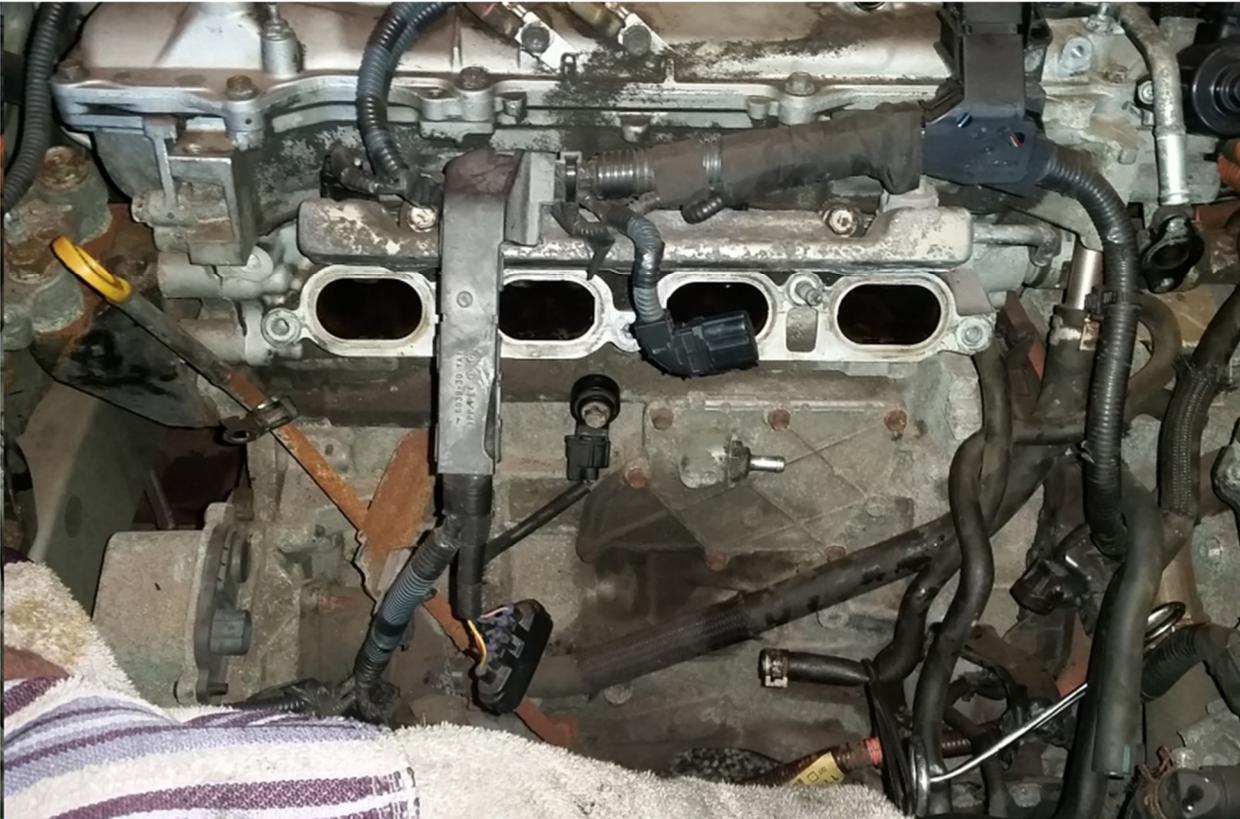
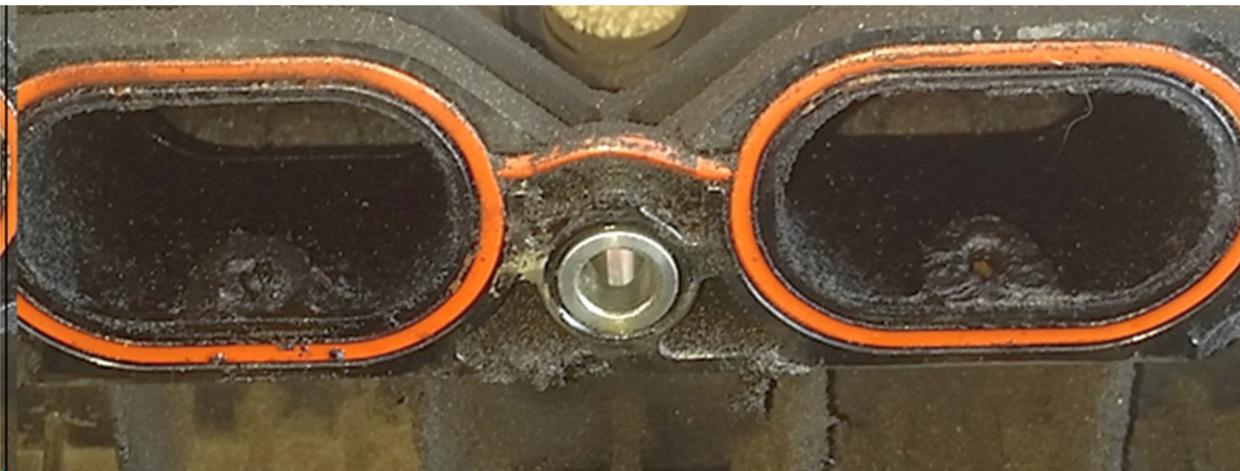
When you remove the intake manifold you will find tons of gummy carbon deposits blocking the EGR path to the intake and quite a bit of heavy gunk/oily substance in and under the throttle body cavity. This blockage is a definite cause of the engine knocking and P030x codes.

The car would also shake when accelerating at certain high torque conditions. Originally there were not error codes but eventually it started to generate P0304 misfire codes. The EGR path was full of a wetter (gummy) carbon deposit where the second Prius.2 was more of a dryer (sootier) carbon build-up.

Intake Manifold (Prius.1)

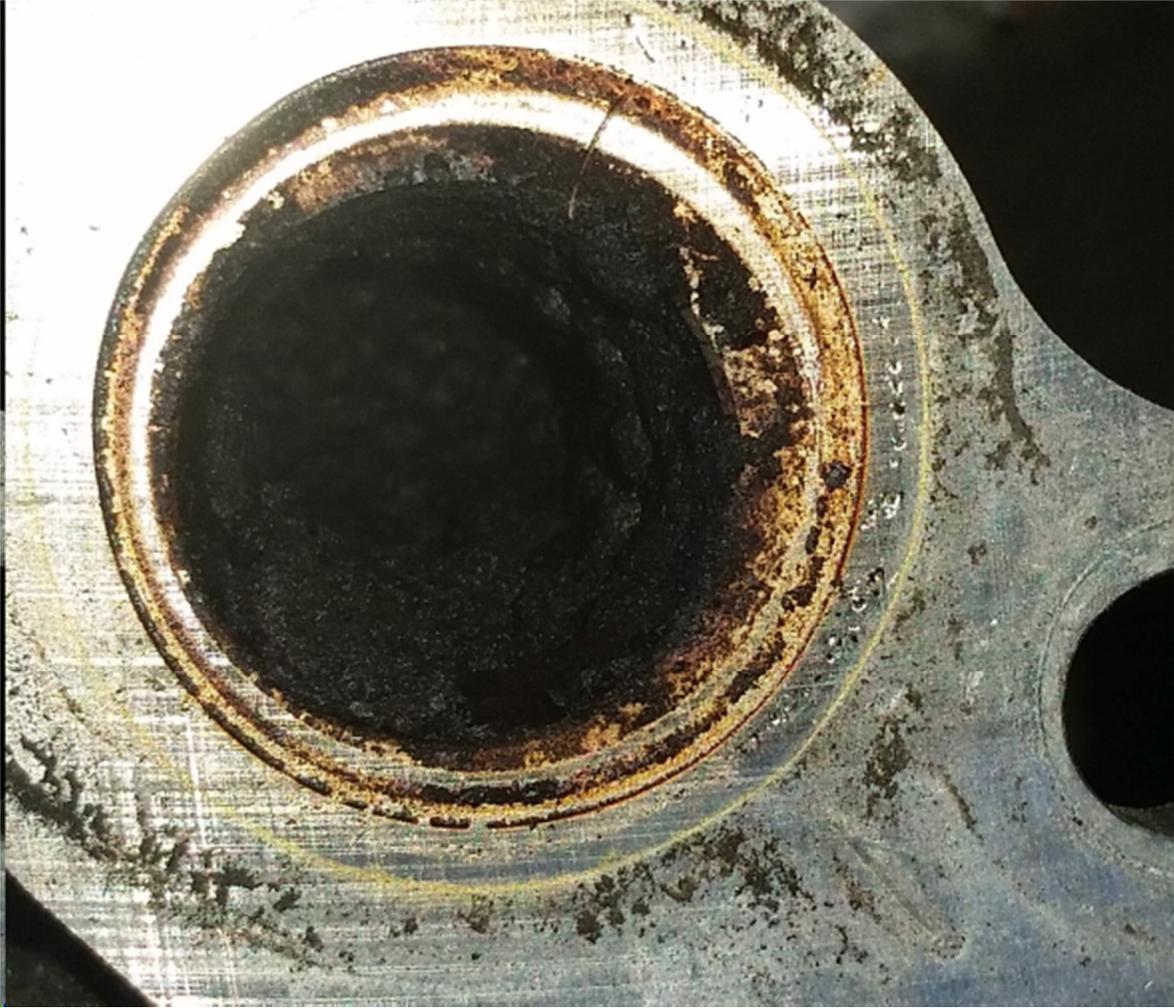
EGR Pipe (Prius.1)

* Inspect / Clean the EGR Pipe

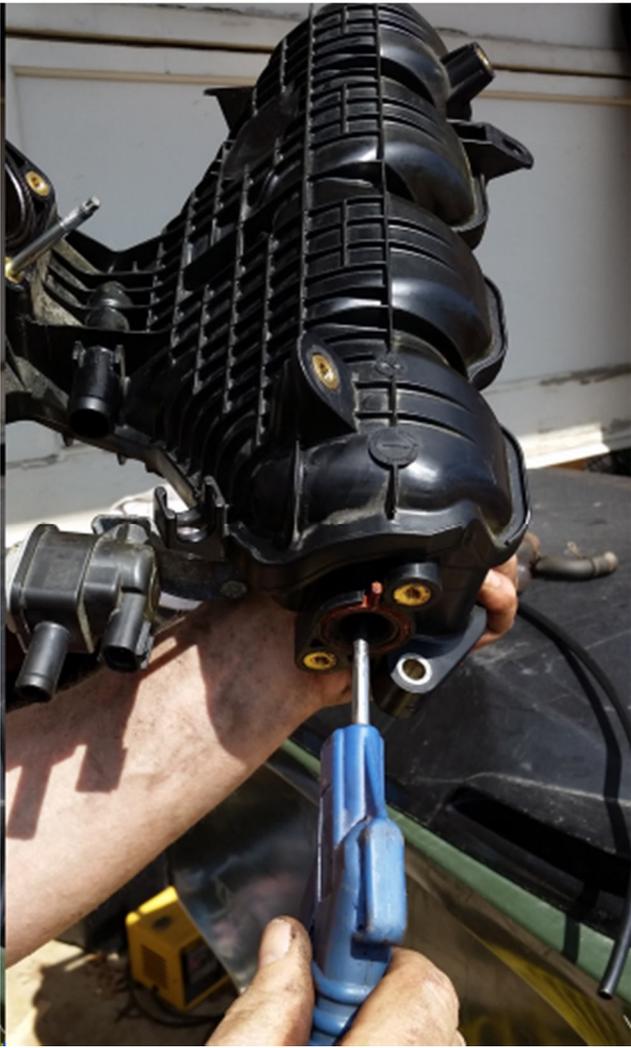
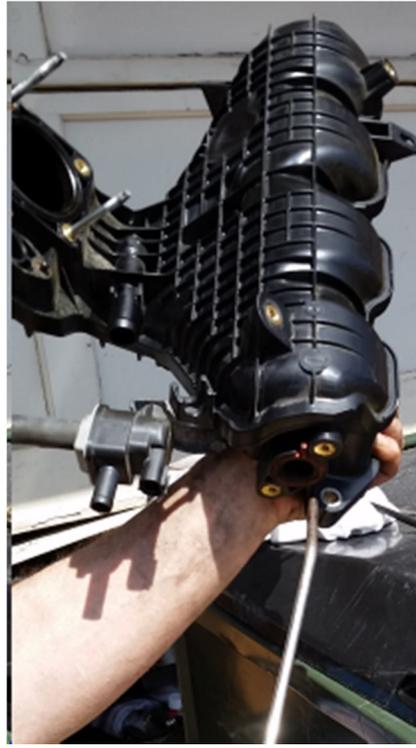
Cleaning Carbon Deposits with Air Nozzle

C. Air nozzle with ~12" extension with has slight bend at the end.

The bend made it easier to scrape the carbon and push air toward the inward chambers.

The more I thought it was clean... the more junk kept coming out.

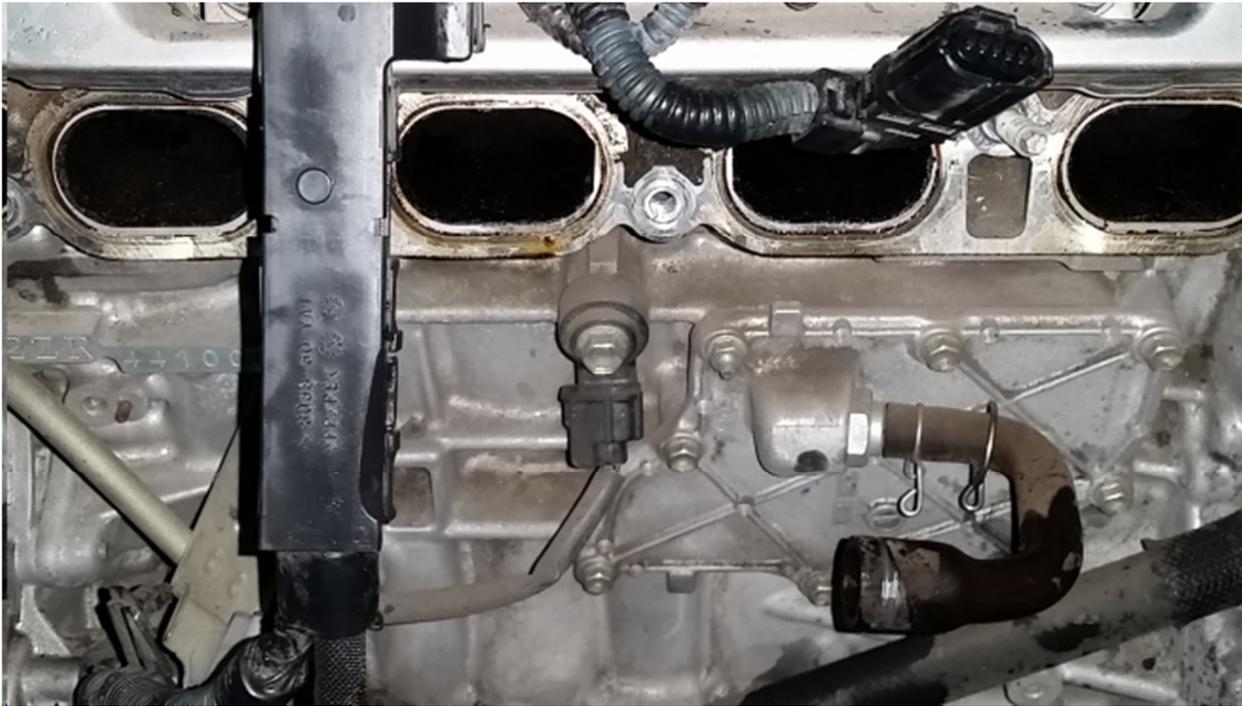
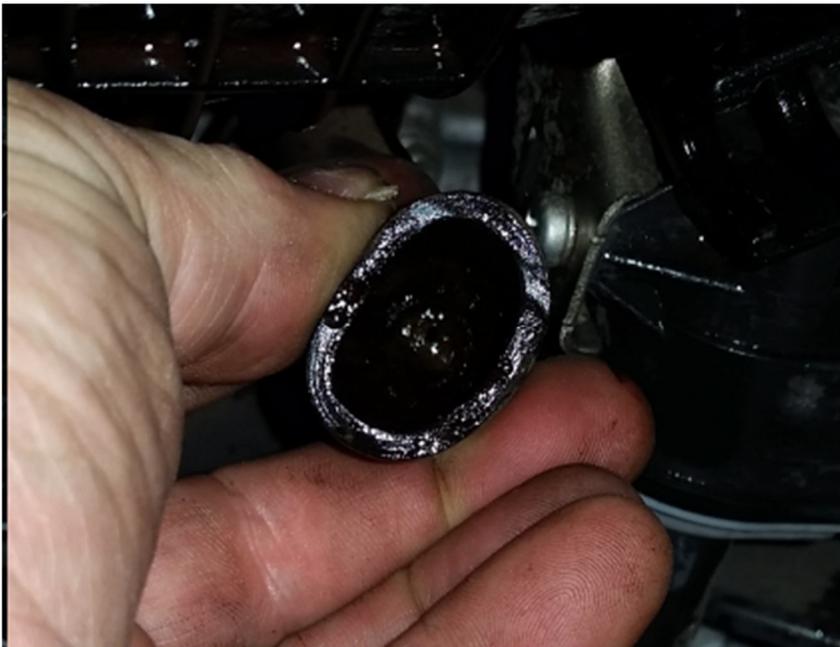
PCV Valve Tube (Prius.2)

* Check the PVC Valve (while you are in there).

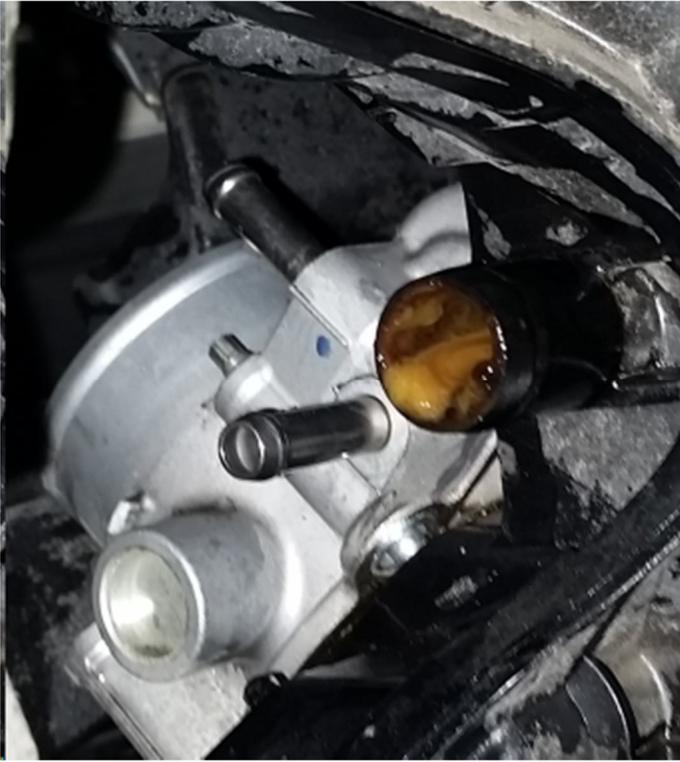
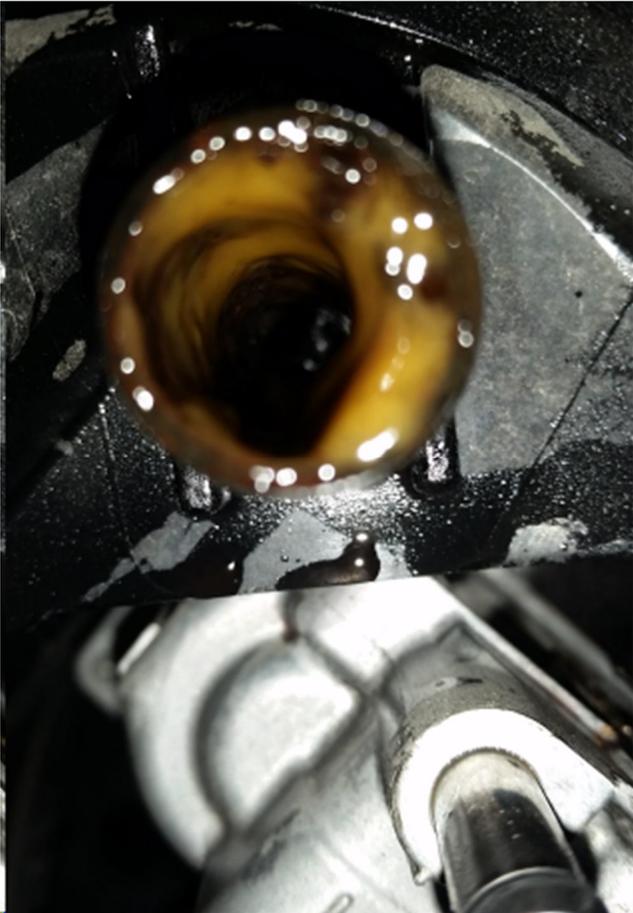
PCV Valve Tube (Prius.2)

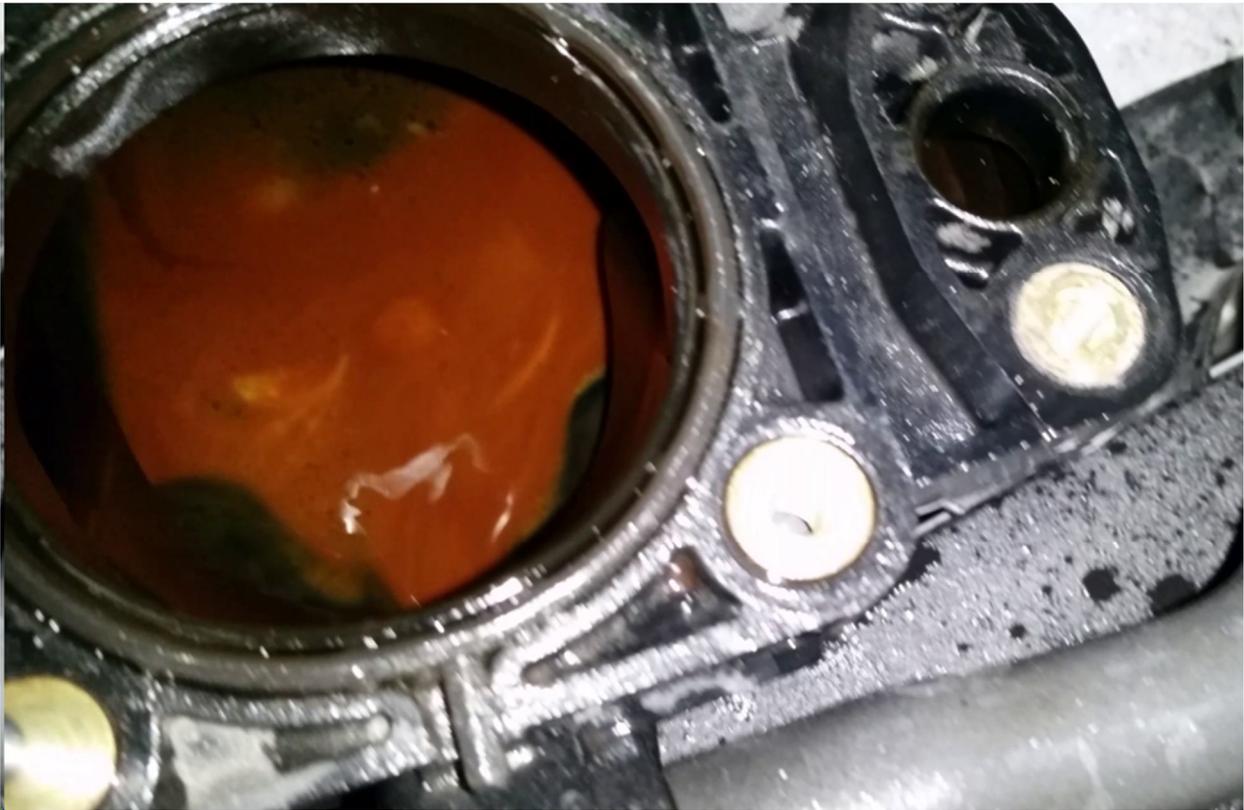
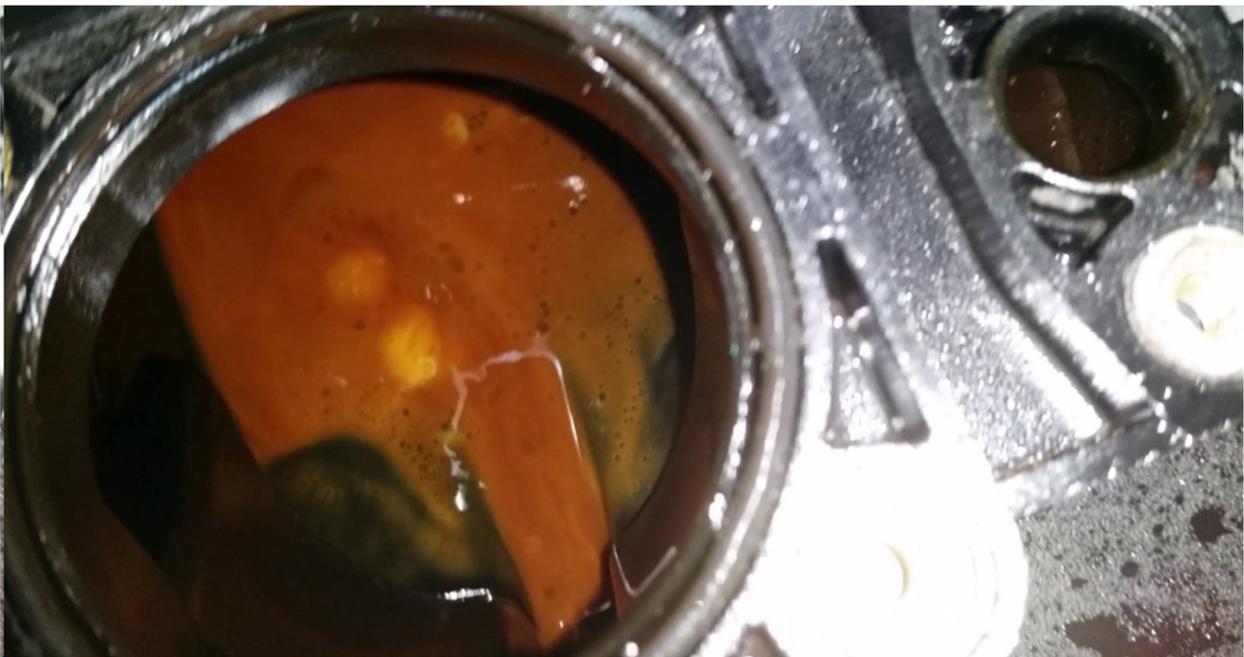
The Intake manifold was not as clogged as bad as Prius.1 but there was a river flow of oily substance under the throttle body. Reading else ware and talking to Toyota techs this may be a common finding with these engines (and perhaps due to the Atkinson cycle design?).

Muck under the Throttle Body... flowing like a river (Prius.2)

* Clean the area below the throttle body inlet.

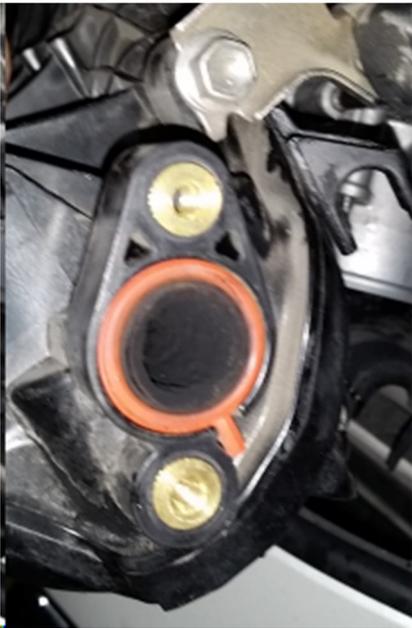
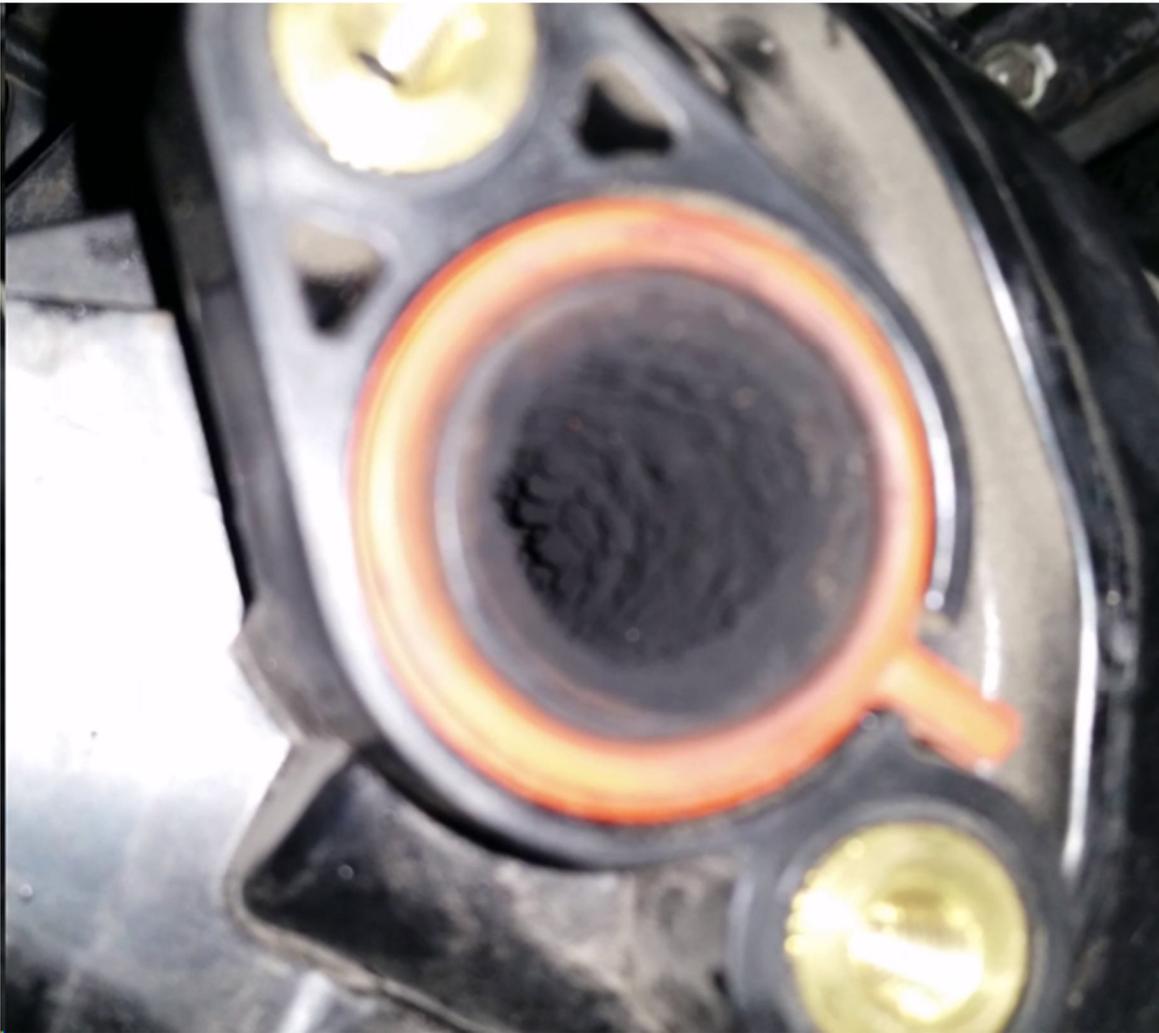
Carbon Deposits in the Intake Manifold EGR Inlet – Dryer / Sootier deposits (Prius.2)

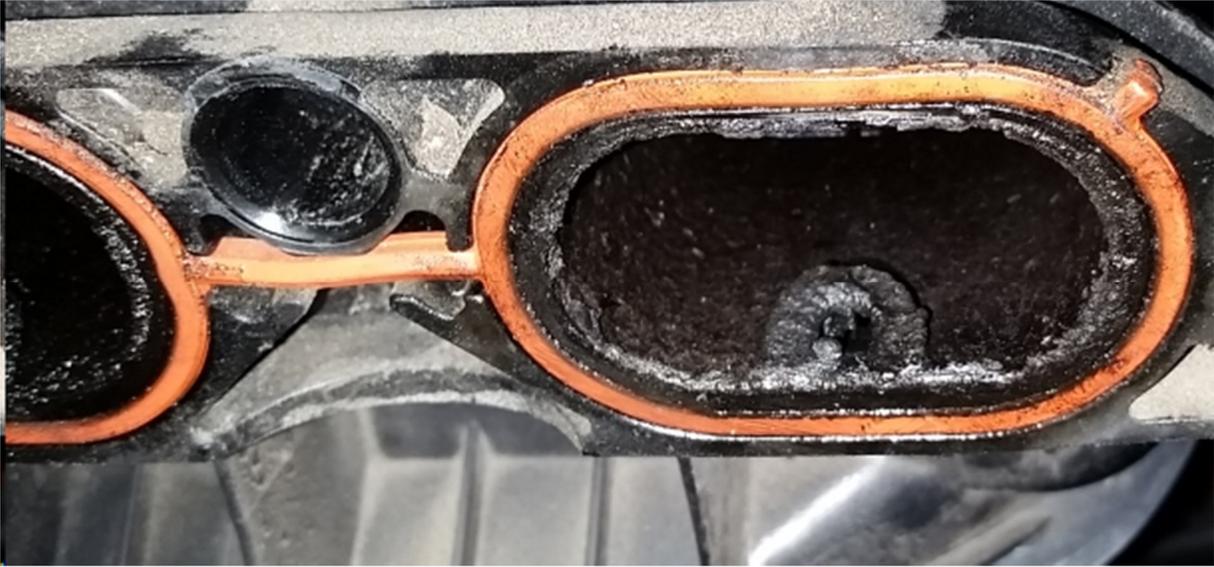
Carbon deposits clogging intake manifold (Prius.2)

* I used a combination of creative tools to clean the intake manifold. It was messy!

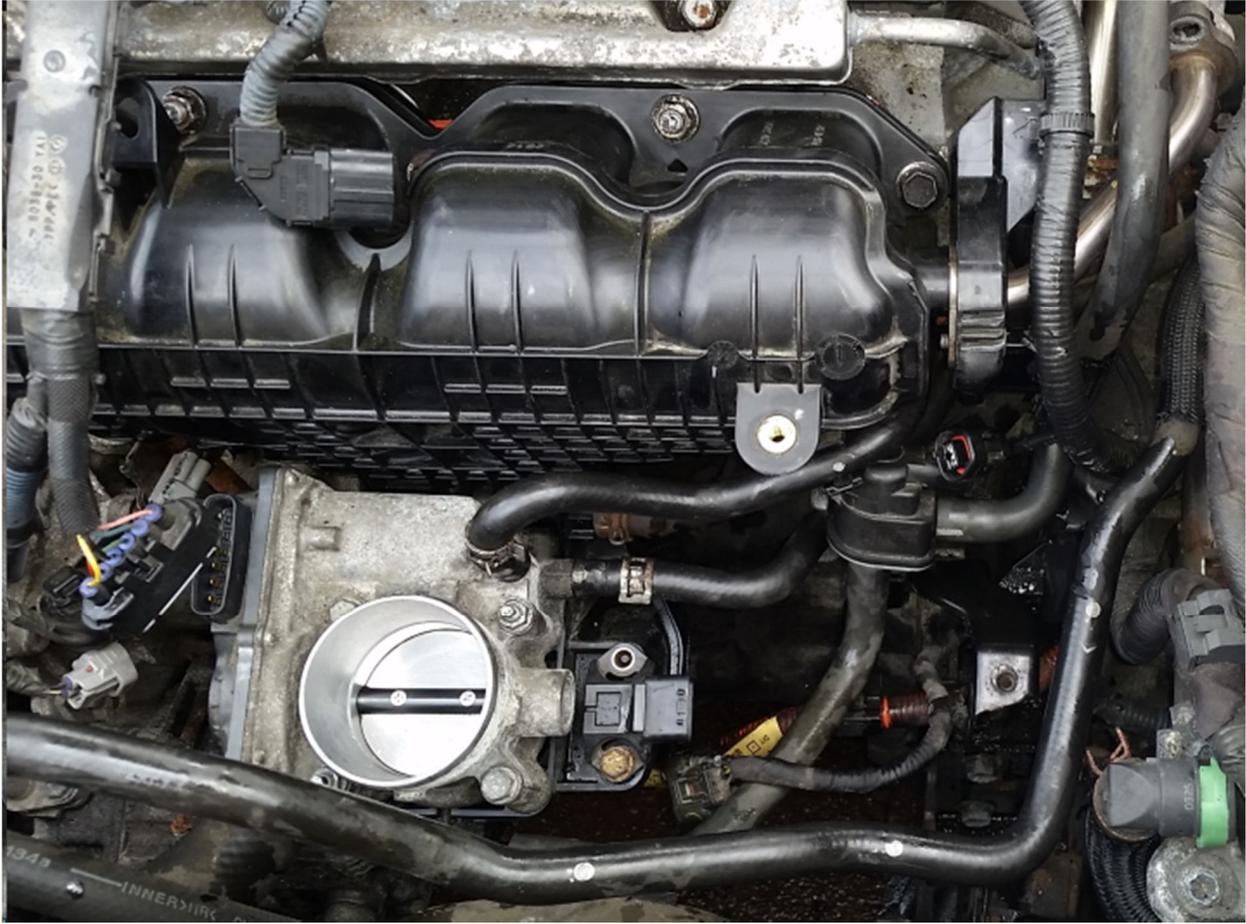
Reassembly almost complete....

Reverse the removal steps.
