# HVAC Evaporator Drain Hose Clogged Due to Insect Intrusion

**Service Category** Vehicle Interior

**Section** Heating/Air Conditioning

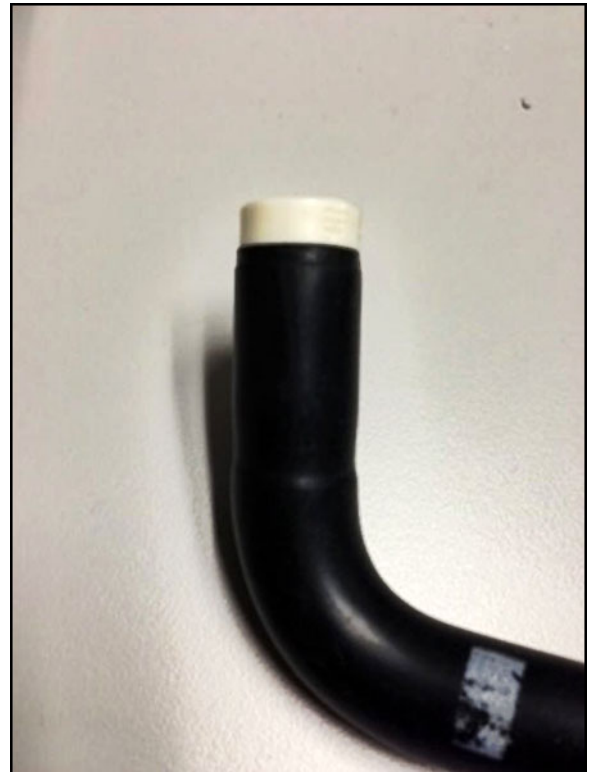
1. Follow the instructions provided in the Safety Requirements for Handling the ARINIX® Tip (Connector, Water Hose) section of this bulletin.
2. Locate the HVAC Evaporator Drain Hose.
3. Following the vehicle specific Repair Manual, remove the HVAC Evaporator Drain Hose.
4. Put on all necessary PPE and install the ARINIX® Tip (Connector, Water Hose) into the NEW HVAC Evaporator Drain Hose listed in the Parts Information section of this bulletin.
5. When installing the ARINIX® Tip, verify it is fully seated in the HVAC Evaporator Drain Hose as shown in Figure 1.
6. Following the vehicle specific Repair Manual, install the HVAC Evaporator Drain Hose.

1. Follow the instructions provided in the Safety Requirements for Handling the ARINIX® Tip (Connector, Water Hose) section of this bulletin.
2. Locate the HVAC Evaporator Drain Hose.
3. Following the vehicle specific Repair Manual, remove the HVAC Evaporator Drain Hose.
4. Put on all necessary PPE and install the ARINIX® Tip into the original HVAC Evaporator Drain Hose listed in the Parts Information section of this bulletin.
5. When installing the ARINIX® Tip, verify it is fully seated in the HVAC Evaporator Drain Hose as shown in Figure 1.
6. Following the vehicle specific Repair Manual, install the HVAC Evaporator Drain Hose.

6. When installing the ARINIX<sup>®</sup> Tip, verify it is fully seated in the HVAC Evaporator Drain Hose as shown in Figure 1.
7. Following the vehicle specific Repair Manual, install the HVAC Evaporator Drain Hose.

1. Follow the instructions provided in the Safety Requirements for Handling the ARINIX<sup>®</sup> Tip (Connector, Water Hose) section of this bulletin.
2. Locate the HVAC Evaporator Drain Hose
3. Following the vehicle specific Repair Manual, remove the HVAC Evaporator Drain Hose.
4. Before installing the ARINIX<sup>®</sup> Tip (Connector, Water Hose) into the original HVAC Evaporator Drain Hose, the end of the hose needs to be cut perpendicular as shown in Figure 2.
5. Put on all necessary PPE and install the ARINIX<sup>®</sup> Tip into the original HVAC Evaporator Drain Hose listed in the Parts Information section of this bulletin.
6. When installing the ARINIX<sup>®</sup> Tip, verify it is fully seated in the HVAC Evaporator Drain Hose as shown in Figure 1.
7. Following the vehicle specific Repair Manual, install the HVAC Evaporator Drain Hose.
