## Gen 2 Prius Water Leak (Cargo Area)

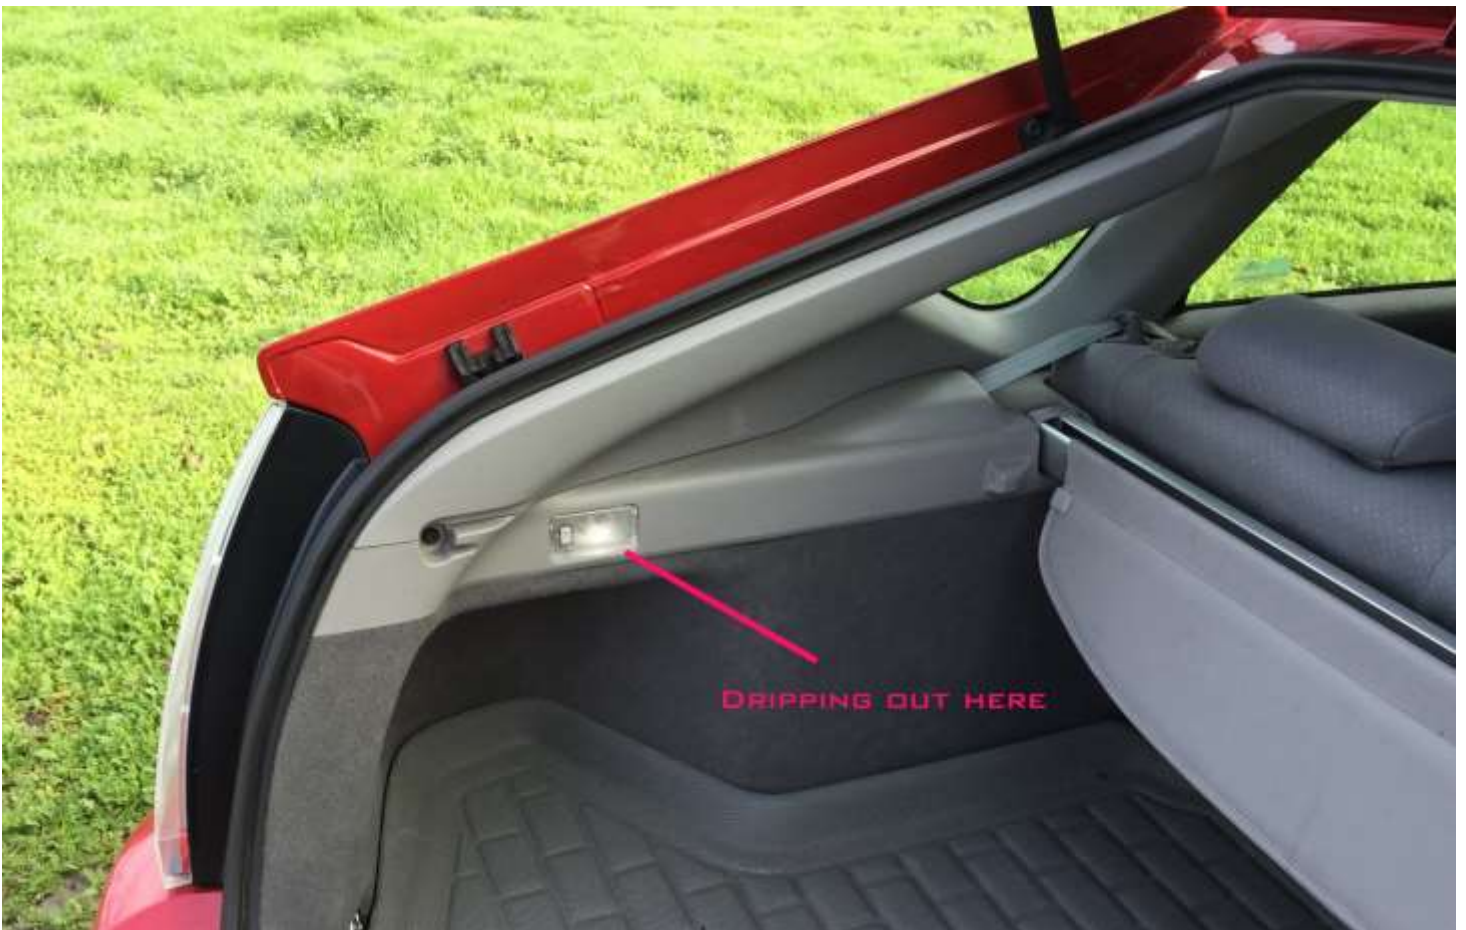
I am the second owner of the 2008 Prius (Gen 2). I completely went 'through' the vehicle when I received it and added WeatherTech mats, ham radio, battery 'drive mode' switch and other amenities. I'd been in the spare tire area when I detailed the vehicle (it was dry and clean). Fast forward to about 2 weeks ago...it actually started raining in California (shocker)...my car had been through at least a dozen wet days over the past year with no problems. However, it 'developed' a new leak in the cargo area...oddly enough the water was dripping out of the cargo light fixture and pooling on my rubberized cargo mat. Since I had some gear and other items in the back at the time, I immediately assumed (never assume) that it was from the hatch seal or the rear window...since the pool of water had flowed outward on the mat. See photo #1 below.

Photo #1 – water drip location

Miraculously, all the water channeled to my light...not a drip made it down the panels into the lower storage spaces. I can completely understand how the water could take a different path and not show itself until the spare tire compartment (or the battery area) is flooded and spilling forward into the HV battery or rear passenger area as others have experience. In my case, I had resealed the weather stripping by pulling it off, cleaning it and applying silicone to suspect locations. Then...a week later with the next rain storm, my cargo light was crying like a baby again and I'd been paying attention to the location. However, the source of the leak was a mystery...by popping out the light, I could feel the body padding was damp behind the panel above the light fixture socket. The Priuschat forum gave me a few tips to check...

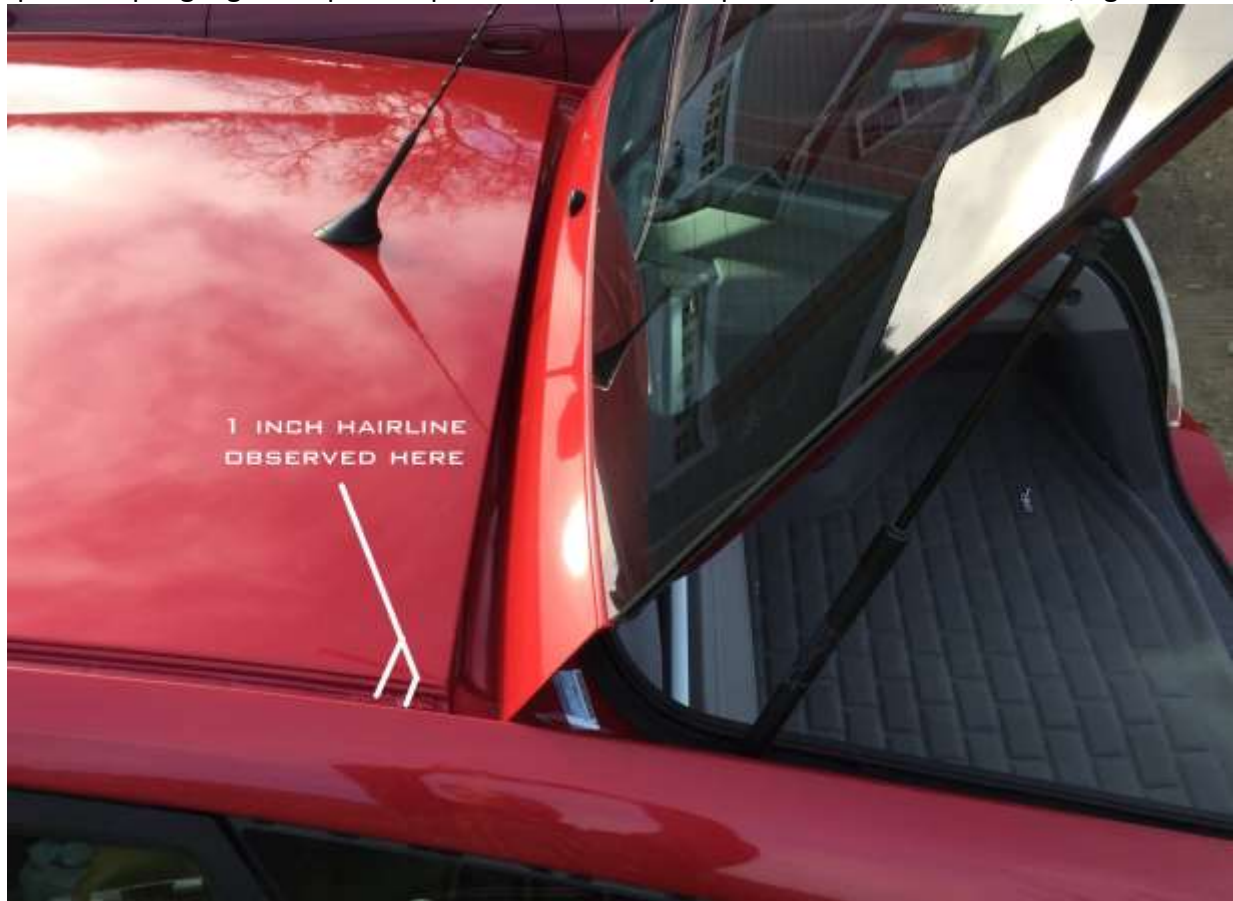
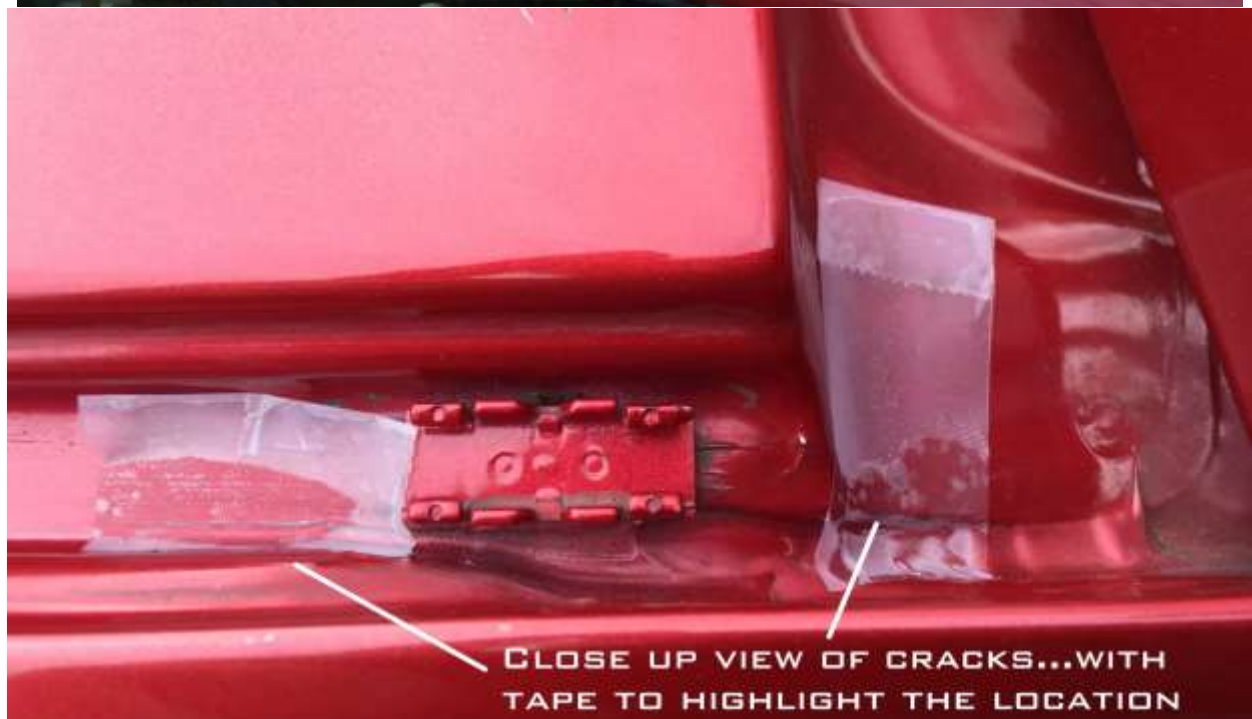
So I popped off the roof gutter covers to check for the infamous “body cracks” that were described in this forum. I carefully cleaned the location and even wiped it down with some rubbing alcohol to reveal what appeared to be a very small hairline crack...almost invisible to the naked eye. See photos below. I used some scotch tape to help highlight the paint separation. No way a cup of water would leak here, right?!

Photos #2 and #3 showing 'possible' crack and how SMALL the crack is...

So I used some Flowable Silicone (windshield sealant) to be sure that the crack filled in. I used a hair dryer to warm and dry out the crack before I applied the sealant. See photo below.

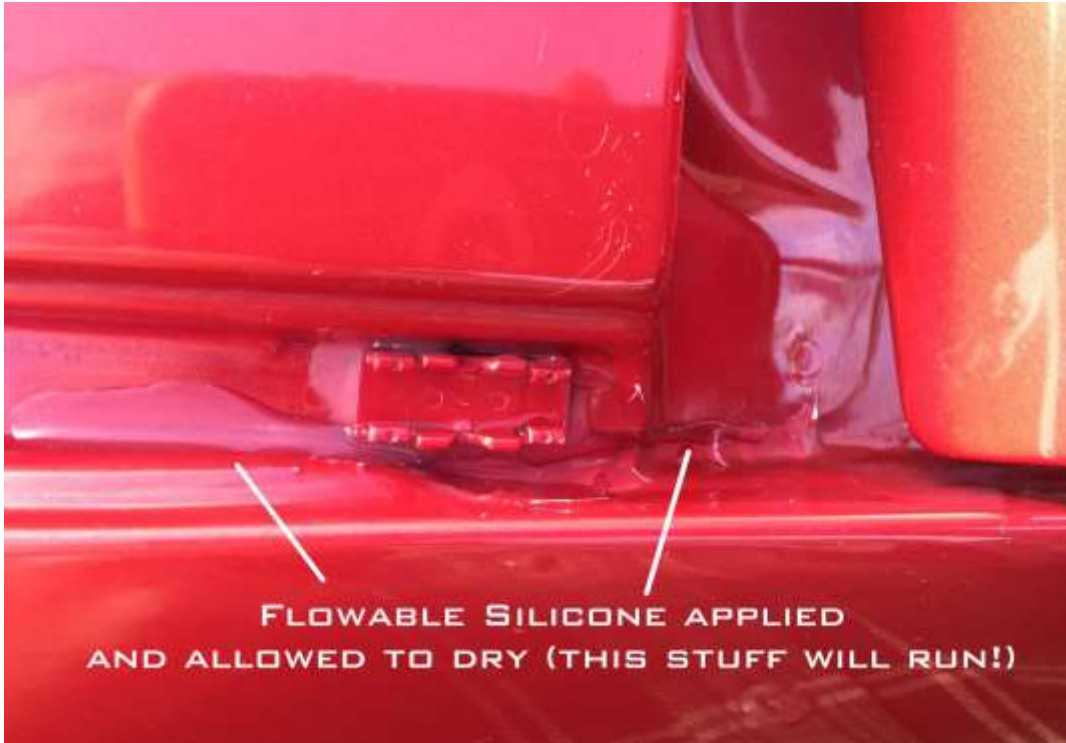
Photo #4 Close-up of the rear driver side roof gutter where suspect crack was

Next step is to get a good, long lasting weather sealant and lay it into the entire length of the rain gutter; something that will last and weather well...and expand/shrink with the vehicle body. I will likely use a bead of sealant and make a spatula out of an old credit card and spread it evenly down the gutter. Hope this helps!

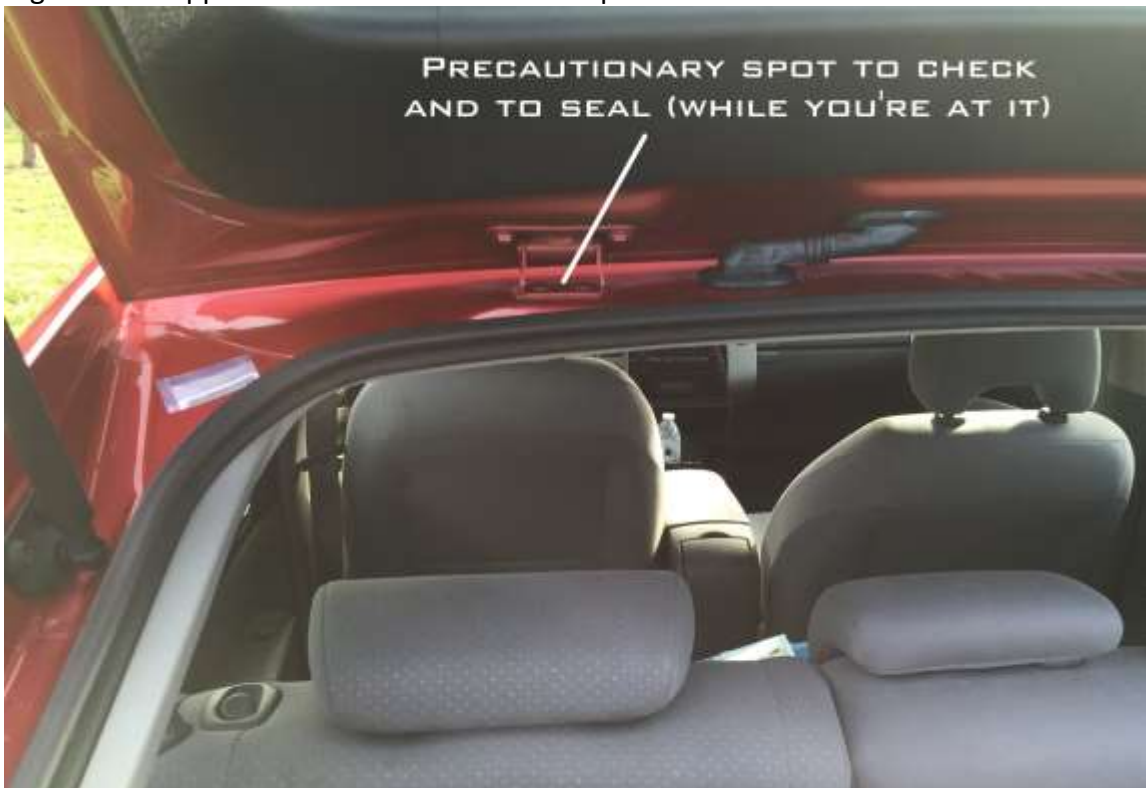
Just to be cover ALL the bases...I also wanted to be sure that there were no other rear body, driver-side sources of water leakage. So...after observing some poor paint coverage a 'lack' of body sealant around one of the hatch hinges...I also applied some sealant there. See photo below.

Photo #5 Rear hatch hinge mount on drivers side

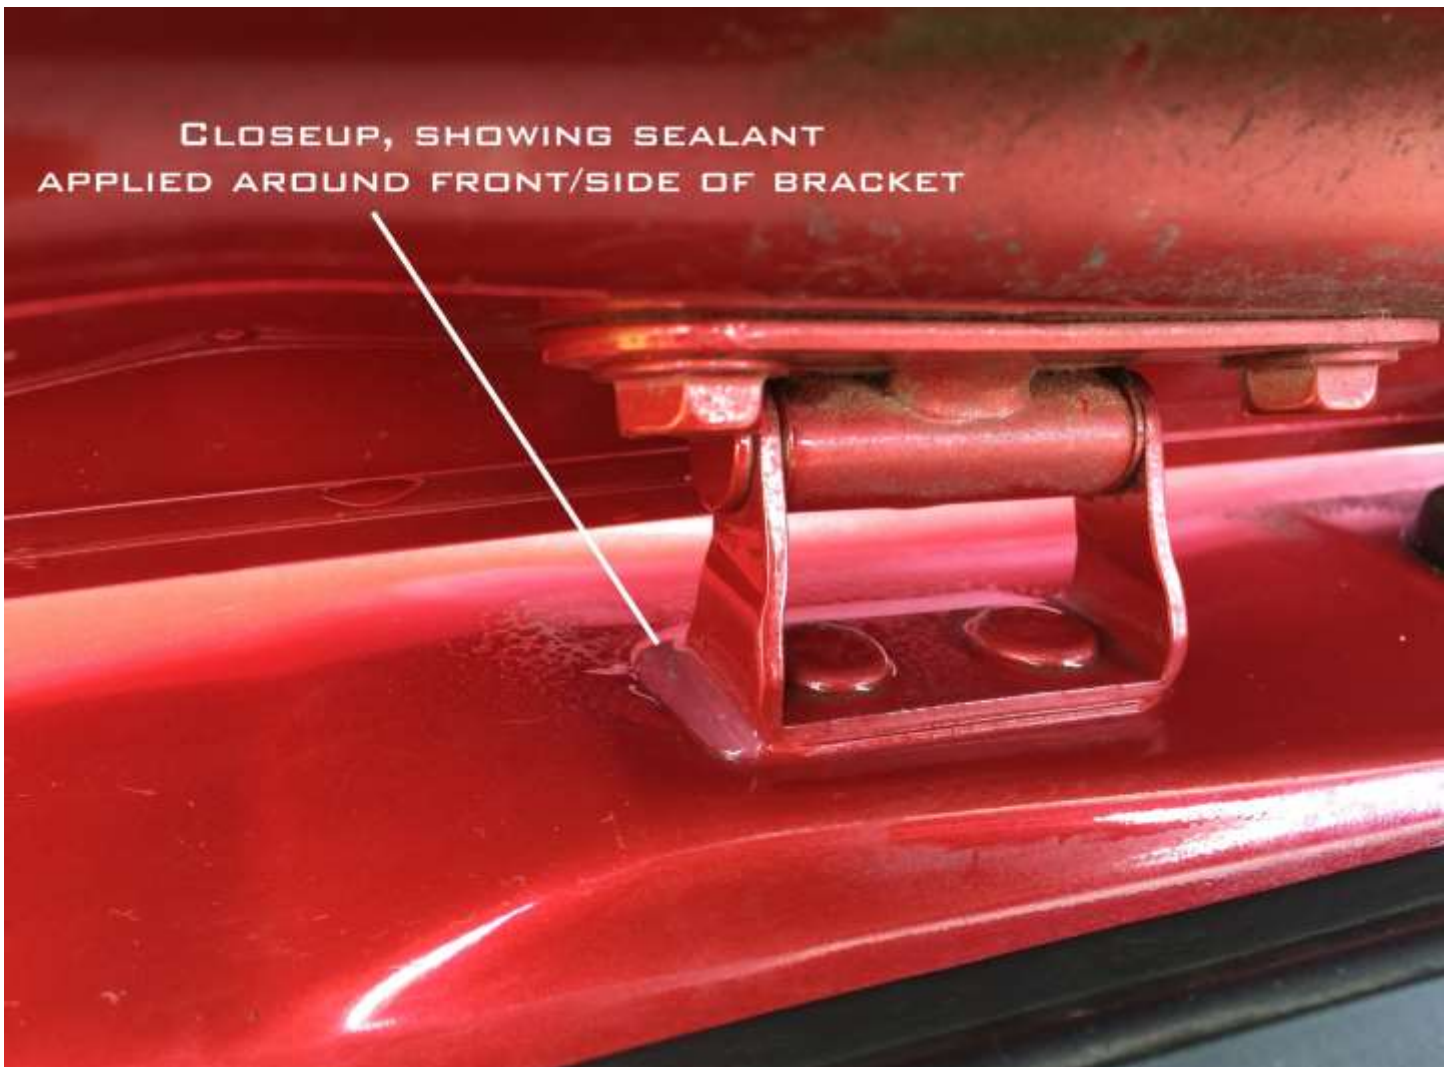
Photo #6 showing sealed hinge base where water could pool...note the checkered paint here...
