Front Edge of Engine Under Cover Warped

YEAR(S)	MODEL(S)	ADDITIONAL INFORMATION
2010	Prius

Some 2010 Prius vehicles may exhibit an engine under cover that has warped at the front edge after oil maintenance has been completed. An updated engine under cover is now available to address this condition.

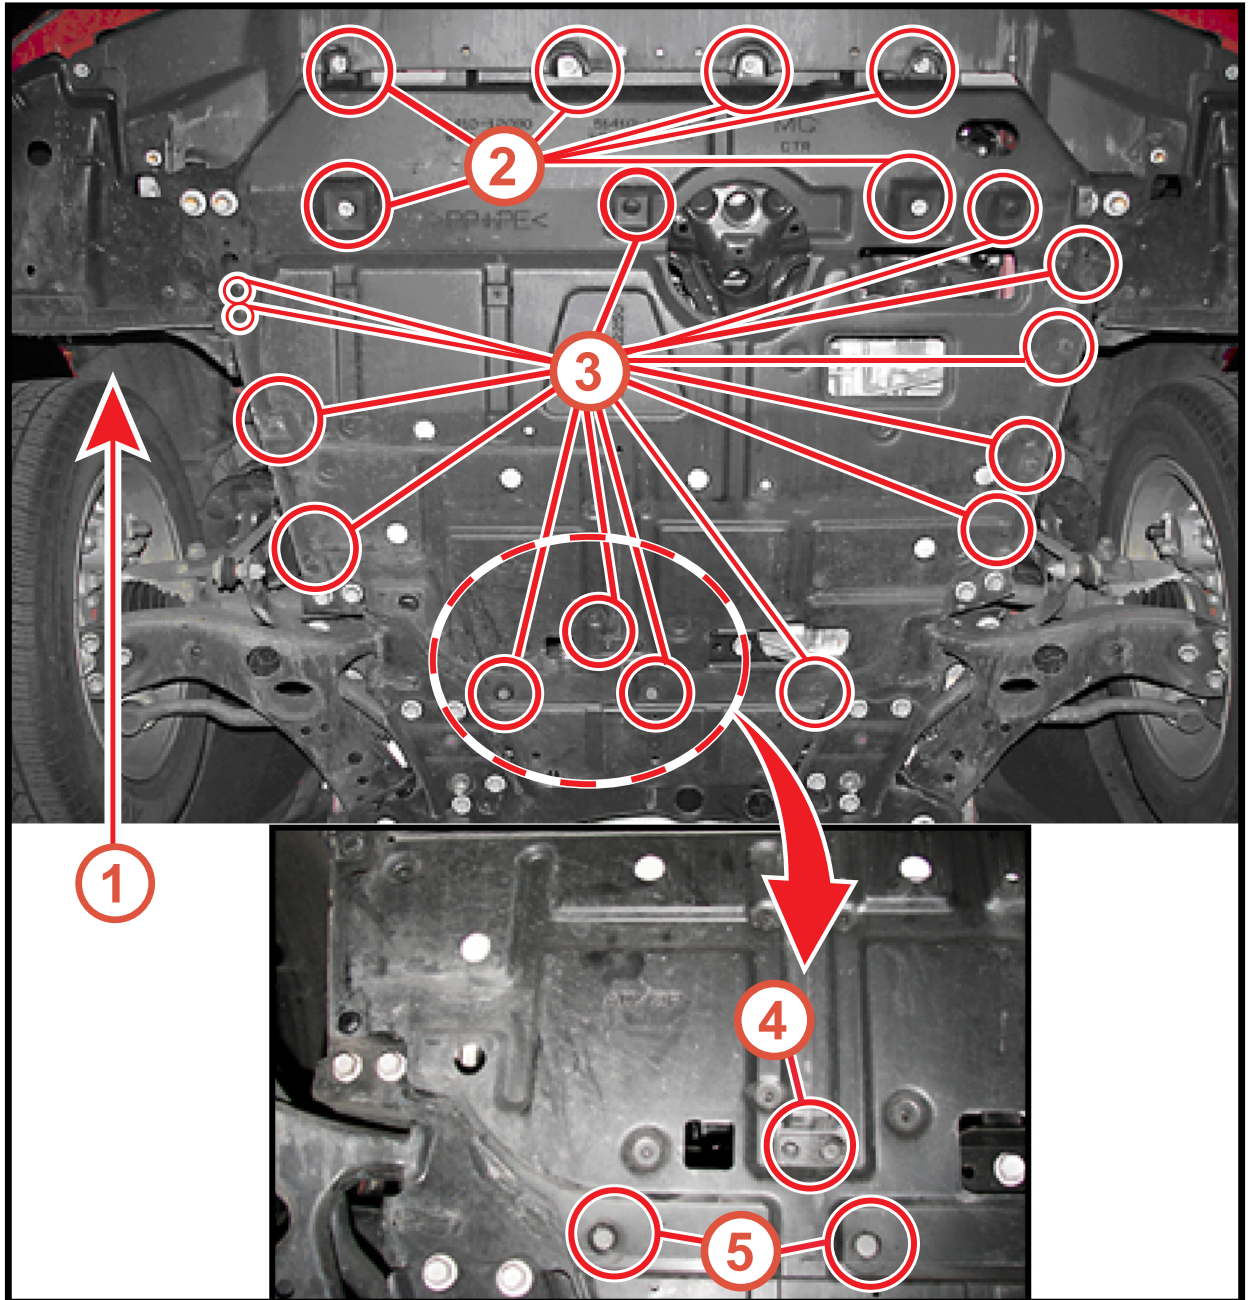
Figure 1.

Clips are not interchangeable. See Figure 1 for specific clip locations.

1	Front of Vehicle
2	Bolt
3	90467-07201 Thin Metal & Plastic Clips

4	90467-07166 Plastic & Plastic Clips
5	90467-09227 Thicker Metal & Plastic Clips

1. Inspect engine under cover and oil filter access panel for warpage.
If warpage is found, replace engine under cover with updated part.
2. Remove the 6 bolts and 14 retaining clips from the engine under cover and slide toward rear of vehicle to remove cover.

3. Position new engine under cover into place and install the 14 retaining clips in their correct locations, then install the 6 bolts (See Figure 1).

Gently pull down on the edges of the engine under cover to ensure the clips are installed in the correct locations.
