Subject: How to Identify Modified HV Batteries

Applicability
All HV Vehicles

2001-2016	Prius	2013-2016	Avalon HV
2010, 2012-2015	Prius PHV	2012-2016	Prius V
2012-2016	Prius C	2007-2016	Camry HV

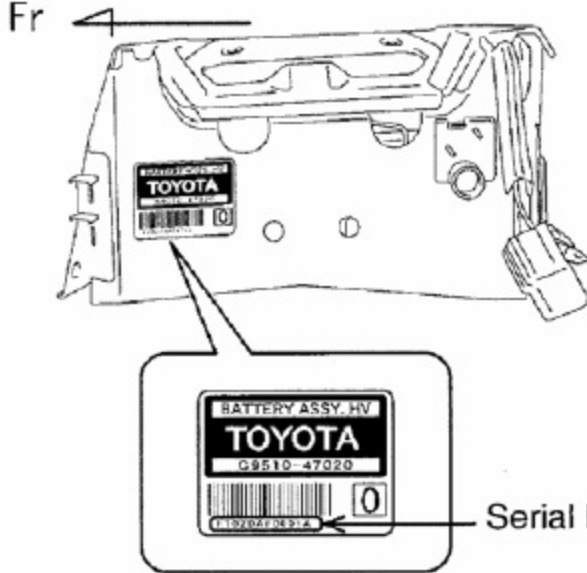
F 19 Z F A B 0004 A
 1 2 3 4 5 6

1. Model: F => Prius
2. Date: 1 to 31
3. Month: 1 to 9, X (10), Y (11), Z (12)
4. Year: D (2000), E (2001), F (2002), G (2003)
5. Supplier of Prius ECU: A => Denso ECU, B => Panasonic ECU
6. Serial No.: Sequence number starting from 0001
