# Fender Rattle/Tick Noise

YEAR(S)	MODEL(S)	ADDITIONAL INFORMATION
2010 – 2011	Prius

Some 2010 - 2011 model year Prius vehicles may exhibit a condition where there is a ticking/rattle type noise from the A-pillar area on either side of the vehicle. This noise has also been identified as a ticking/rattling type noise from the instrument panel. Revised upper fender retainer clips have been developed to address this condition.

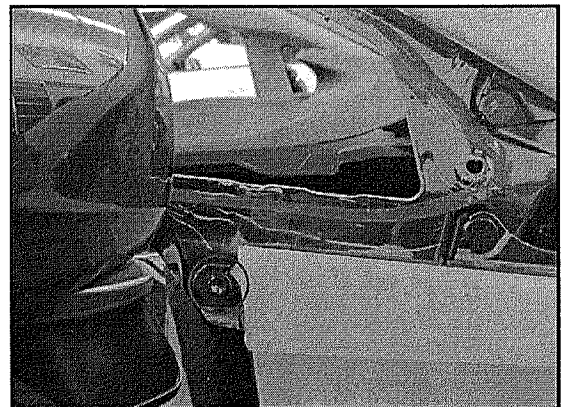
Figure 3.

B. Open the front door and remove the topmost bolt holding the fender to the body.

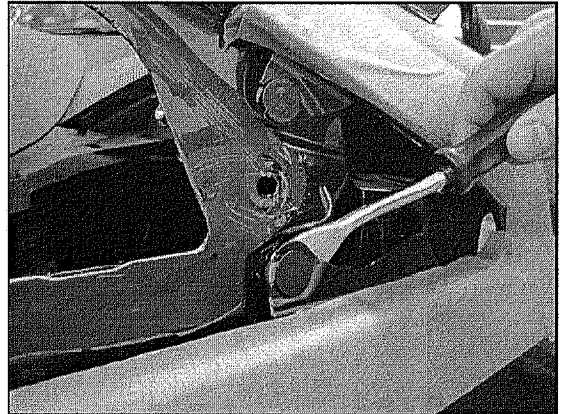
Figure 4.

- C. Using a pry tool, gently remove the 2 retainer clips holding the fender in place.

When removing clips, be sure not to damage the fender sheet metal by exerting too much force.

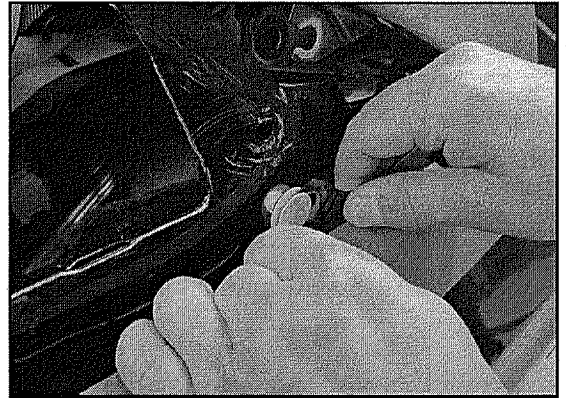
Figure 6.

- E. Slide the new clips into the fender, making sure they are seated properly.

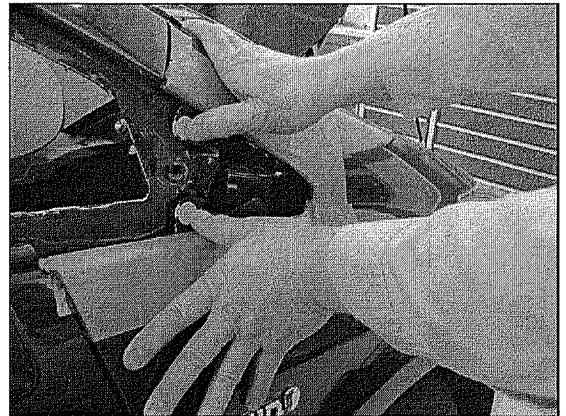
Figure 7.

- F. Guide the clips into their corresponding mounting holes and apply pressure to make sure that the clips seat fully.

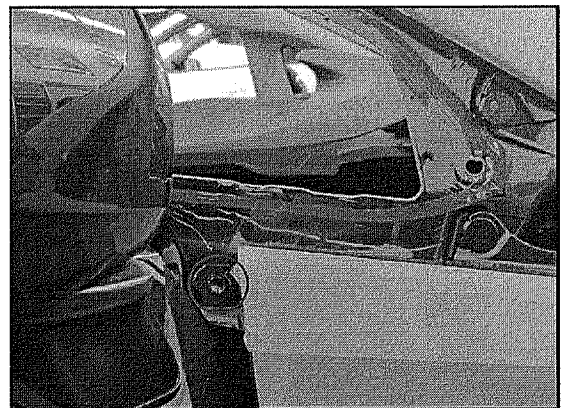
Figure 9.

- A. Open the front door and install the top most bolt holding the fender to the body.  
Torque: 13.5 N\*m (1.38 kgf\*cm, 10 ft\*lbf)
