Mindaugas Markauskas

Prius Gen2 - great HV battery repair / s

4 06 2019

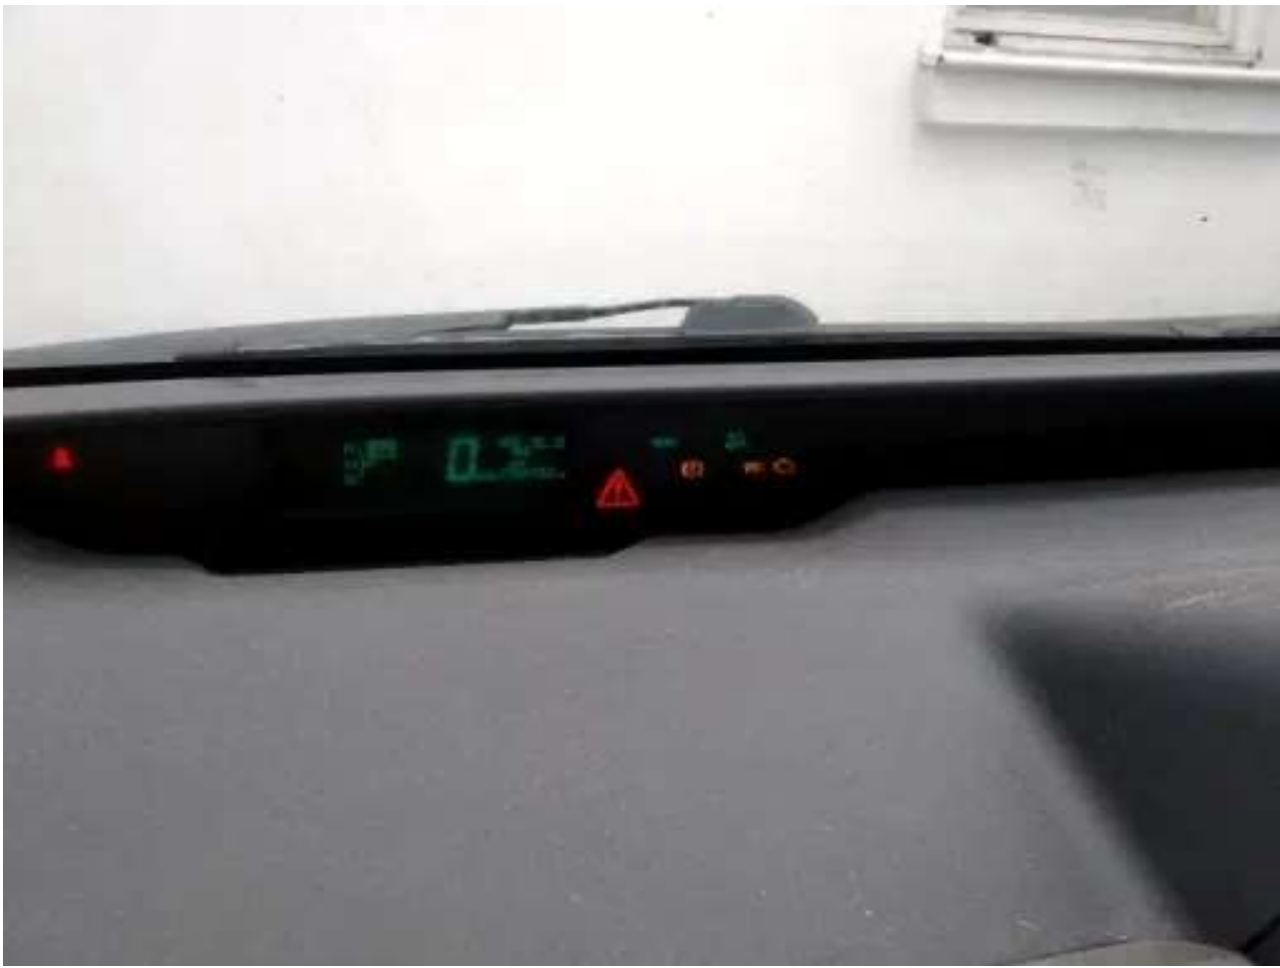
First there is a big exclamation point on the panel like what just happened to me:

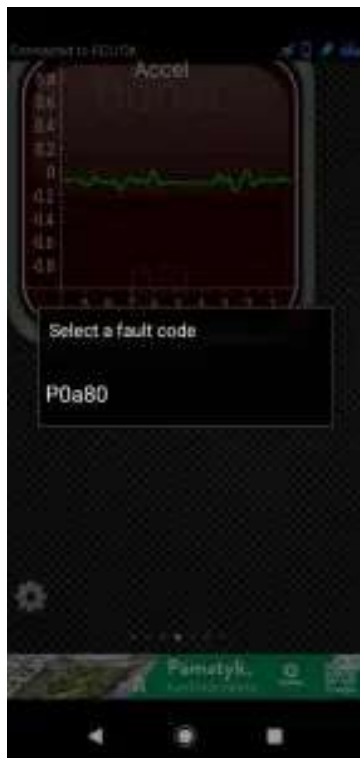
When the OBD2 is switched on in the phone, we see an error which, as it turns out, later sends to replace the HV battery:

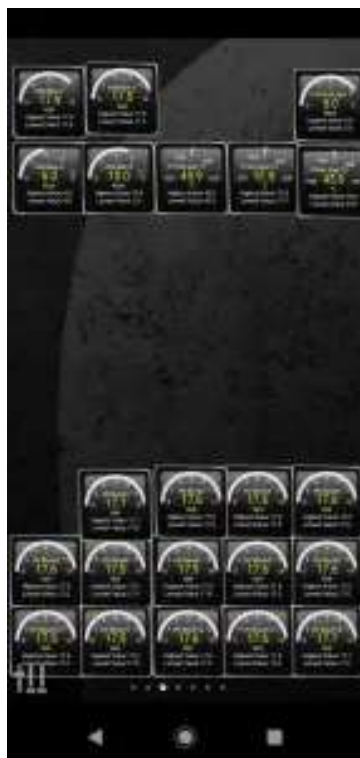
Looking at the HV battery data we see that something is wrong with the 7 module. when charging the battery it shows a slightly higher voltage of 17.9V, where the rest is about 17.6V:

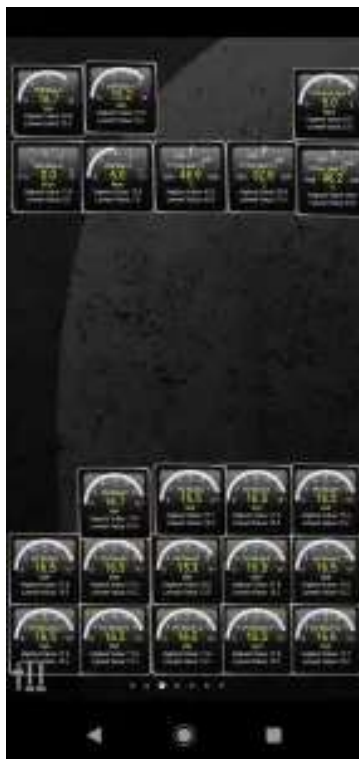
When charging is complete, the situation is fully visible, as now this module in the idle state becomes the weakest, 15.3V, where others have 16.5-16.6V:

Here we have a 1.3V difference at rest, and a red triangle is thrown when a 2V difference between the highest and lowest voltage modules is reached a couple of times. Of course it will be here. The conclusion is that one of the modules in pair 7 died.

Note the HV battery temperatures as well. They reach over 52 degrees, the battery ventilation fan is currently running at 5. And that's not the end, the temperature rises to 55 and above while driving, and the fan starts running in the most powerful 6 mode. For these reasons, as I mentioned earlier, driving such a car for longer distances becomes dangerous.

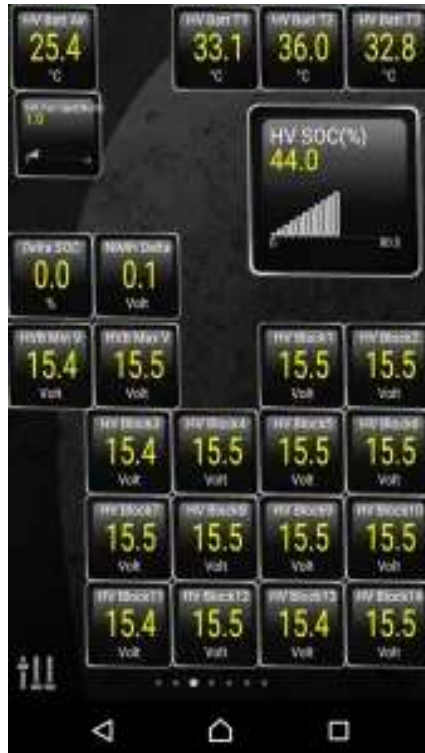
For fun, I found a phone picture taken after a recent purchase of a Prius (<https://mindogas.wordpress.com/2015/06/15/antrasis-automobilis-toyota-prius-gen2/>):

I don't remember how much was driven before the photo was taken, but we see a 7 pair here is good, the temperature is normal and the Delta SOC deviation is 0 percent.

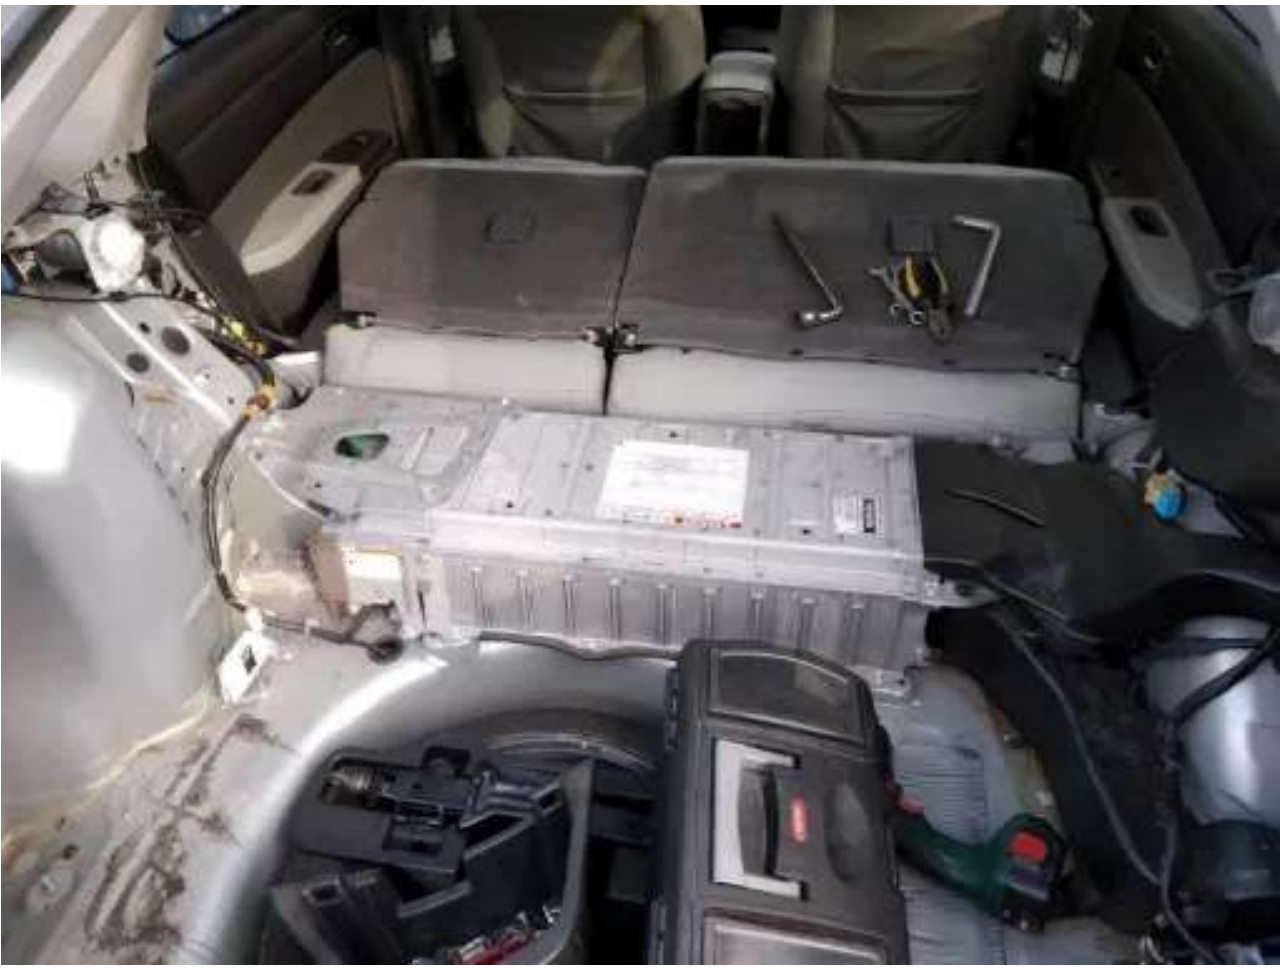
So, in the trunk of the car you first need to remove the entire interior:

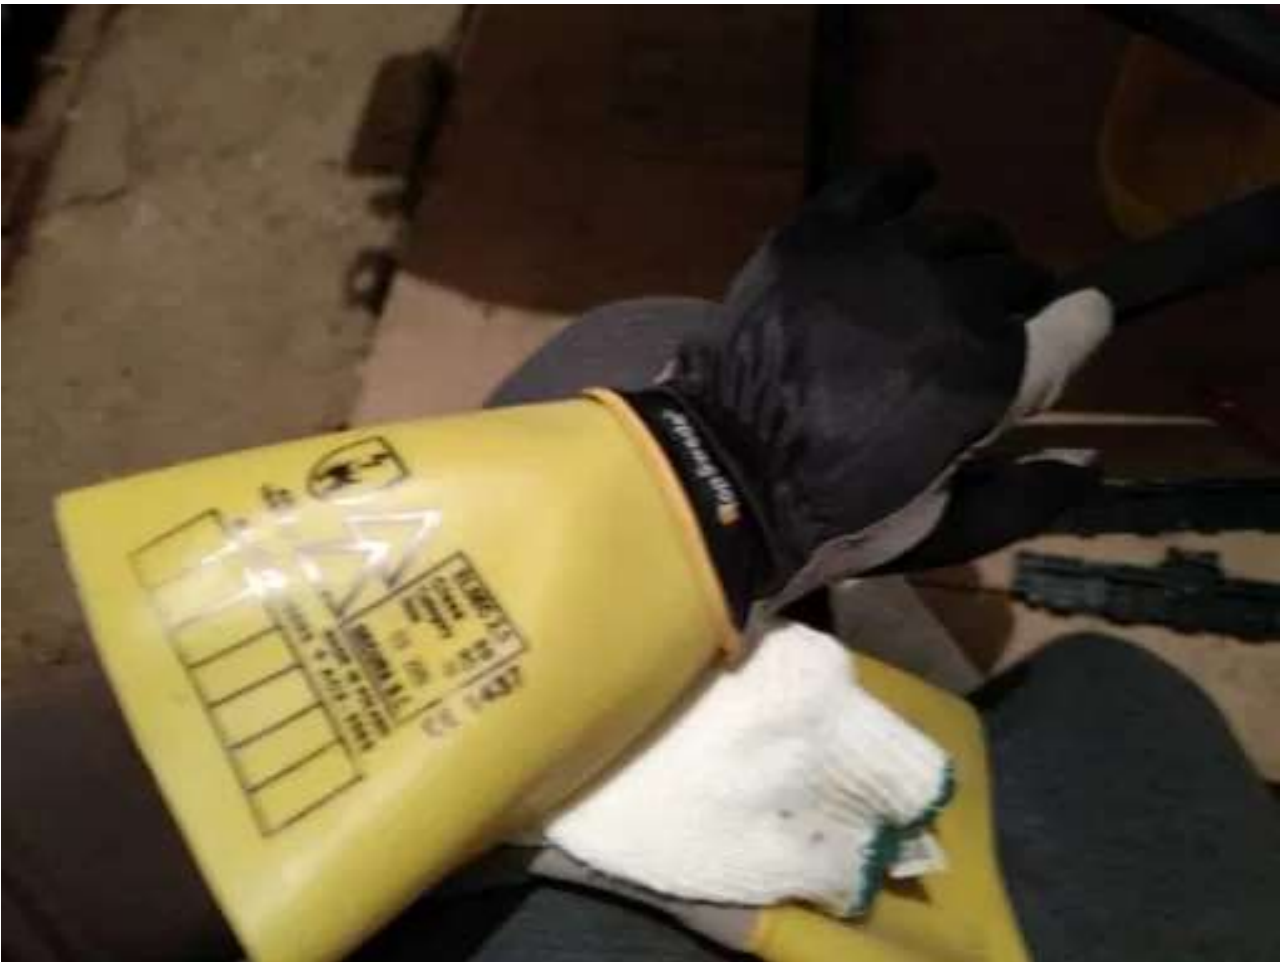
And when it comes time to disconnect the HV service connector and the HV wires themselves, it's worth thinking about gloves for working with high voltage:

Yes, a person who knows what they are doing (or maybe just doesn't understand what they are doing) will do without them, but don't forget that you are working with potentially ~ 210V DC. I had up to 500V

gloves with check. If without inspection - I would recommend 1000V gloves. To make the work comfortable, I advise you to put cotton (white in the picture) gloves on your hands under the rubber so that we sweat less and if we sweat more comfortably it will be removed and put on the rubber. On top of that, I advise you to put on even thin, turned leather gloves (dark in the photo) to protect her rubber gloves from sharp metal corners. Also, the use of gloves is not always necessary, but only when disconnecting the HV wires and later when unscrewing the battery modules.

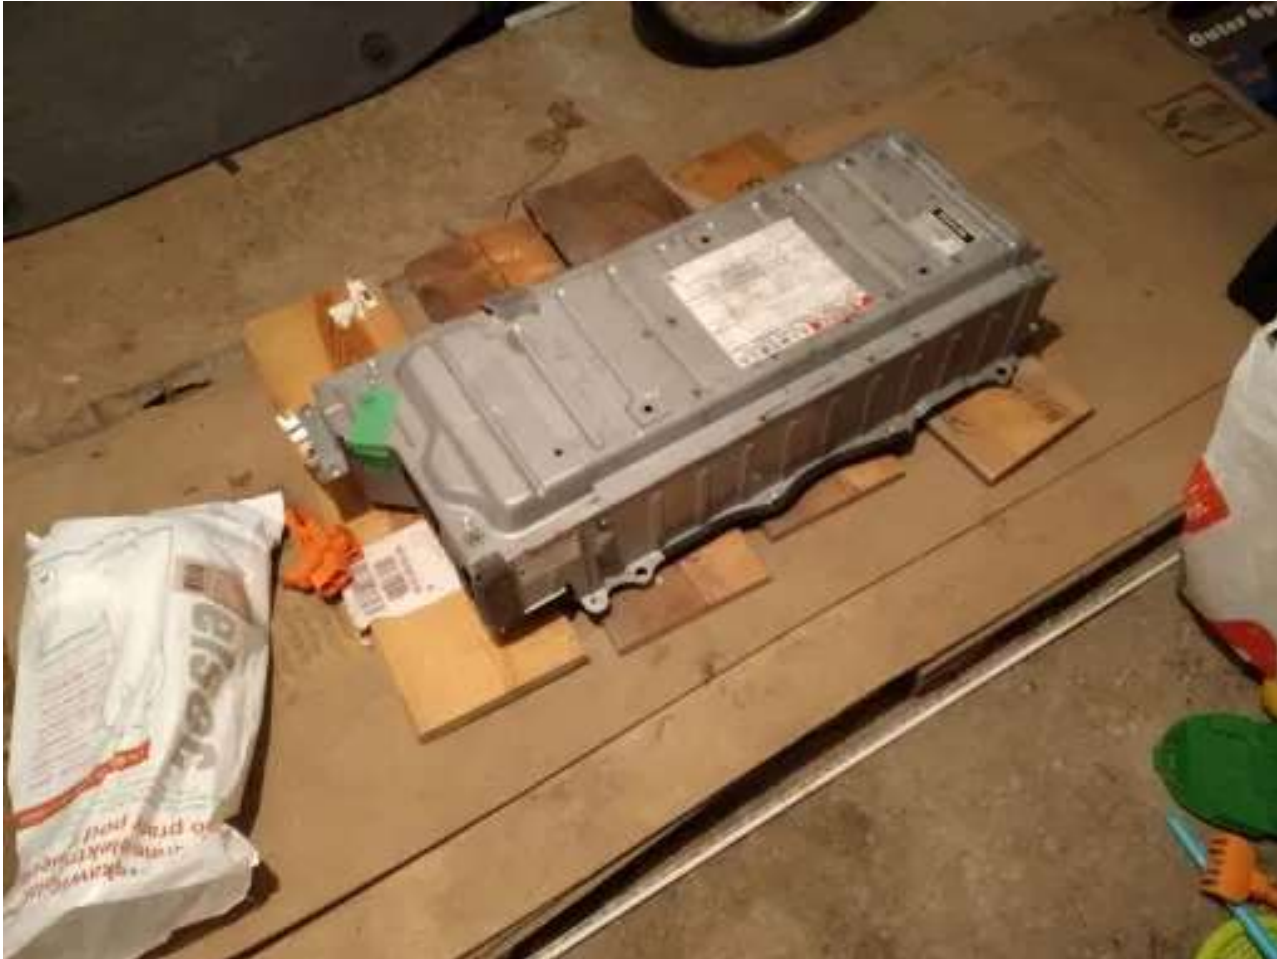
Soon the battery had already been removed and taken to the basement for further dismantling:

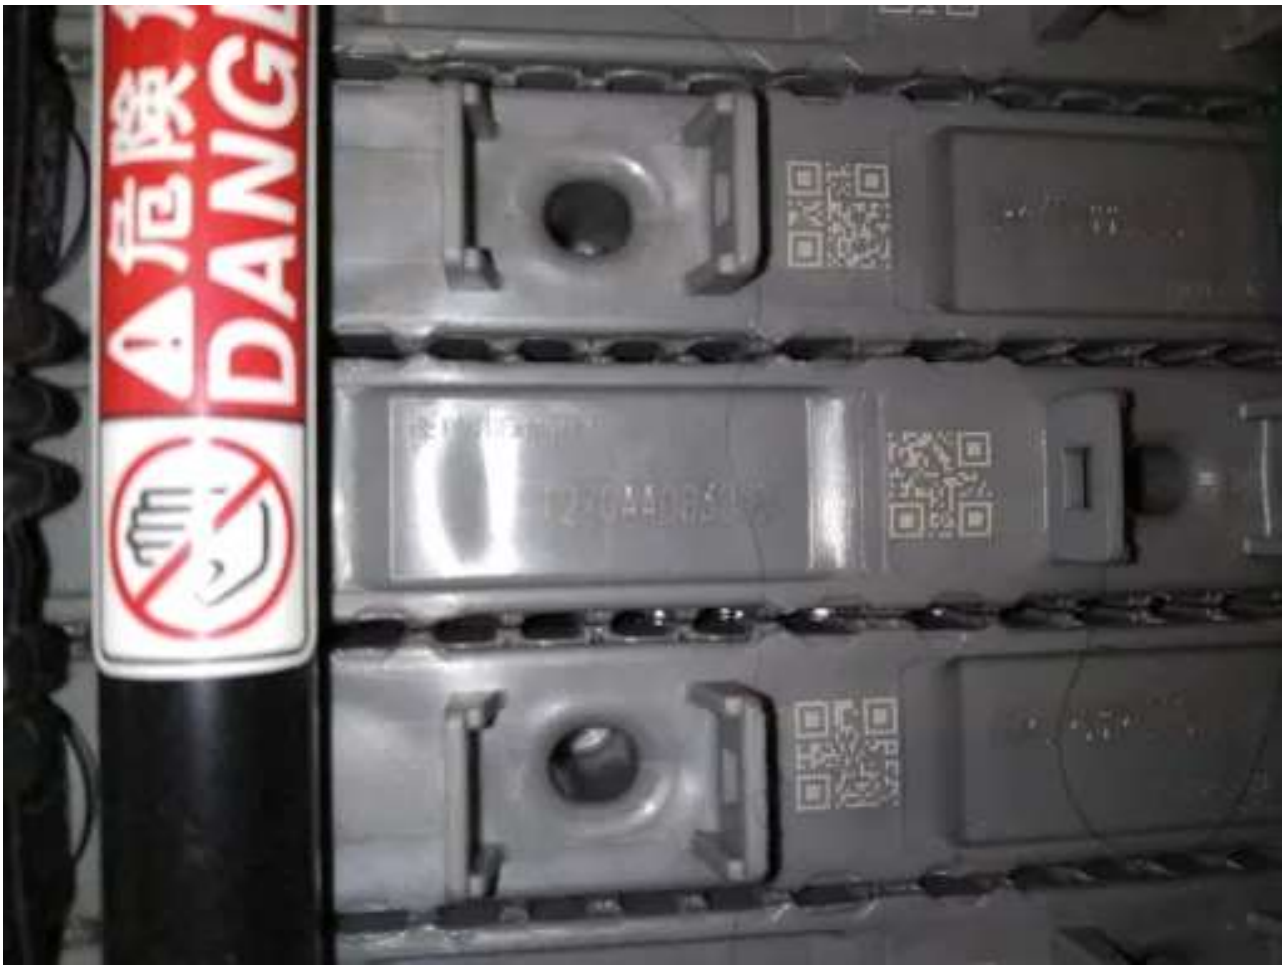
The first interesting thing about disassembling the battery itself is whether the cells in it have not been changed and how old it is:

Here we see each module starts with 12ZG, which means 12-12-2005 (source: <https://priuschat.com/threads/hv-battery-date-code.198957/> (<https://priuschat.com/threads/hv-battery-date-code.198957/>)). Served for 14 years.

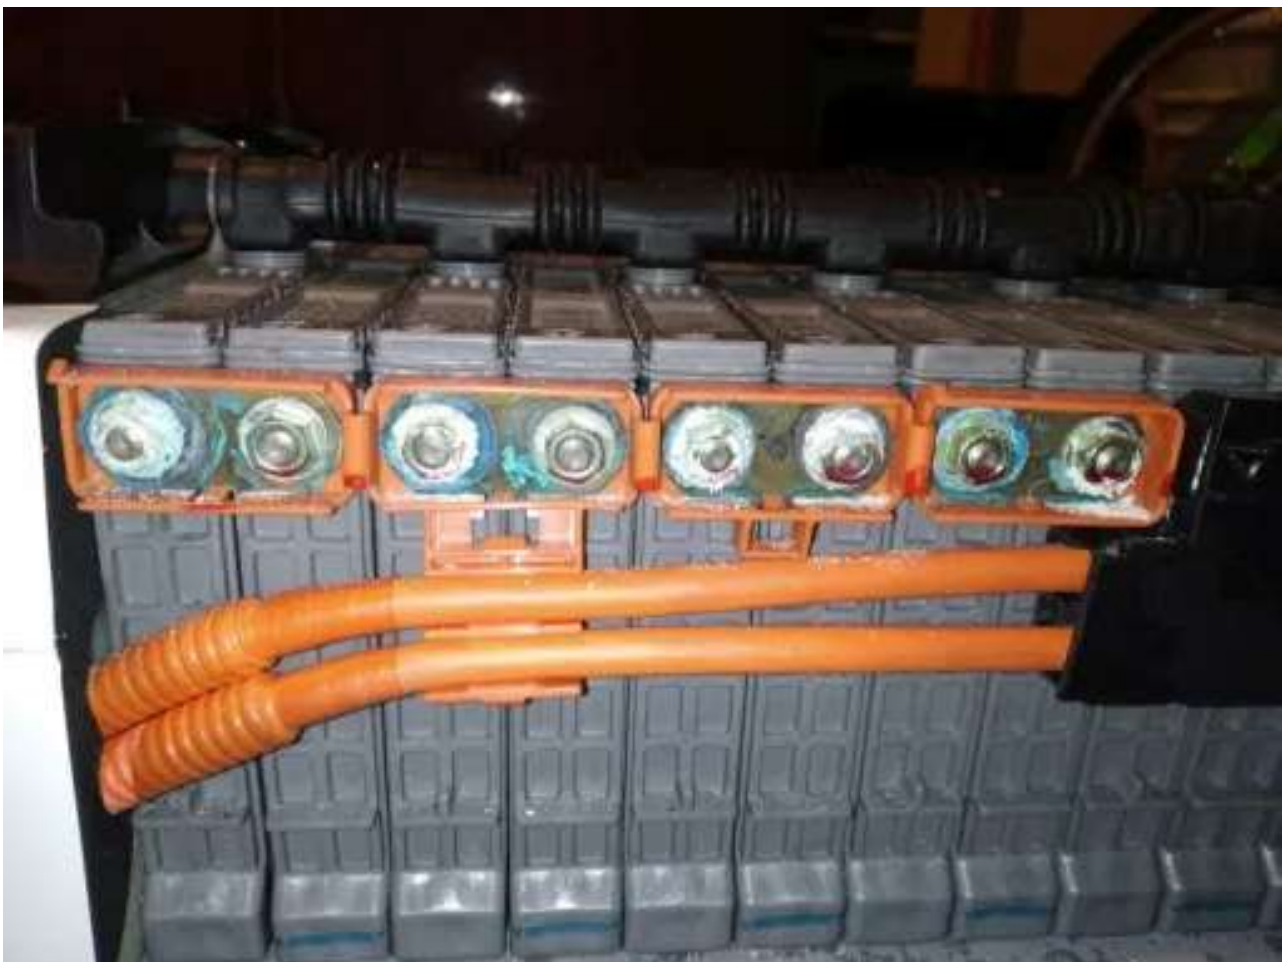
Inside, I still found what I was hoping for, the terminals connecting the fairly strongly oxidized modules:

Copper terminals are used here for better resistance, which do so in the presence of moisture. Stainless steel contacts would be perhaps better here, but its electrical properties are poor. So I put on the protective gloves again and disconnect everything:

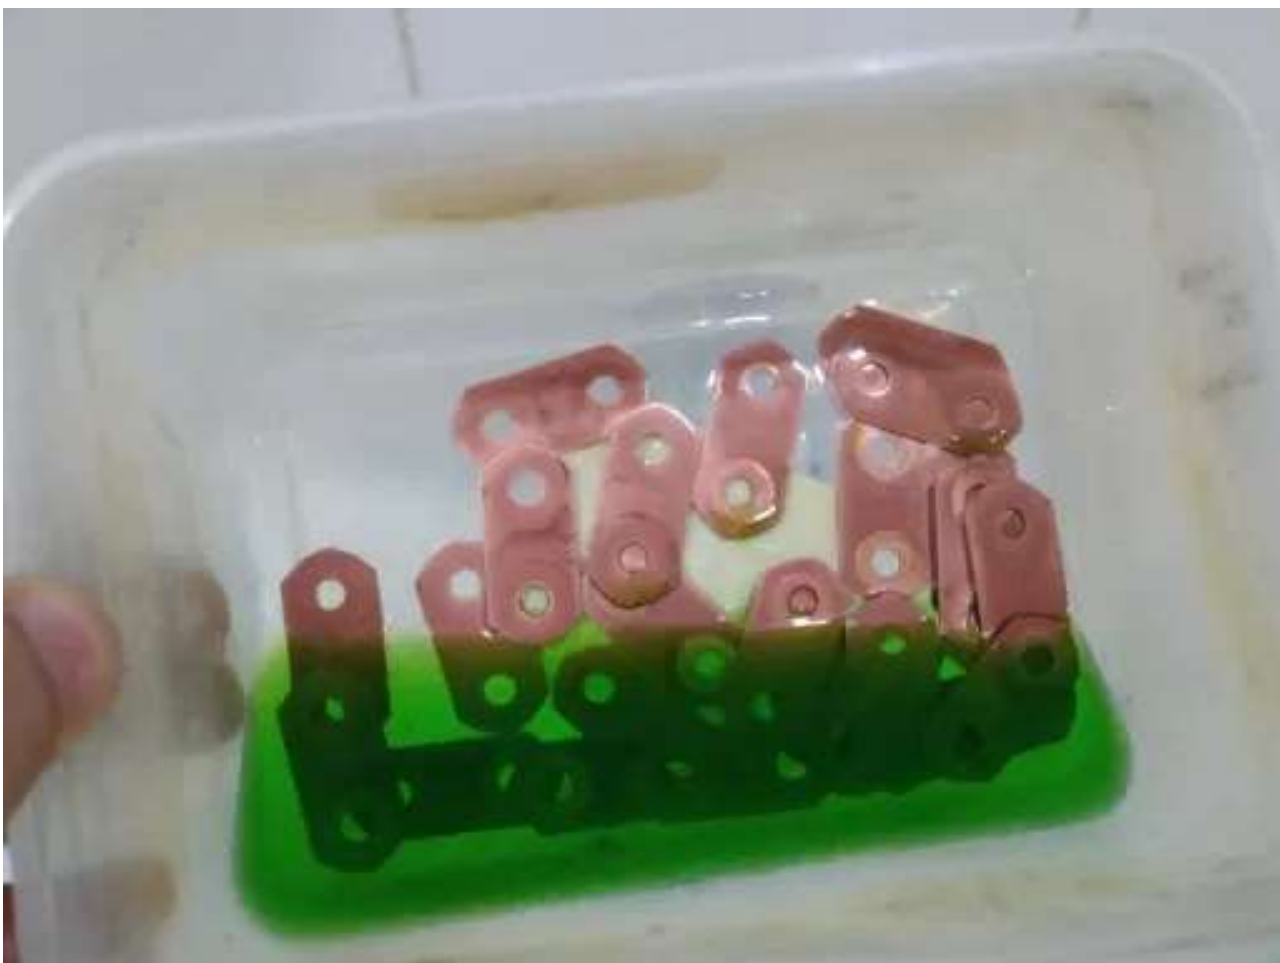
I still saw the voltage of each module and for some reason I didn't see much disconnection, I was hoping at this point that it would only be enough to clean the contacts. I cleaned them with a solution of hydrogen peroxide and hydrochloric acid used for PCB etching:

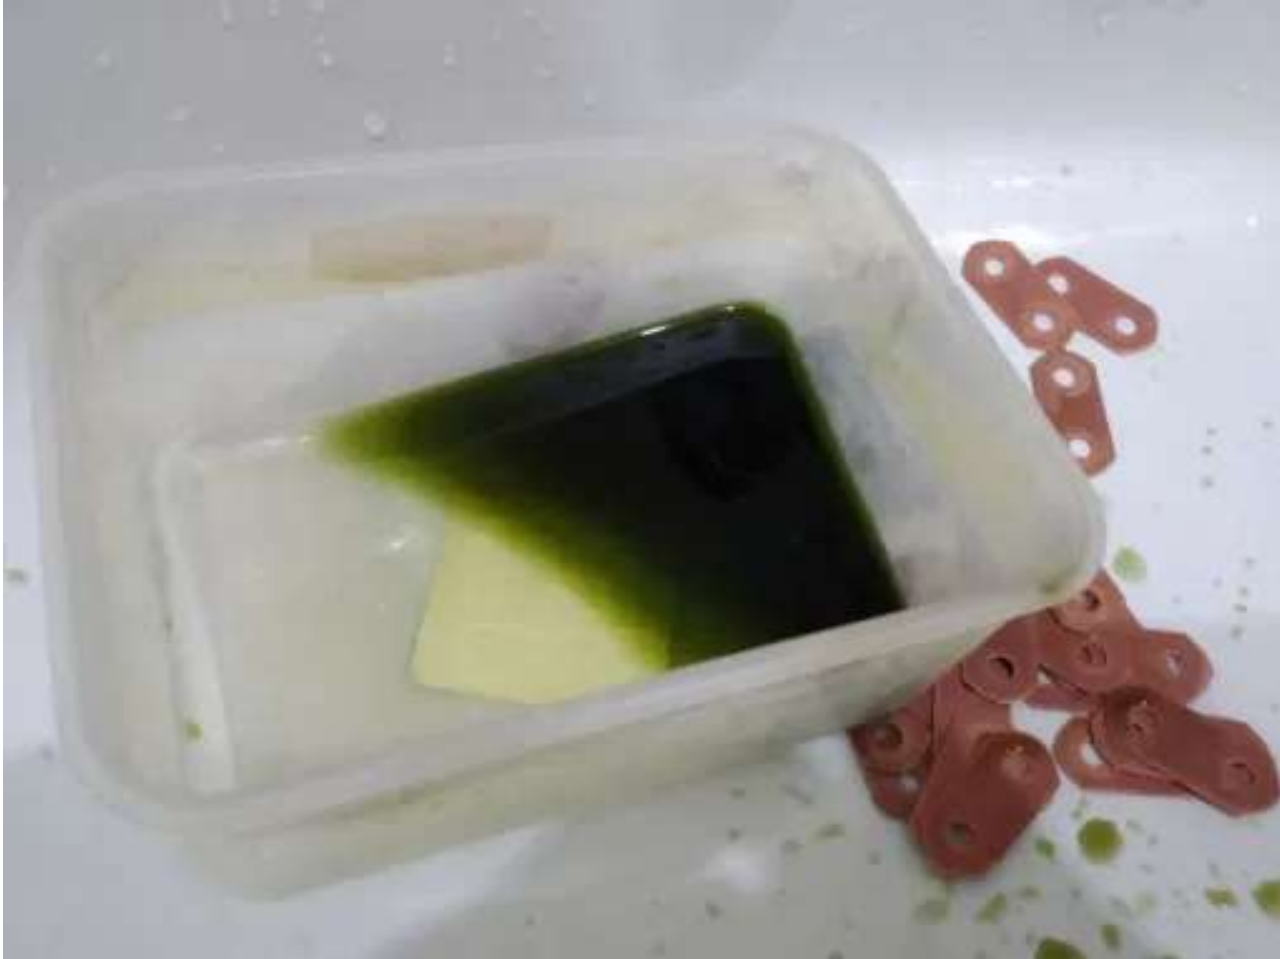
After just 15 seconds of rinsing, it was enough to remove plaque:

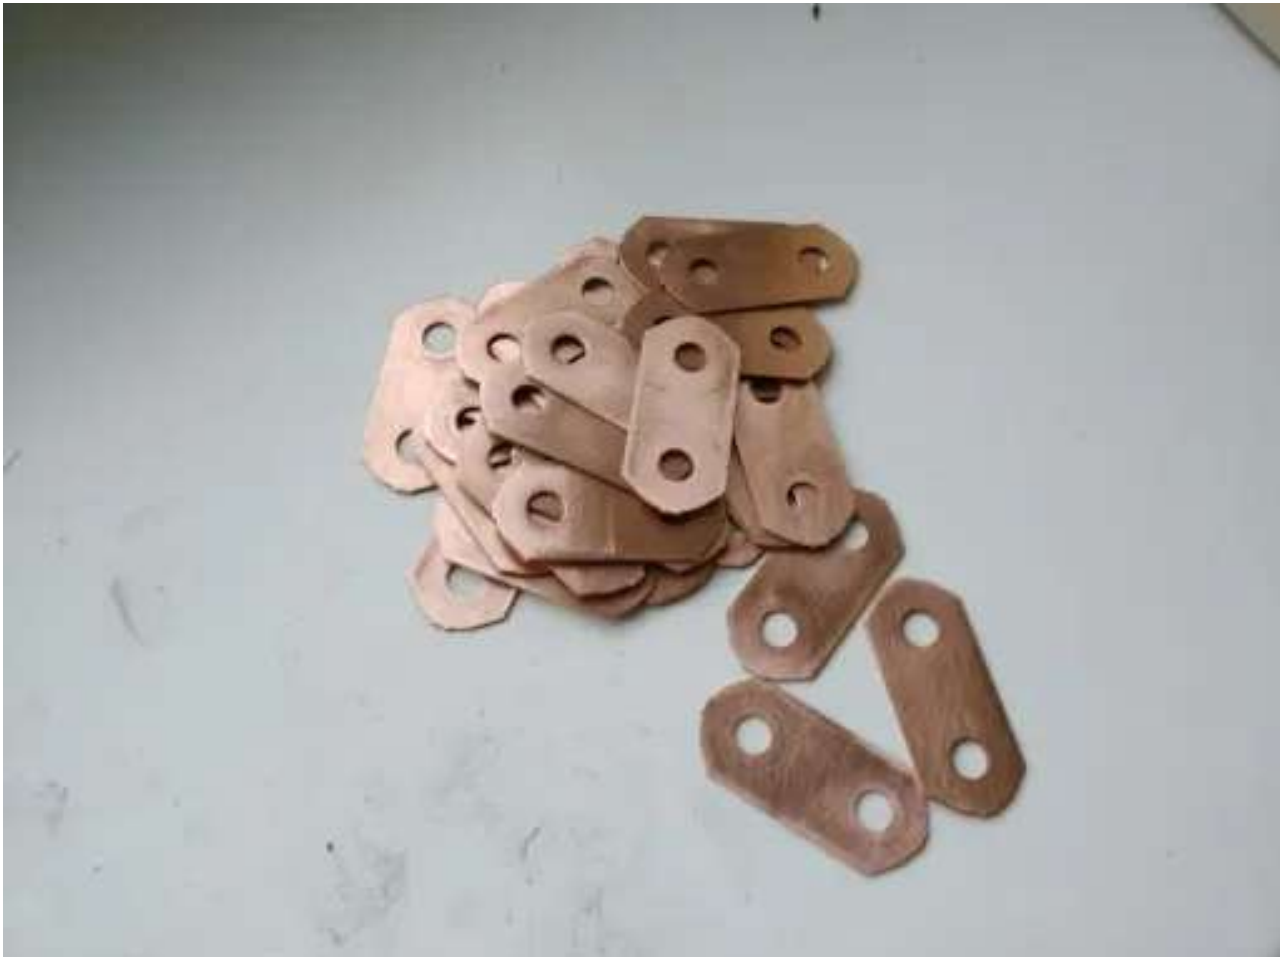
Then I neutralized the acid with baking soda and with 400 sandpaper I further cleaned the plates:

I put the battery back, installed it in the car but unfortunately the problem was not solved. However, that pair of 7 modules was really weak and here is not the option that their bad readings due to contacts.

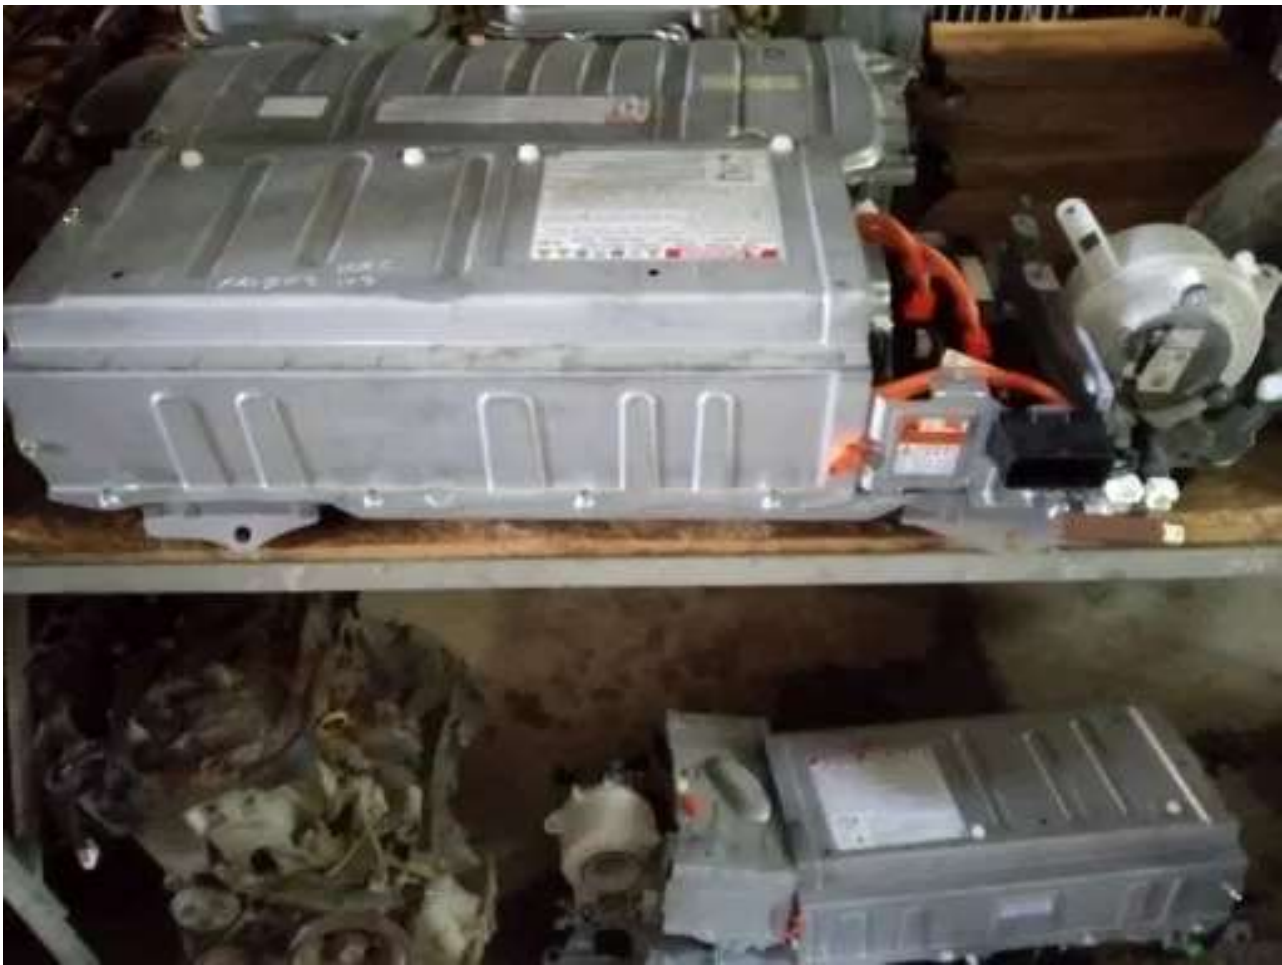
Here is a list of only the latest Prius. The salesman from Utena was especially stuck, who spoke similarly about what he was talking about but talked nonsense and wanted 2000Eur for probably the 2016 Prius battery. I was still trying to figure out if the whole Prius would be with the battery, maybe the Plug-In battery wanted to sell me, or maybe he was making fun of me here in some way (maybe someone made fun of him yesterday?), But without explaining anything, I noticed that no longer dominoes. After a few calls I found what else to look for and you see a few hints on the list - the 2016-2019 Toyota CH-R. They have exactly the same NiMH battery as the Gen4 Prius, and there are many broken ones in Lithuania. When buying, it should be clear that it has not been in stock for a very long time, otherwise there may be problems with its deposition.

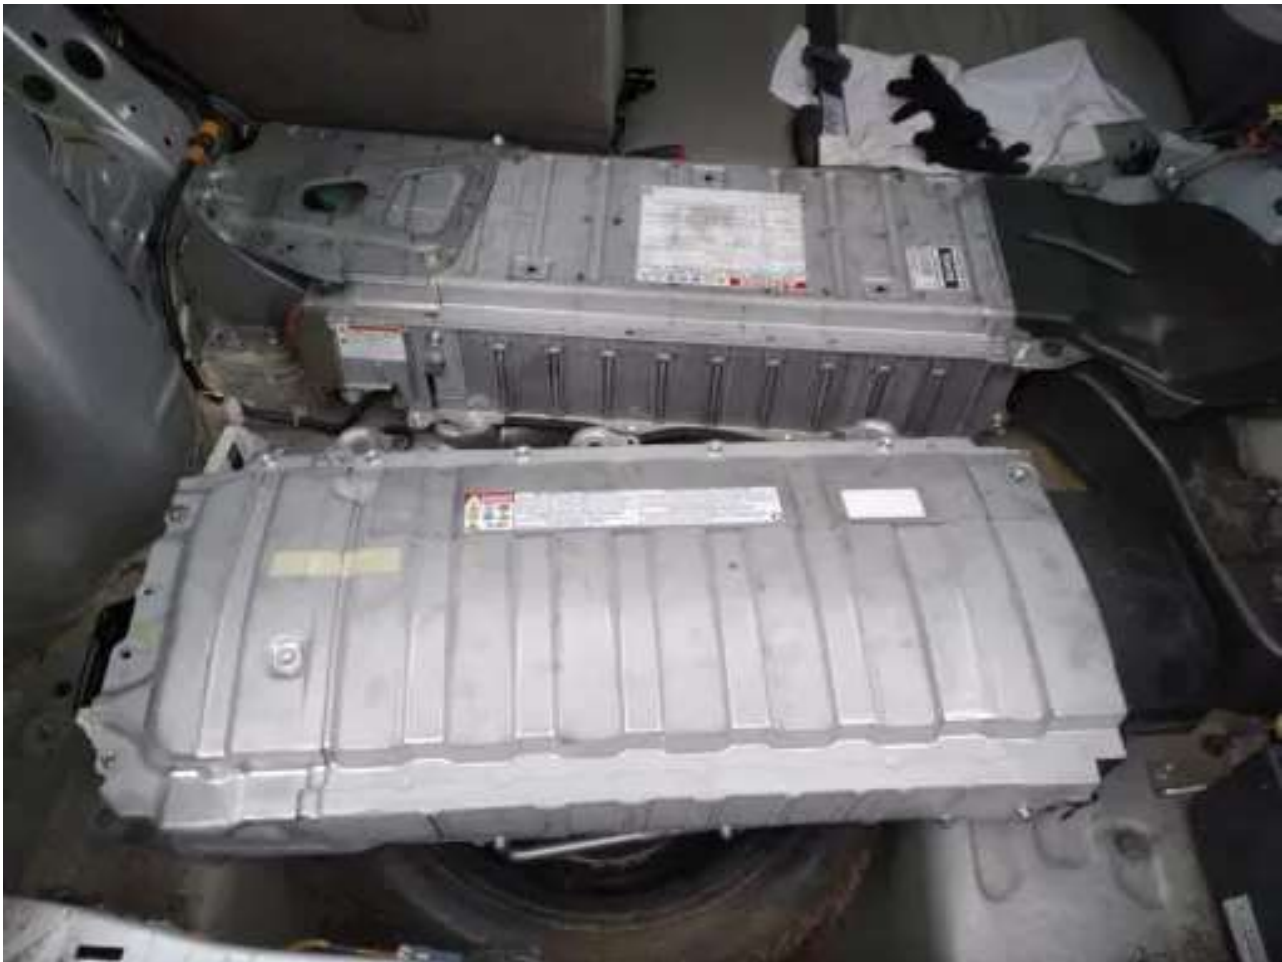
So, we buy a 2018 CH-R battery for 550Eur and drive home. The battery itself next to the old one may look suspiciously different in size, but later you will see that everything is fine:

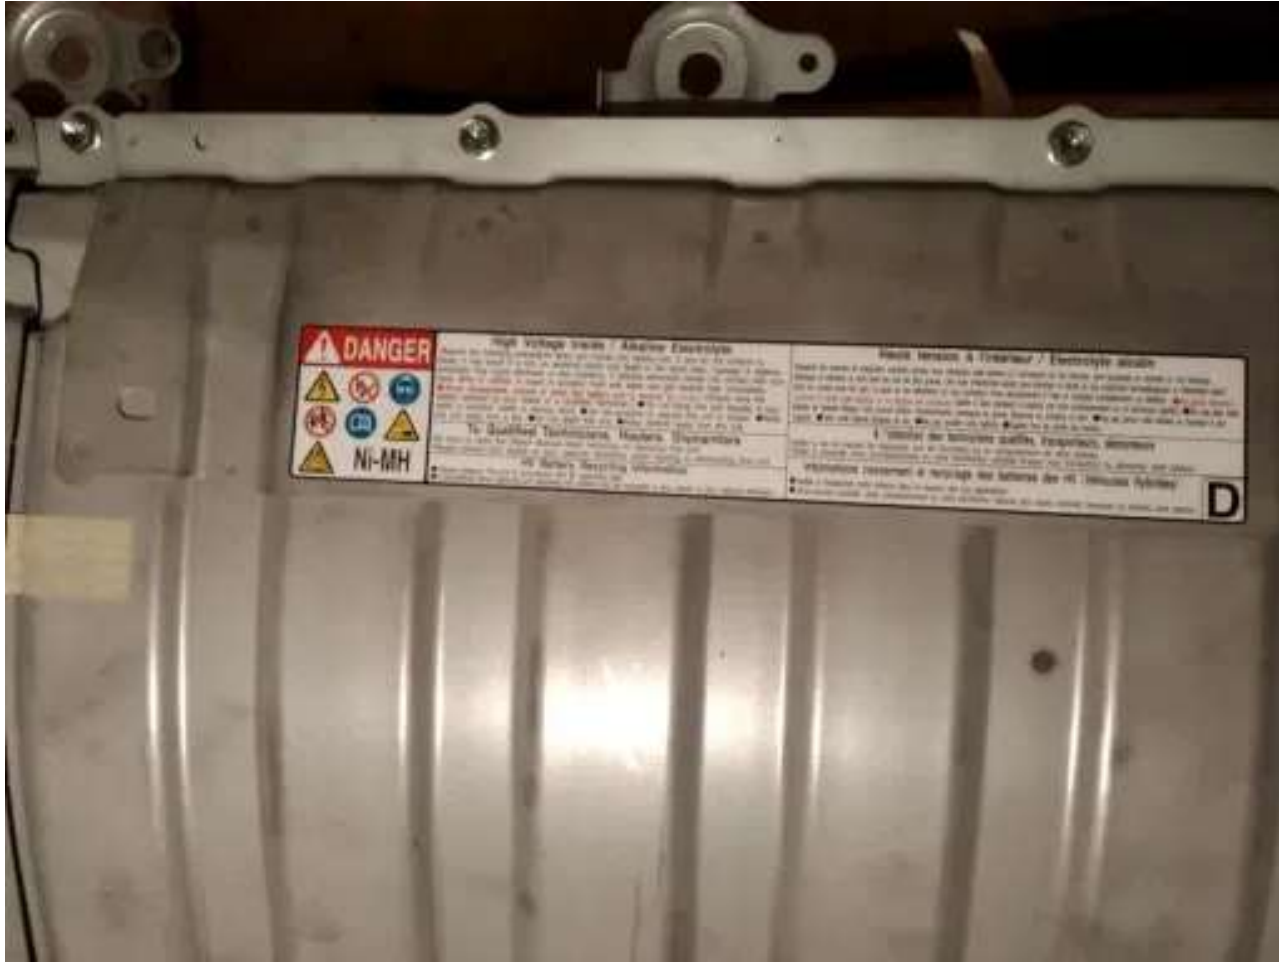
When choosing a battery for used cars, it is still important to know what you need. There are several hybrids that use Lion batteries so you should ask / check if there is a NiMH marking on the wick:

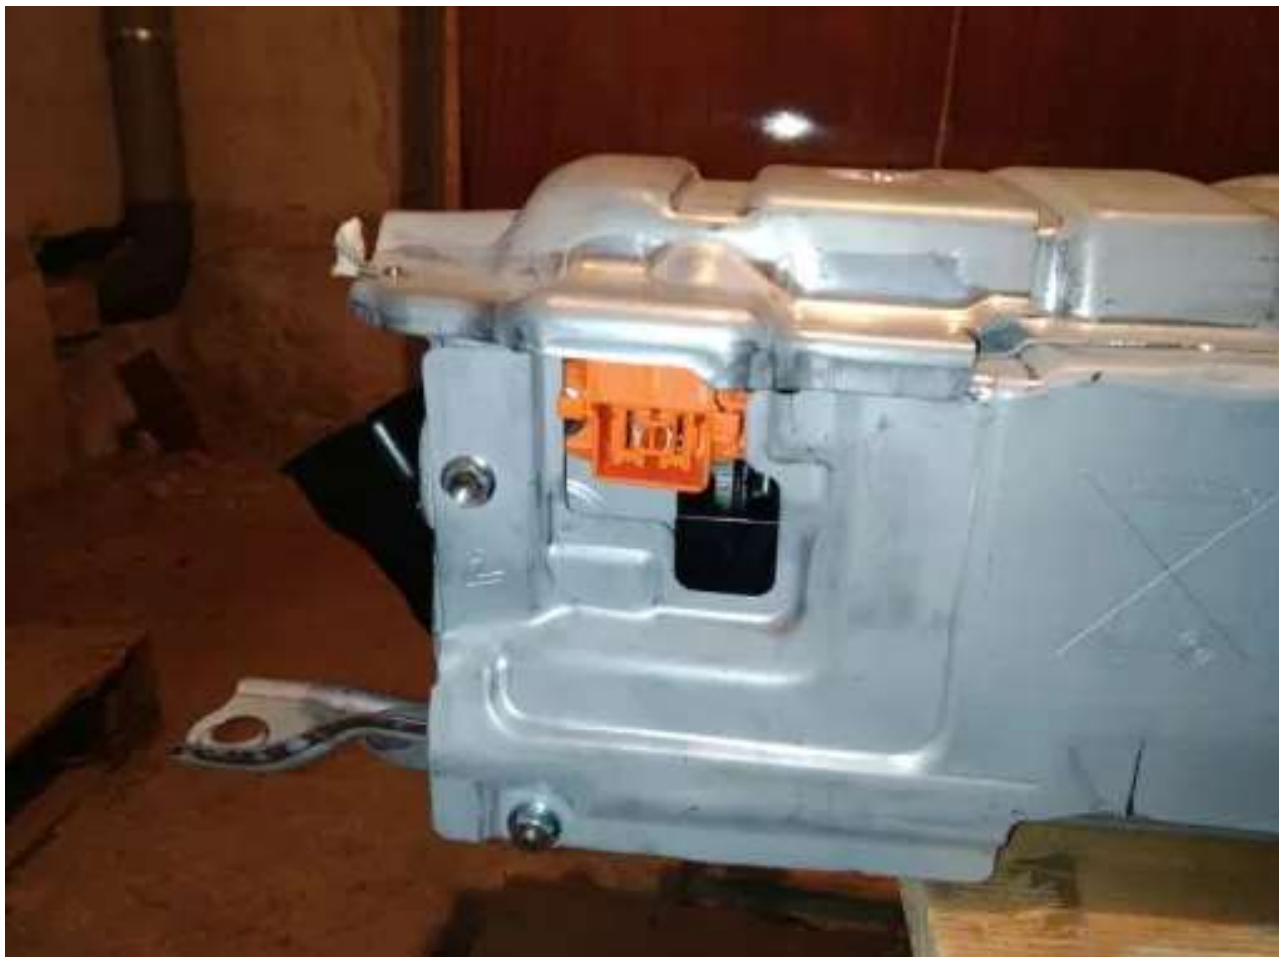
As for the battery itself, I'm impressed with how Toyota has evolved since the days of Gen2 (or even Gen1). The battery has become as flat as possible while using the same modules, and the Service Plug has become miniature:

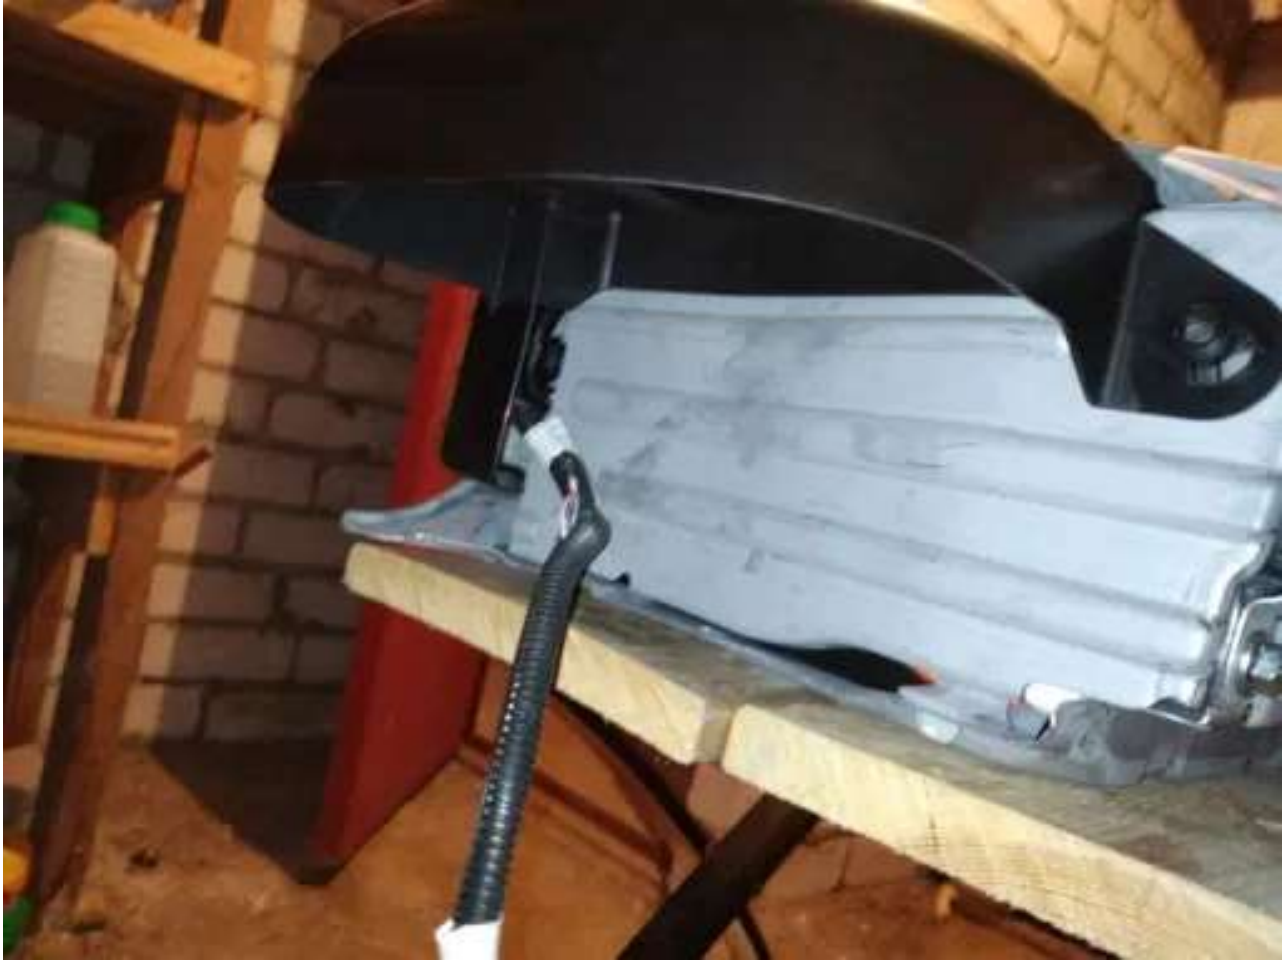
The air supply now develops from one side:

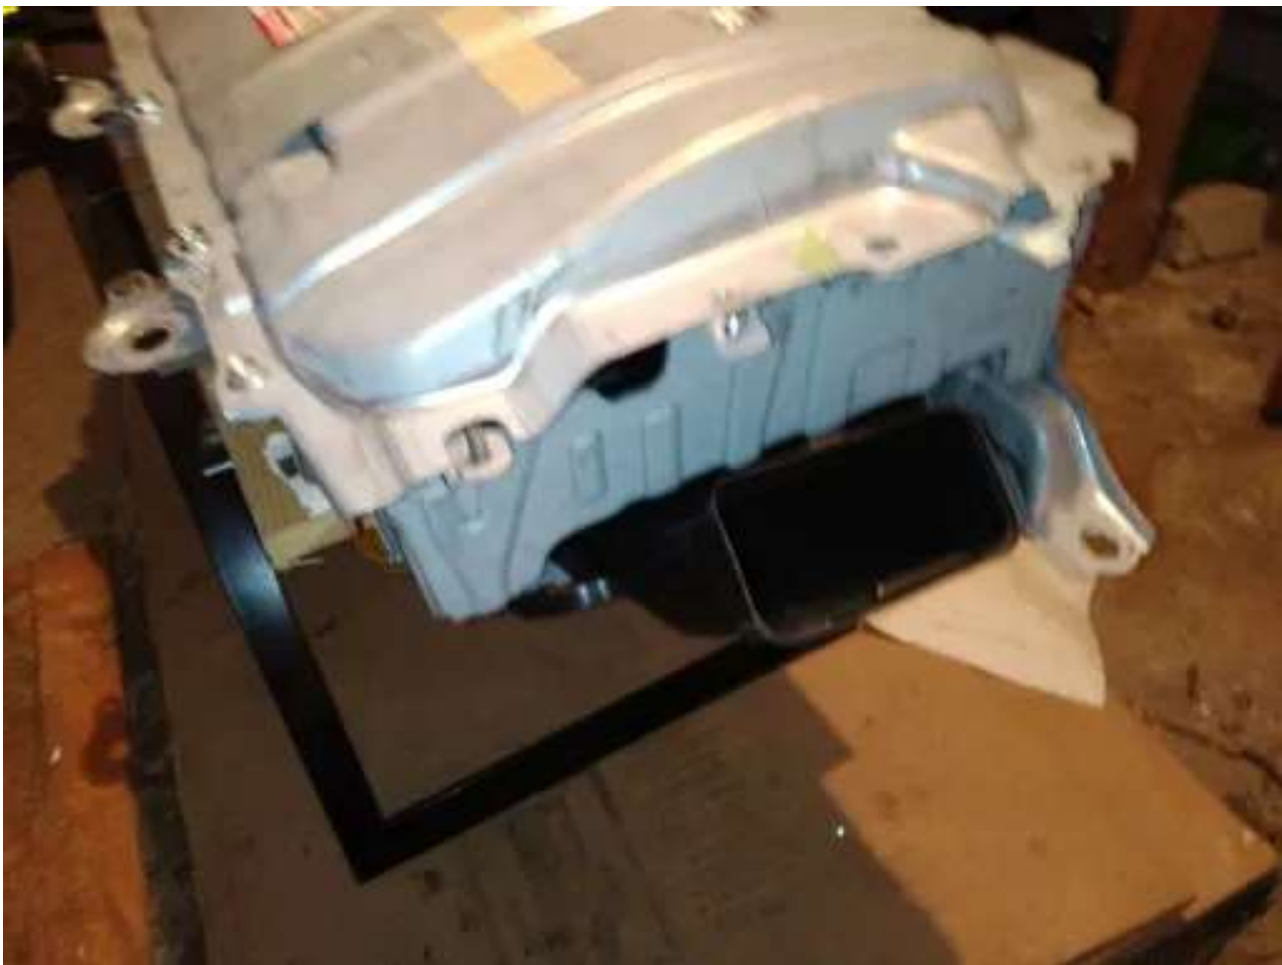
And the way out of the next:

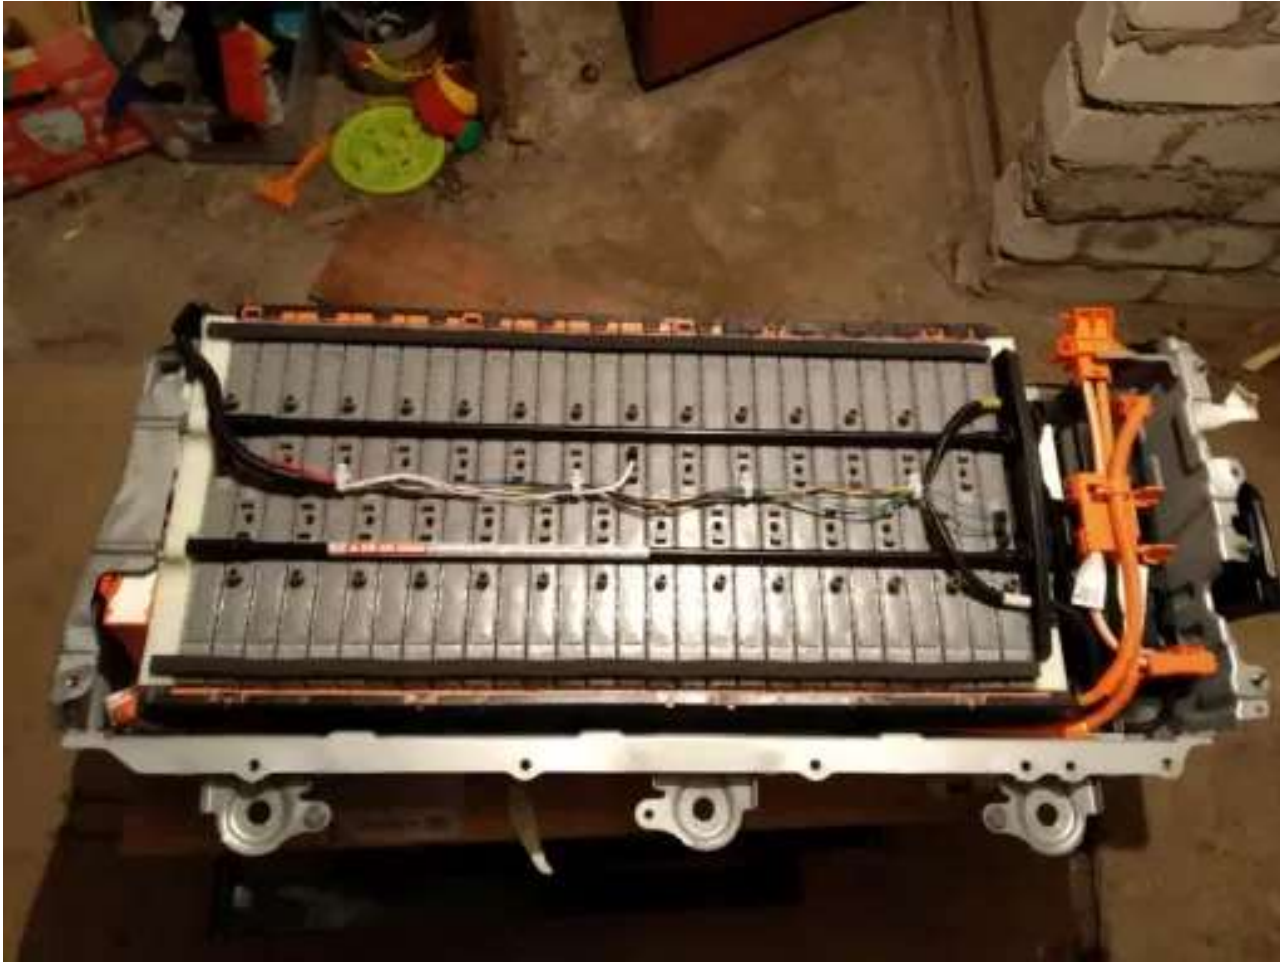
And after removing the tin, it turns out that the air ducts are also used for overpressure ventilation of the modules by giving up two additional hoses:

By the way, we can see here that the temperature sensors in the new battery are at the top and in the new one at the bottom. Also the battery ECU is now moved to the other side, but that's not very important to me. What's interesting is the production date:
