Mindaugas Markauskas

Prius Gen2 - great HV battery repair / s

4 06 2019

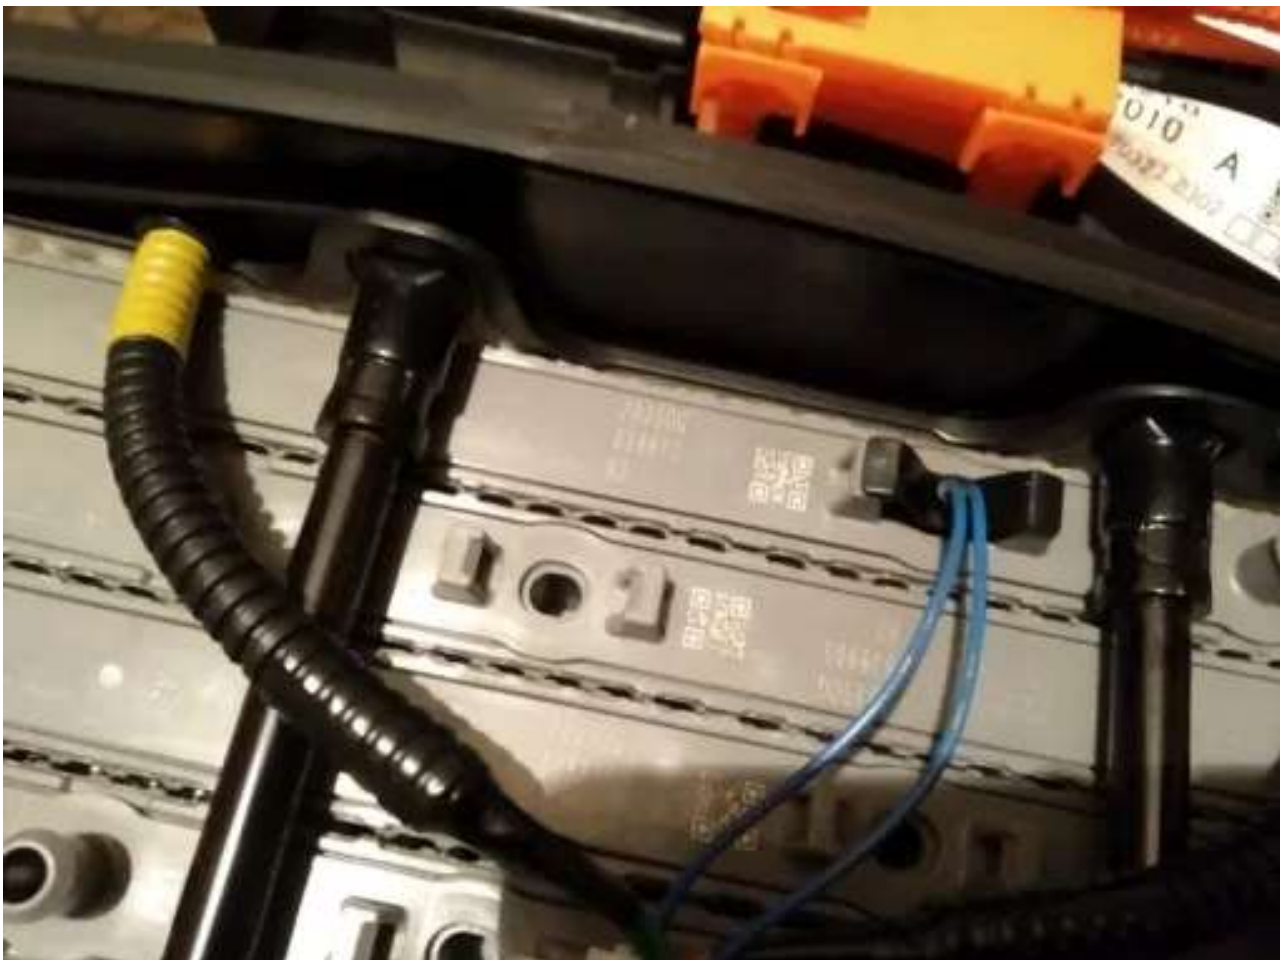
203S says that the modules must be in production on 2017-02-20.

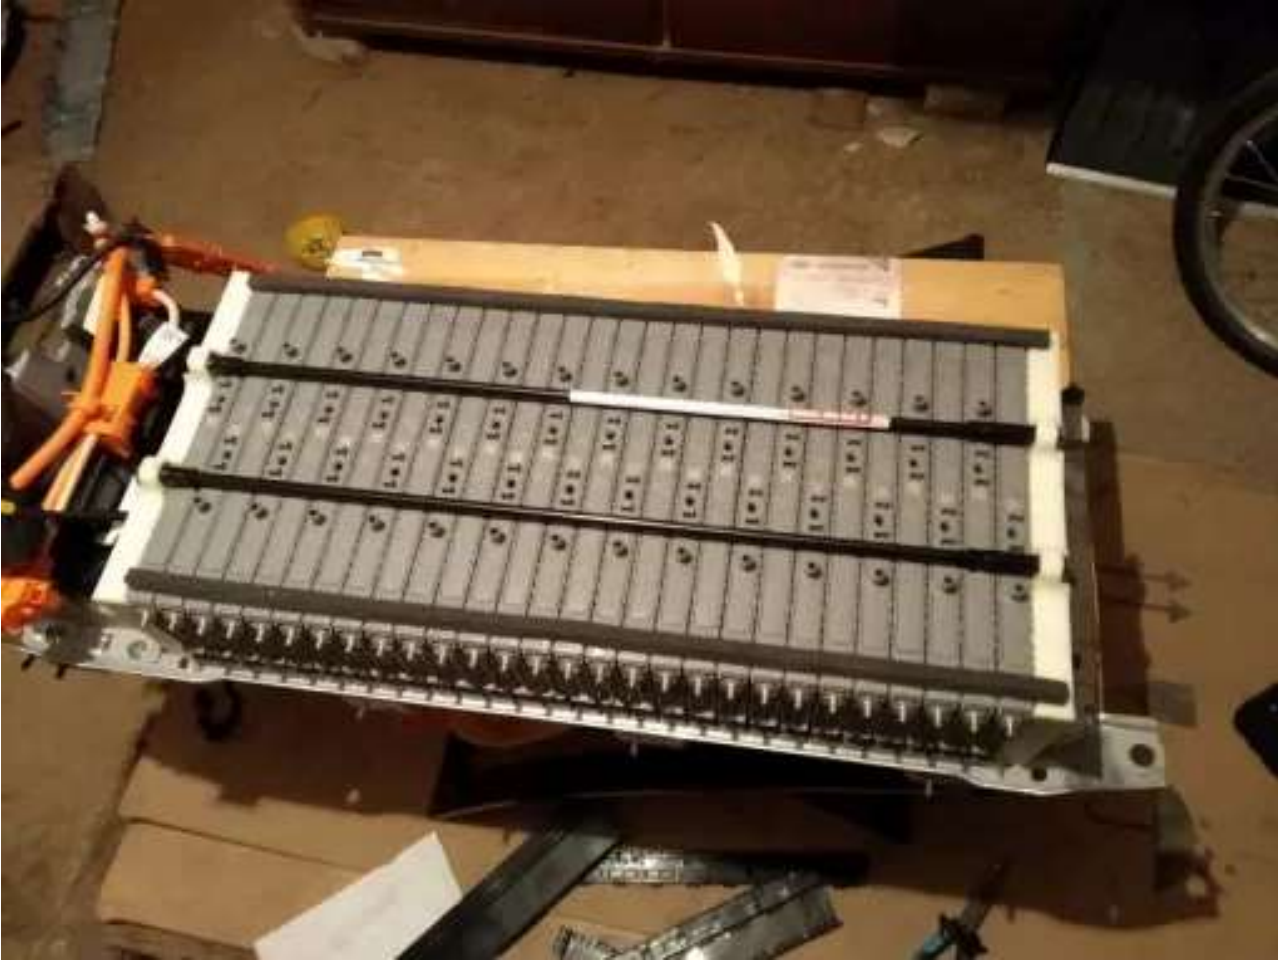
Now we put on protective gloves and strip the new battery:

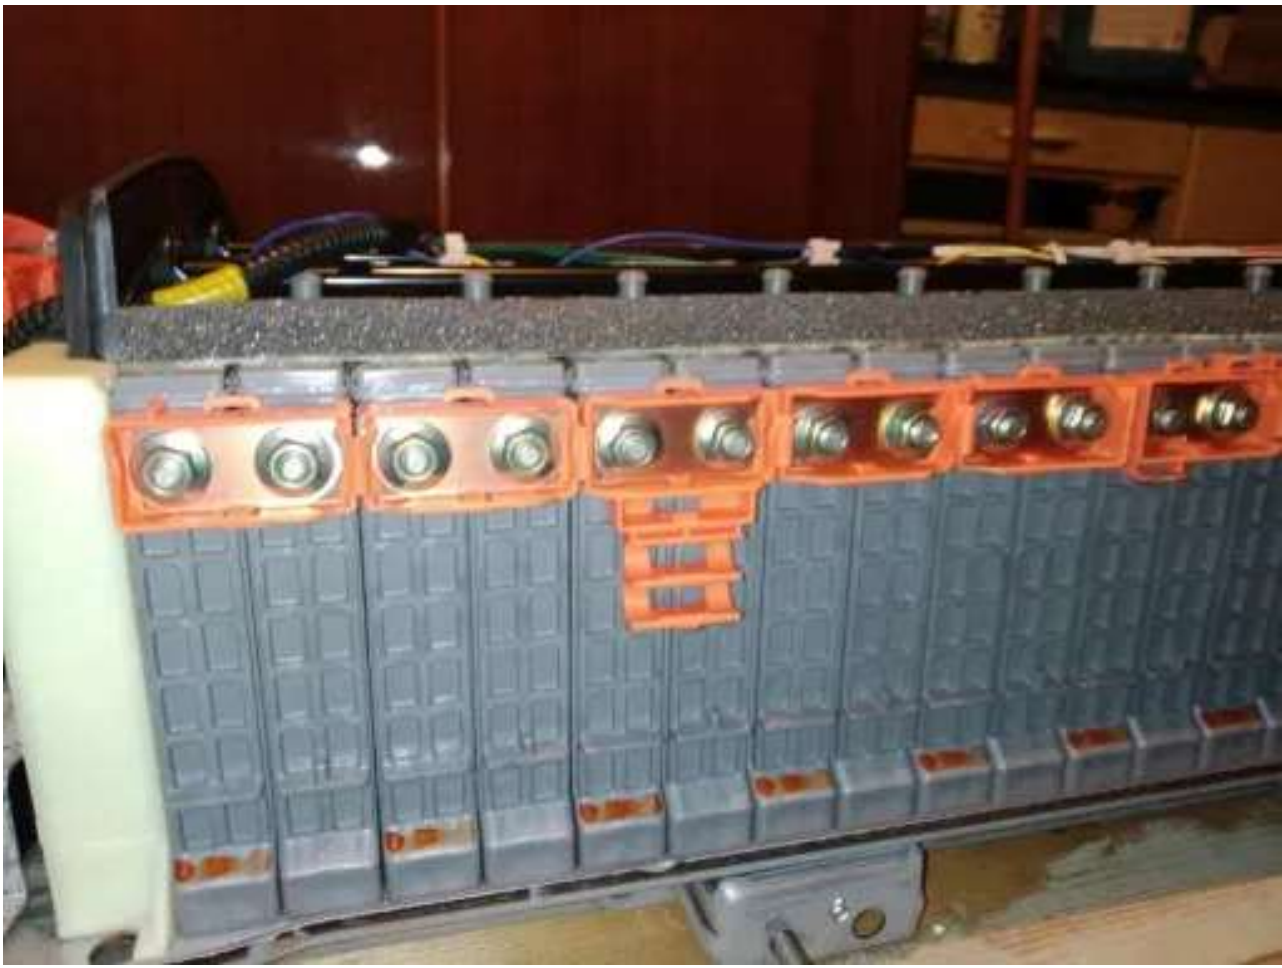
I'm a little nervous about doing this because these battery contacts are like new. This means that I could use them for an old battery without getting tired of cleaning old contacts:

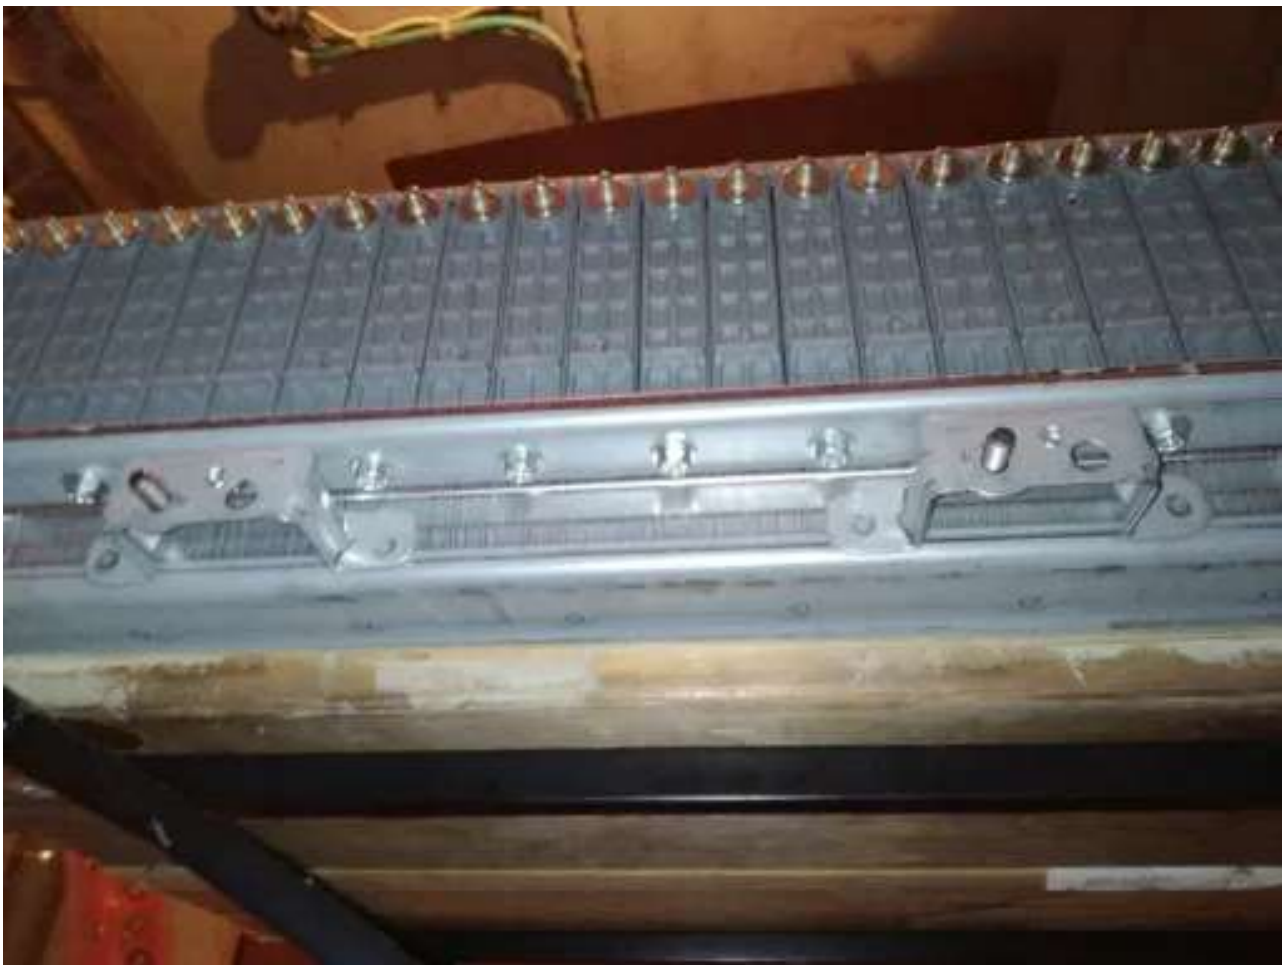
To remove the entire module pack, 14 nuts must be unscrewed on both sides from below:

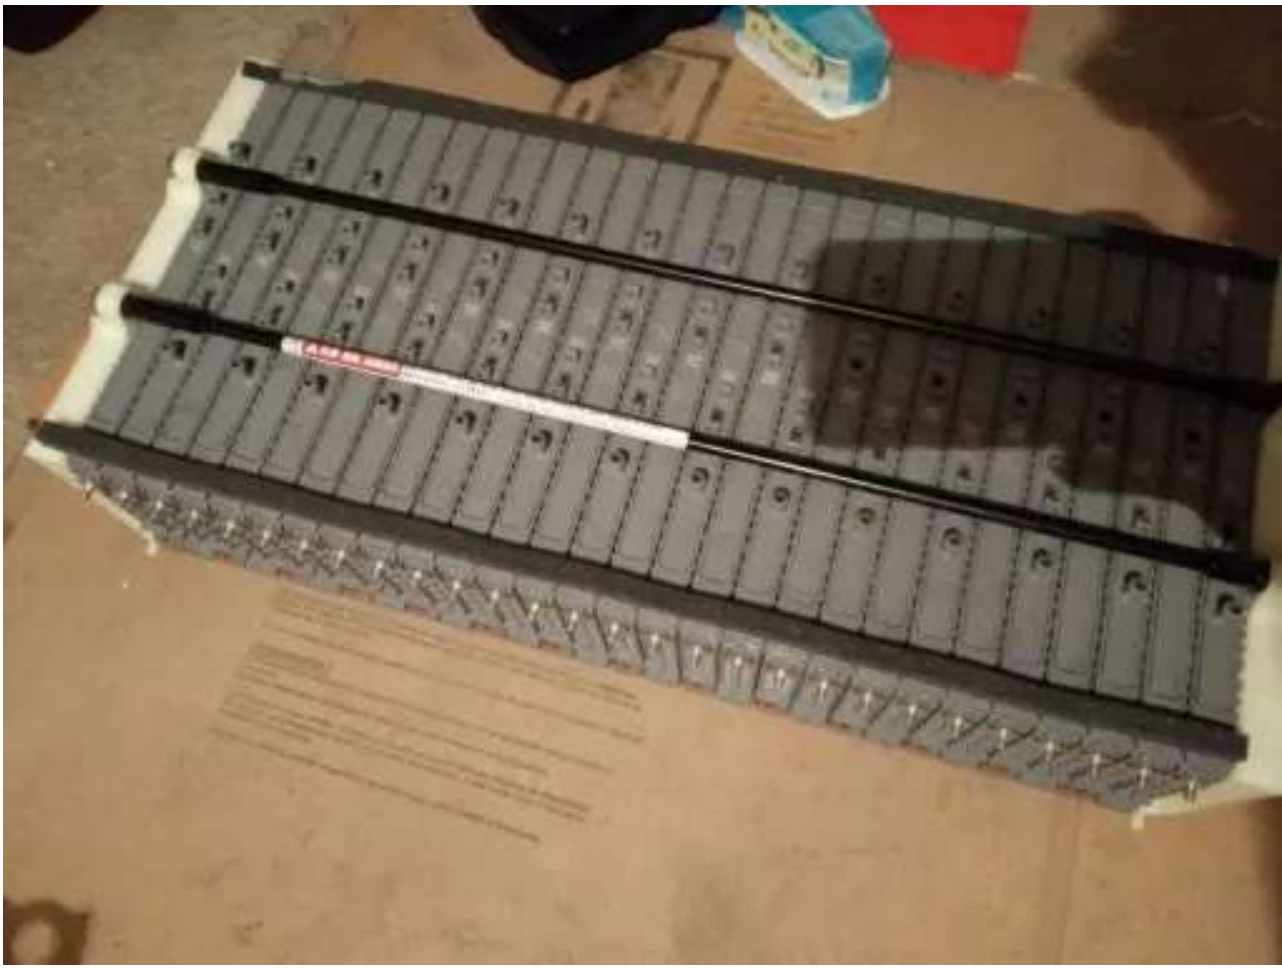
And then we can put the whole package of modules until we dismantle the old battery:

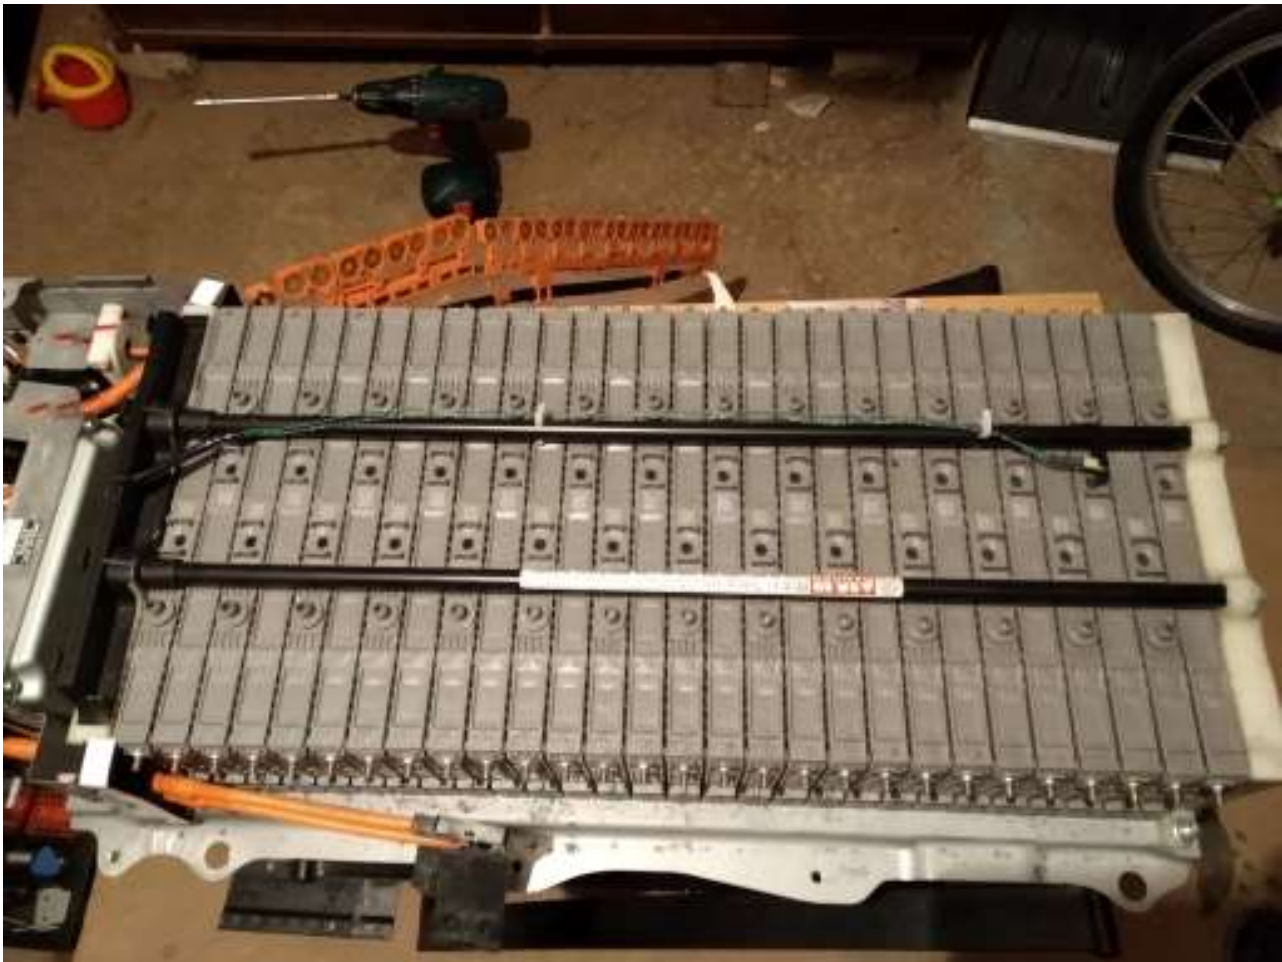
It was thought that I might overdo the whole package of modules because its dimensions are very similar, but when I finished stripping the old battery, I noticed that the closest contact to the ECU in the new battery is Plus, and in the old Minus .:

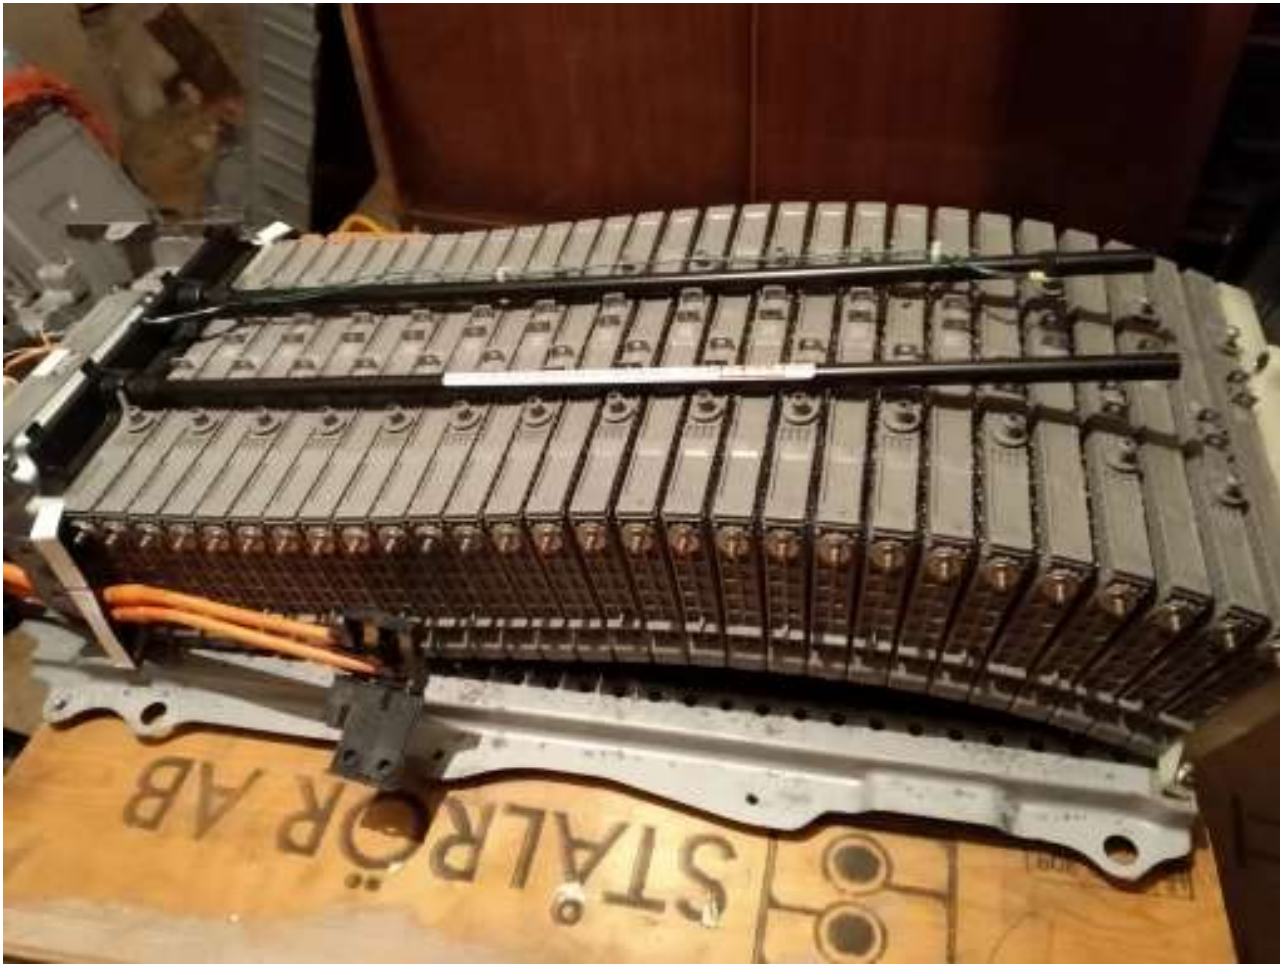
So the modules will have to be changed anyway. Now I unscrew the lower screws and do what can't be done with the old battery, which is still warm - I loosen the 4 screws that press the pack from the sides before removing the whole pack and frame:

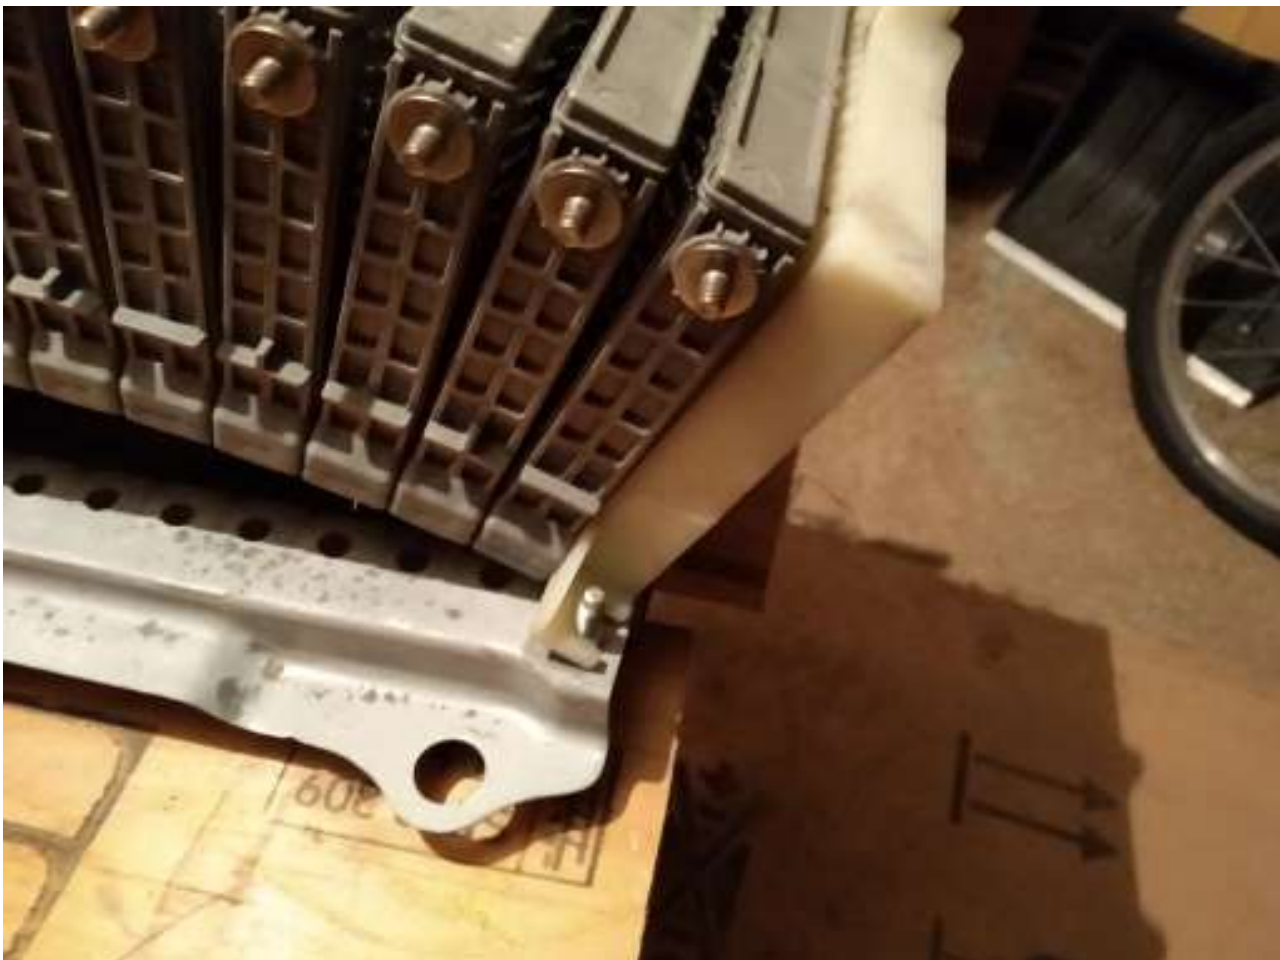
Here you can see that the frame bolts at the bottom did not allow the last module to be placed and the modules that expanded from the heat became such a worm:

To avoid this, either wait a few hours for the modules to cool down, or lift the package vertically before disassembling so that the modules shoot upwards as they expand.

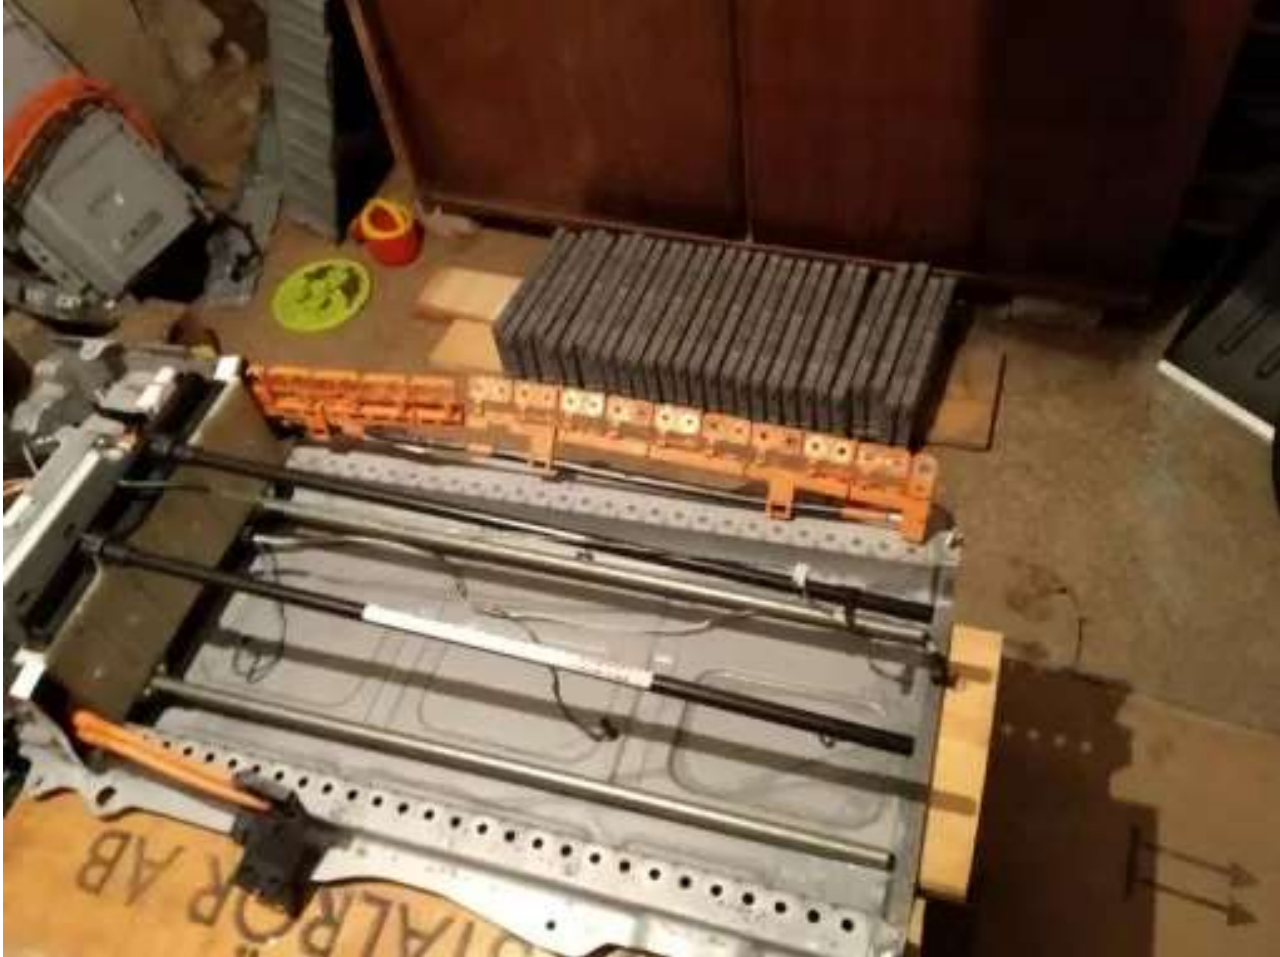
Finally, after scratching this pushed corner, I removed all the cells and stood up without disturbing the sequence to the side:

While I was doing the following work, those cells kept whispering as they shrank, but eventually acquired their original size.

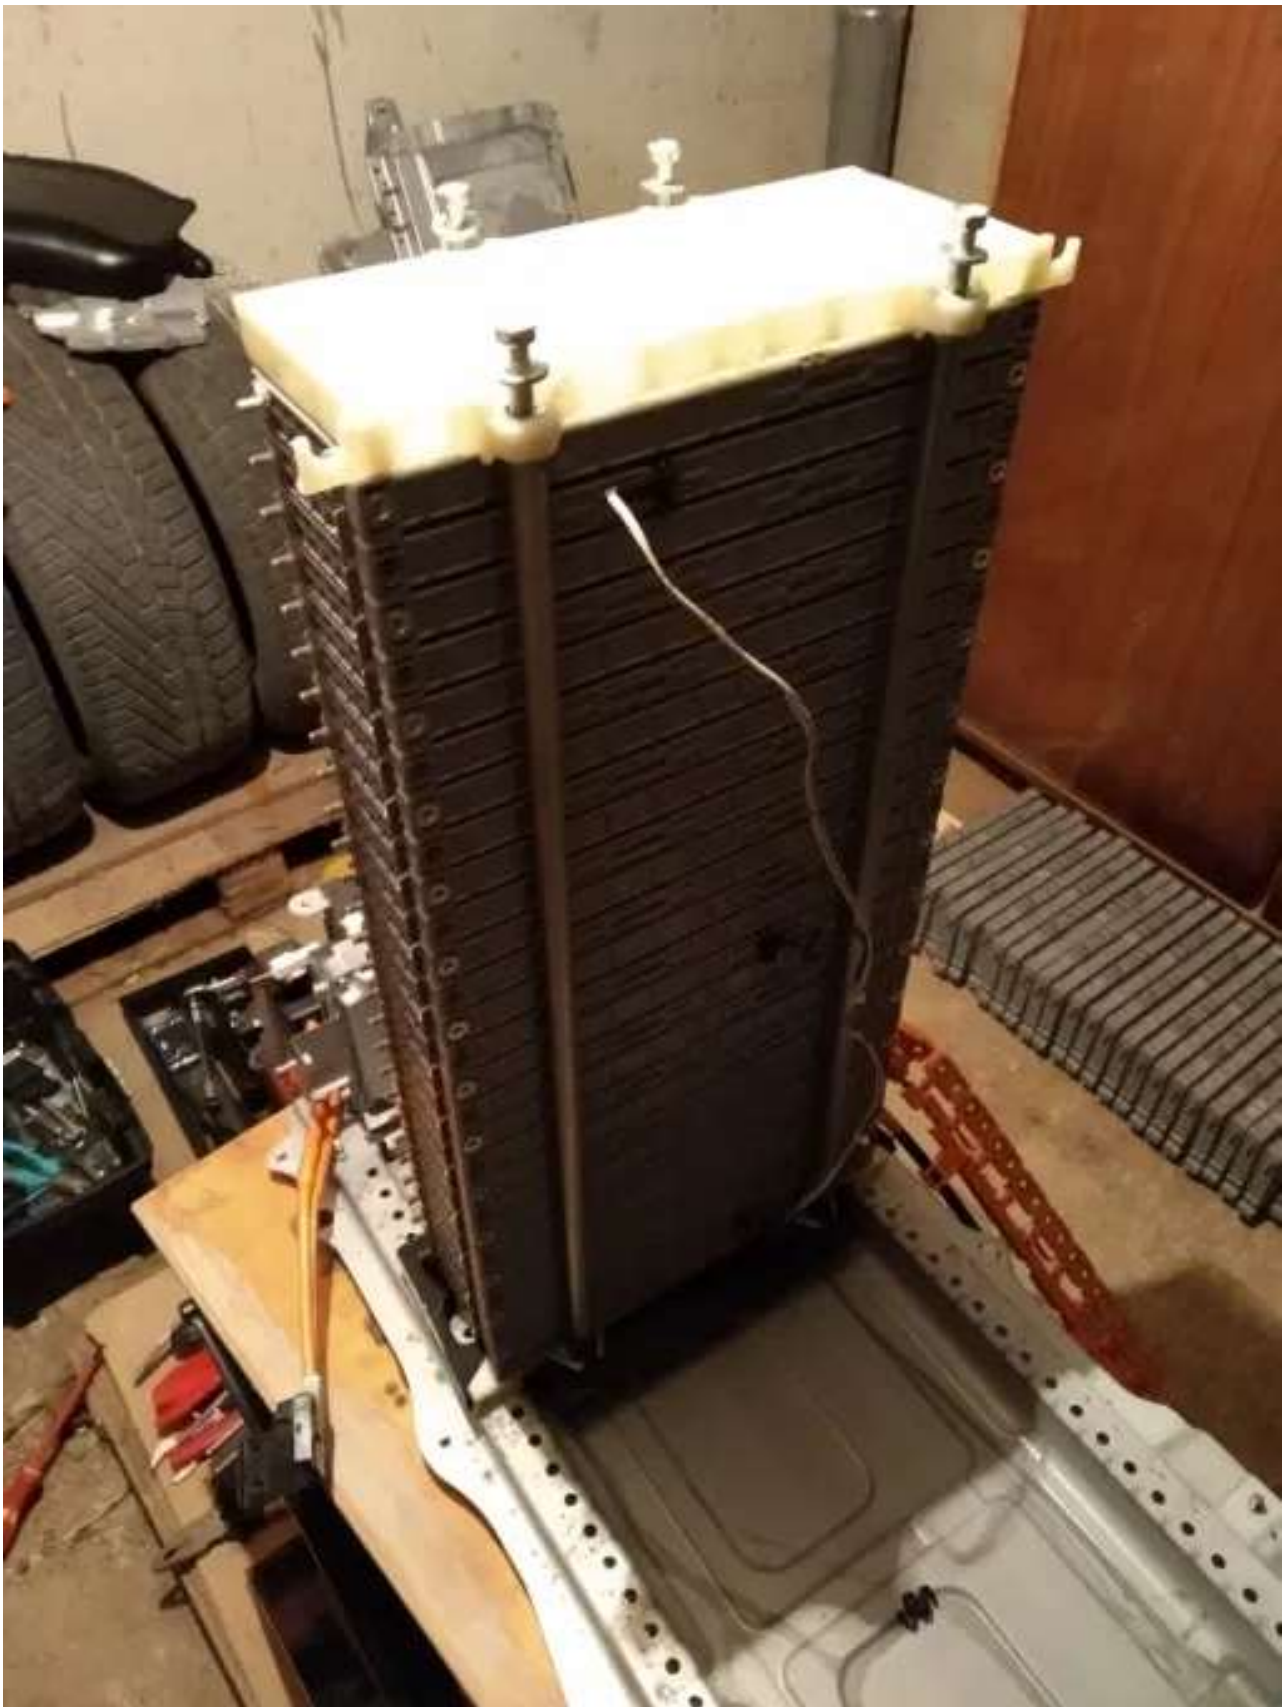
And we stack them in the old frame built vertically:

It is very convenient to attach the temperature sensors at the beginning, middle and end, and to screw the package with screws one pleasure.

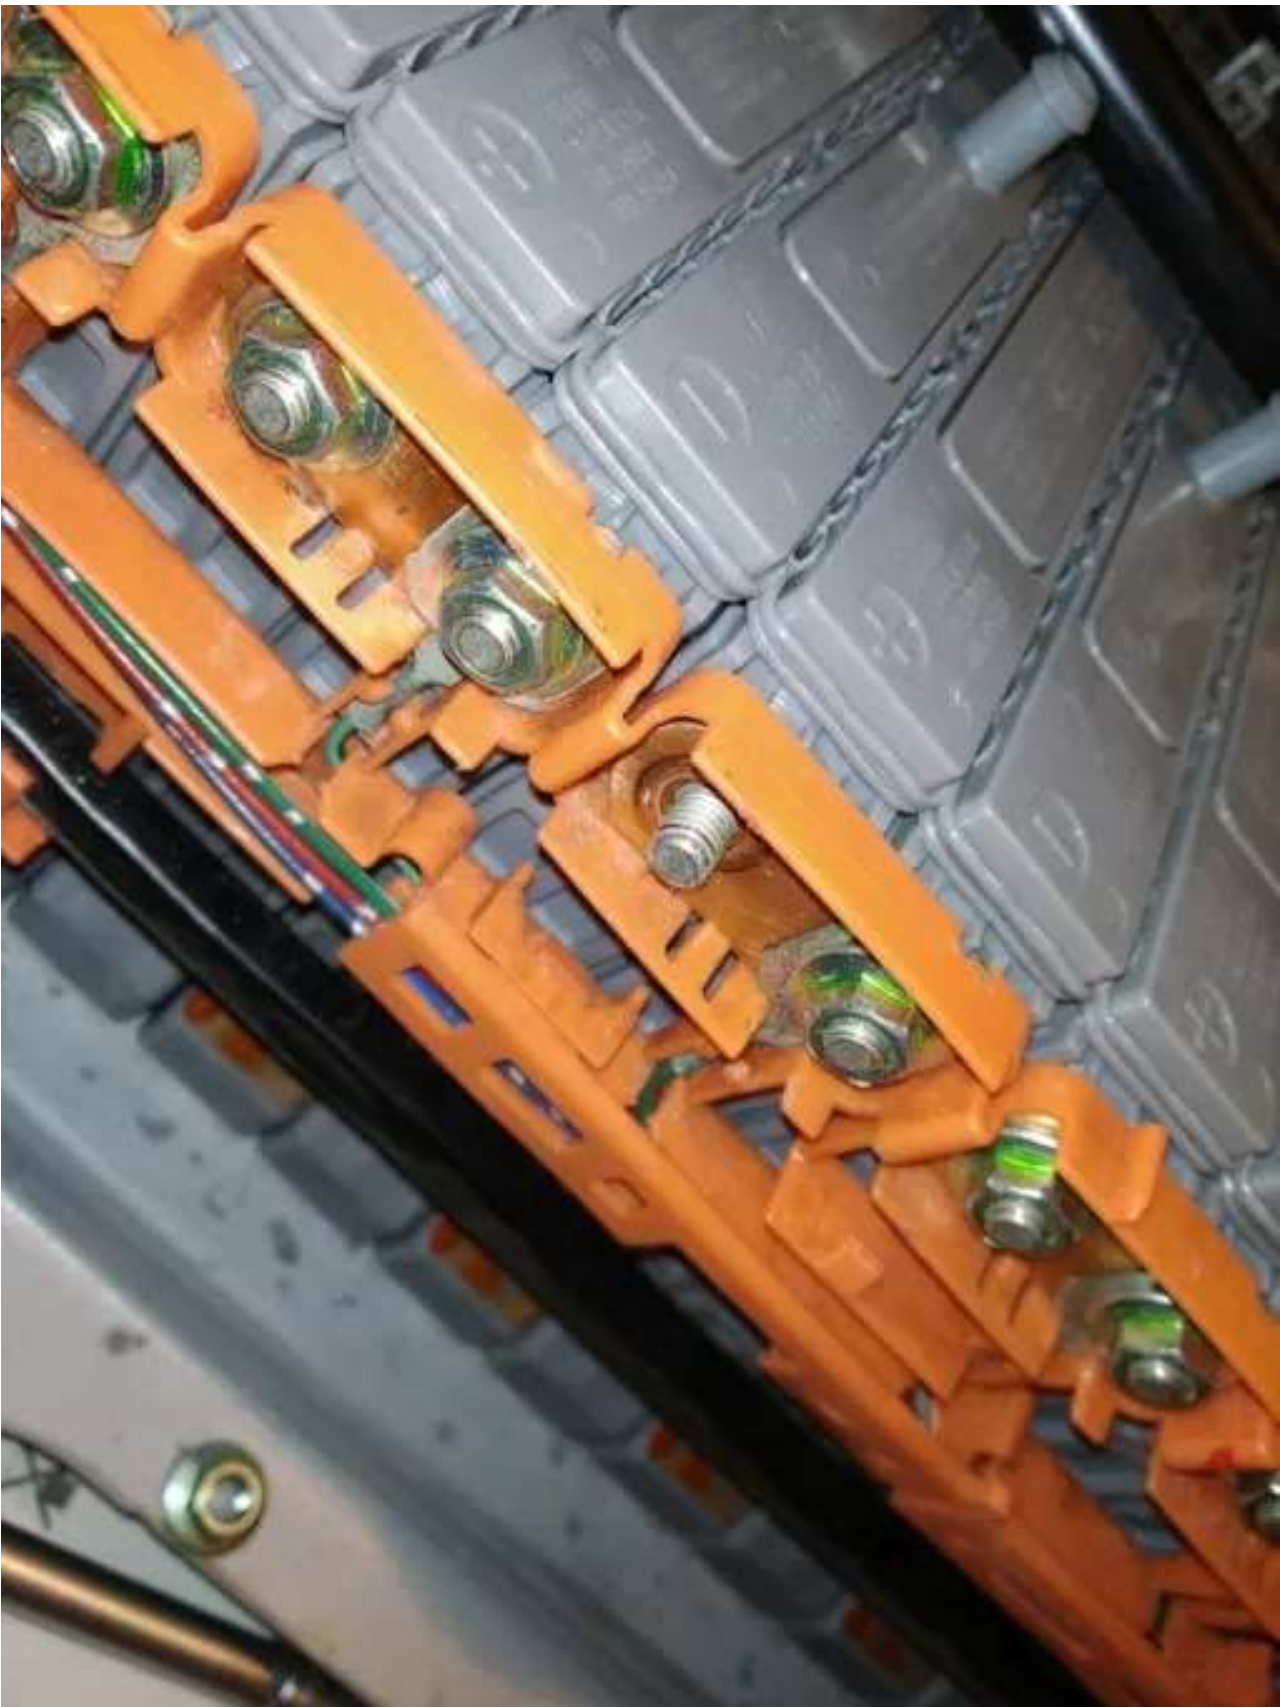
Later, I laid the package back in the frame, screwed in the 28 screws from the bottom, and it was time to put on protective gloves and start screwing the contact terminals into the chain. Here I made one mistake - I turned the screws with a screwdriver and in doing so I hurriedly damaged the thread of one of the modules:

So I had to unscrew the whole strip of terminals and try to carefully fix the thread with a tap:

It didn't quite work out, the nut stuck anyway and didn't catch the road. So I had to use my brother's advice - to sand the beginning of the thread with a pencil as if you were carving a pencil. After removing one or two turns of the thread in this way, the nut was successfully fitted. If it failed then the headache would be very much as losing one module would be no good. I would advise you to use the screwdriver only to loosen the bolts and nuts, because there are really a lot of them, but it is better to give yourself time and do everything more carefully to tighten it.

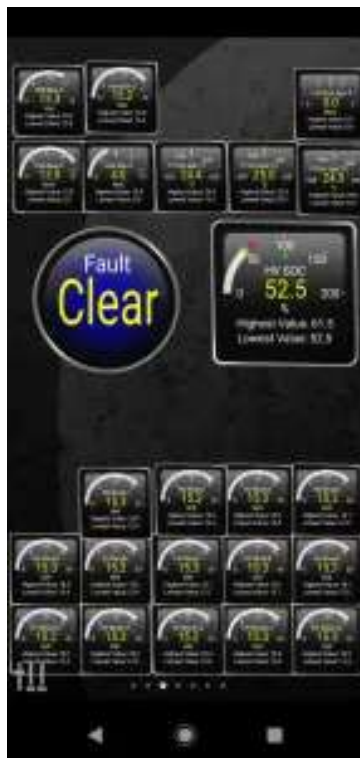
Now it's time to take a look at ODB2 after a half-hour ride:

We see that the voltage of all modules is balanced. That must be the case, because I tried to make sure that even the pairs of modules would coincide during the transplant. The temperature is completely low, only 25 degrees in the center. That's the way it should be, because the modules are almost new, and to some extent (but I don't guarantee) its new production has bigger lower internal resistance (<https://priuschat.com/threads/gen3-hv-batteries-for-gen2.137902/>) and this would allow them to give up or absorb more energy and emit less heat. By the way, did you notice the new Fault Clear button? That's what I often printed on while driving with a faulty HV battery.

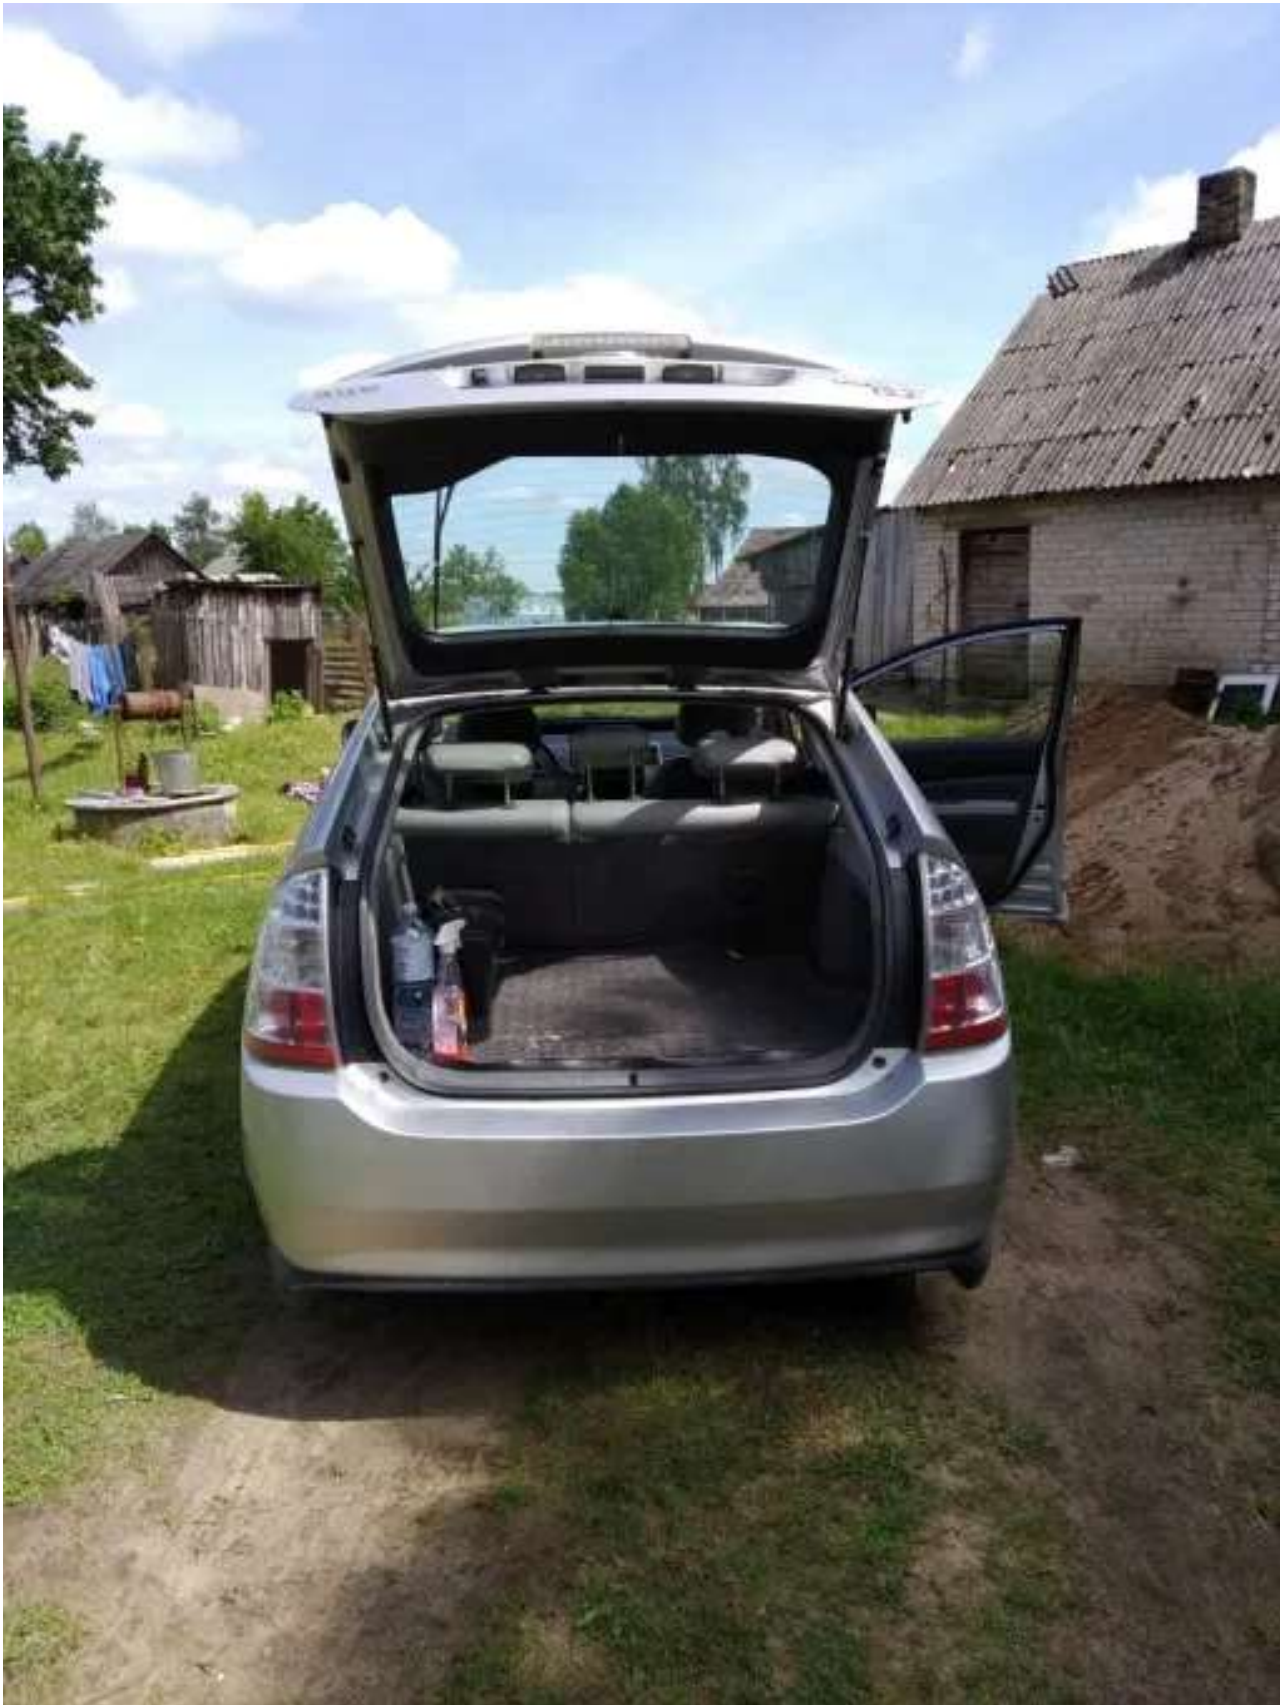
I drove the first hundred kilometers in the city and another hundred on the highway without assembling the interior. For all the anger, if everything had to be dismantled again. Finally, without any problems, I gathered everything:

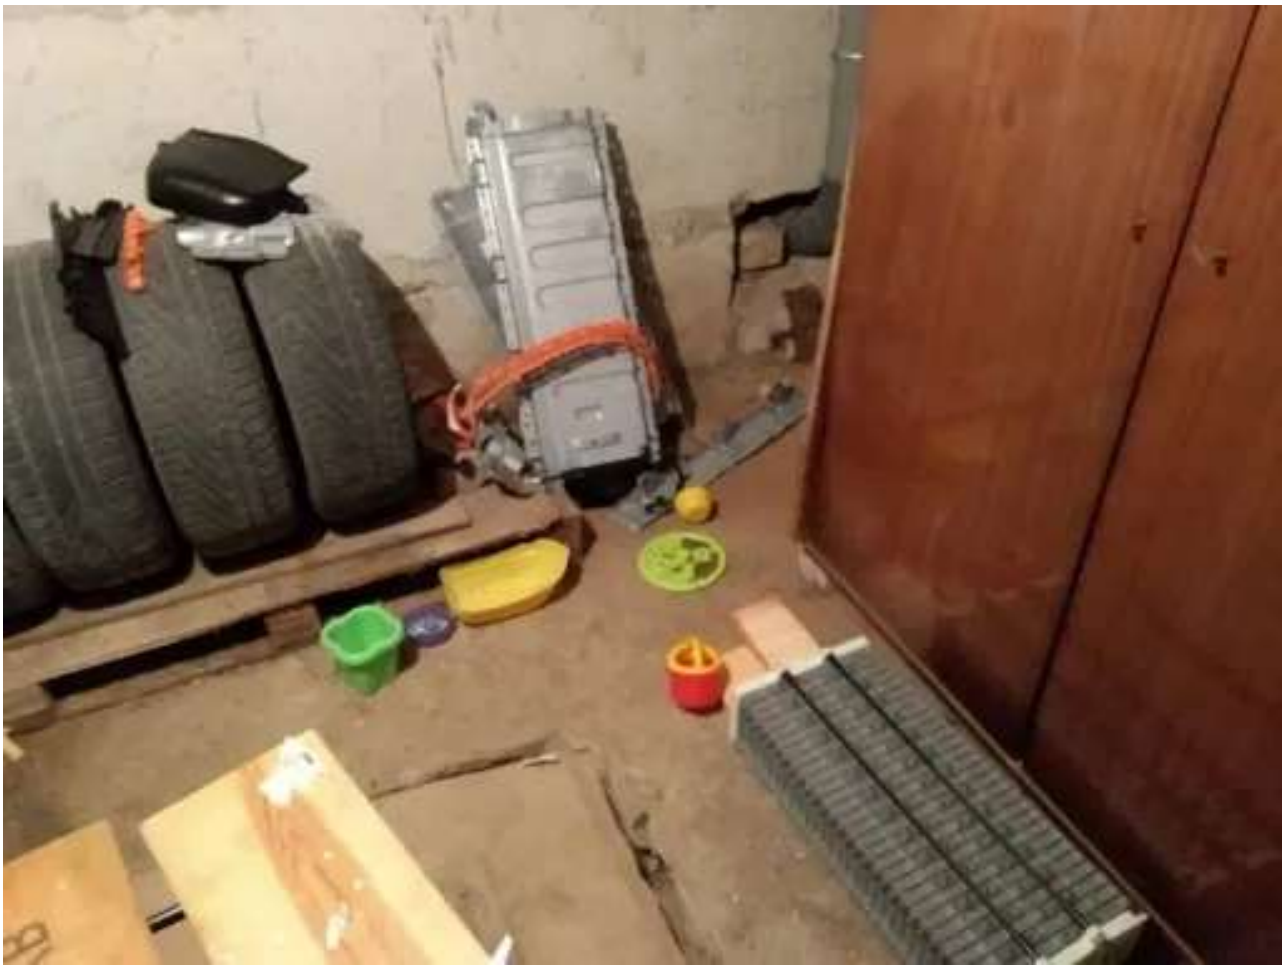
There are still some details left in the basement:

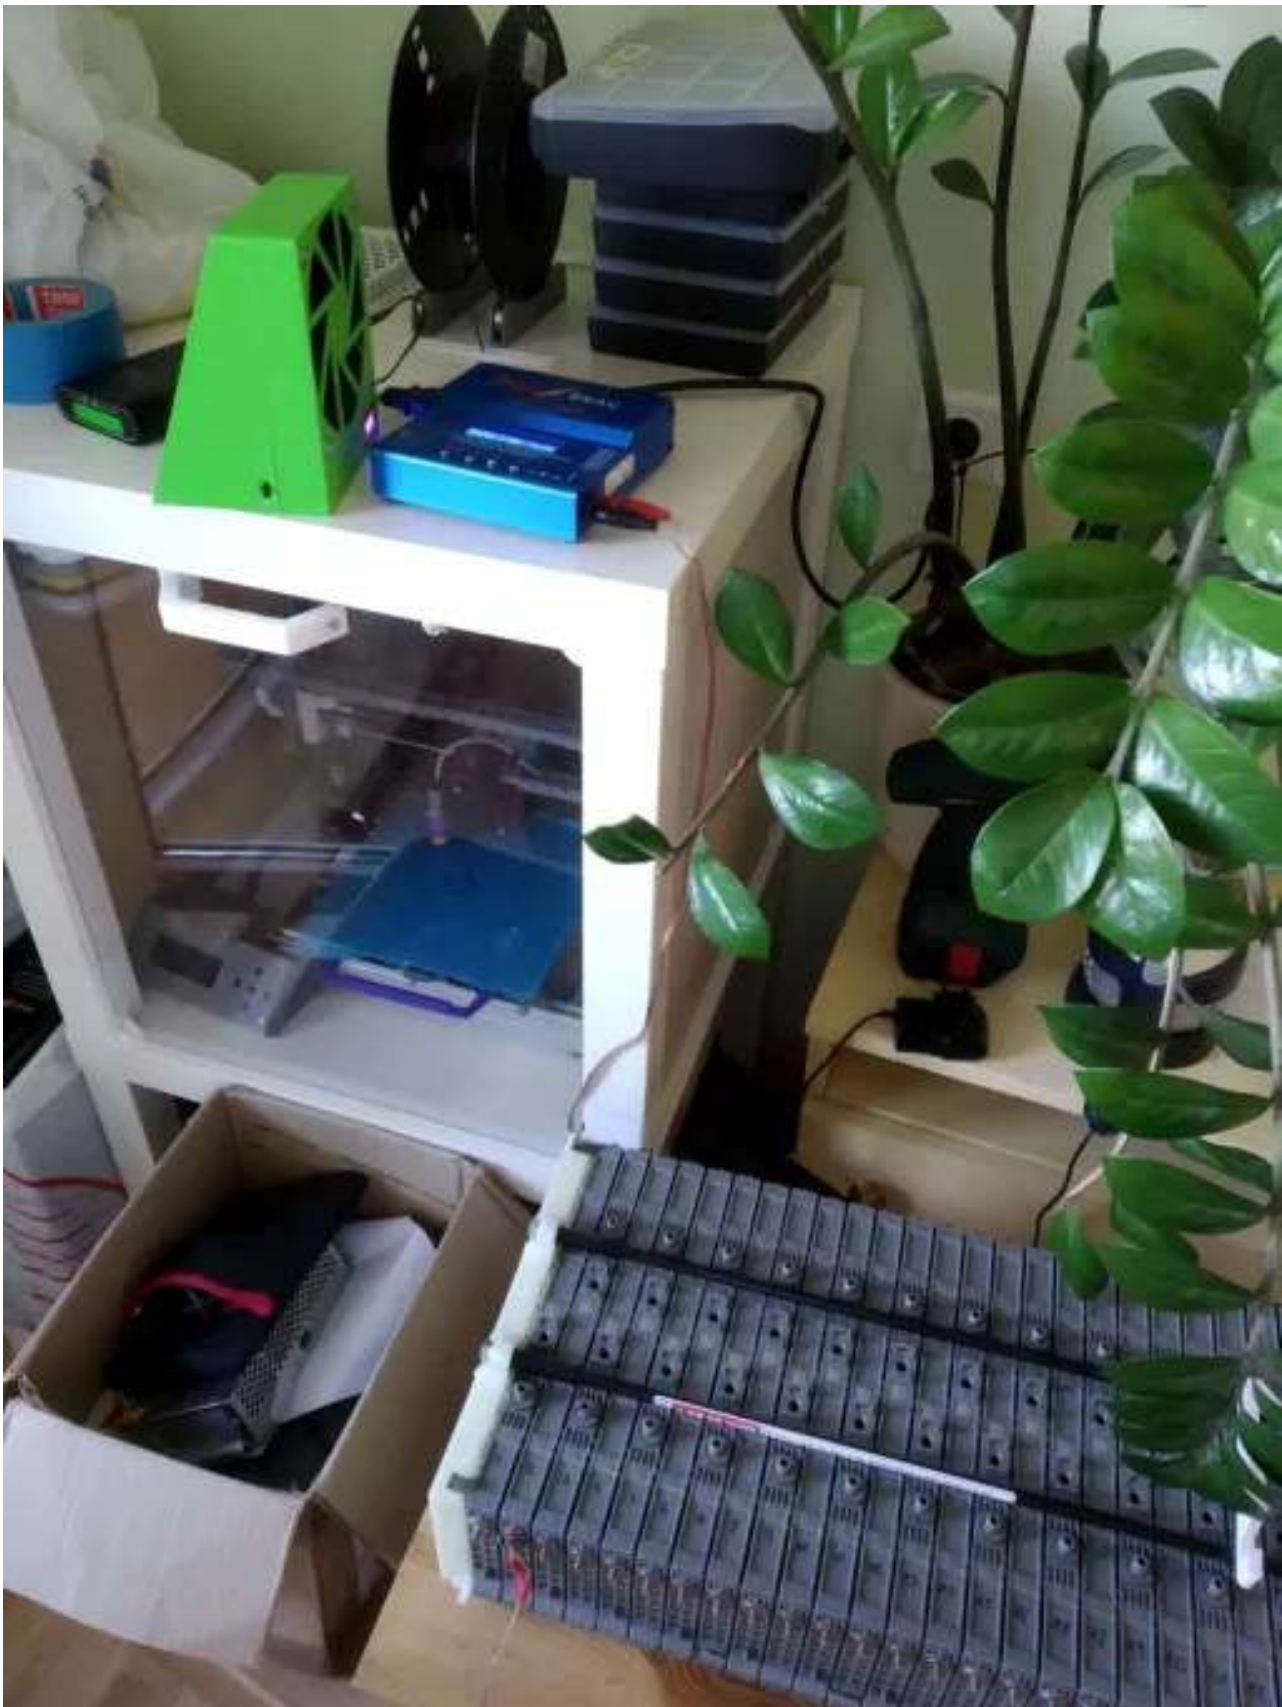
Ką daryti su likusiais moduliais? Juos sudėjau eilės tvarką į naujos baterijos rėmą ir jau pradėjau testuoti modulius su vieninteliu turimu iMax B6 pakrovėju:

Su vienu pakrovėju tai truks apie mėnesį laiko, nes jis iškrauti gali vos 0,7A prie 7V (t.y. ~5W). Gal kam reikia modulio vieno kito? 😊
