Re: Toyota Safety Recall 12V-537 –Dealer Notification Remedy Phase 1, Interim Phase 2

**Subject: Safety Recall - C0T Phase 1 Remedy Notification**  
**C2T Phase 2 Interim Notification**  
2004 to certain 2009 Model Year Prius Vehicles  
Steering Intermediate Extension Shaft

**TECHNICAL INSTRUCTIONS**  
**FOR**  
**SAFETY RECALL C0T**  
**STEERING INTERMEDIATE EXTENSION SHAFT**  
**2004 – CERTAIN 2009 MODEL YEAR PRIUS**

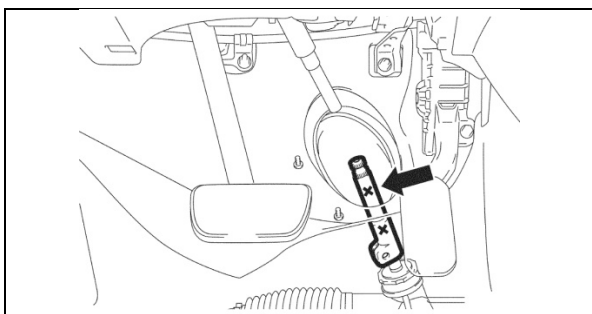
**STOP** The new shaft in the kit (04001-41212) is manufactured with a countersink, mark the NG shaft to confirm it is not reused.

18. REMOVE THE EXTENSION SHAFT

a) Remove the extension shaft.

b) Mark the shaft so it is not reused.

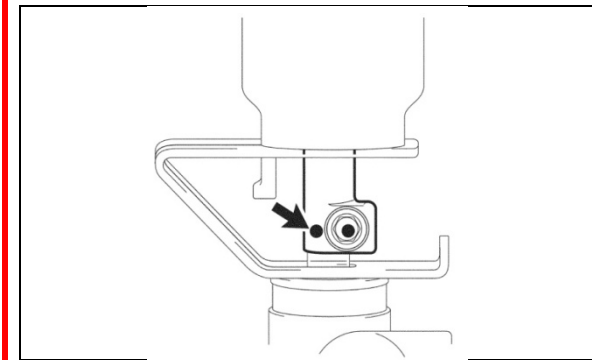
- a) Confirm that a **NEW** shaft and **NEW** bolt has been installed.
- b) Confirm the lower end of the shaft has been fully seated.  
**NOTE: If only the edge of the shaft is engaged, the bolt can be tightened but the shaft may become disconnected.**

**25. INSPECT THE EXTENSION SHAFT**

- c) Mark the shaft to confirm the inspection has been performed.
