Microscopic Analysis Report

Customer Name: ROBERT WILSON
 Reservoir Description: 2ZR-FXE ENG FILTER

Sample Date: 02/21/17
 Lab Number: 655005

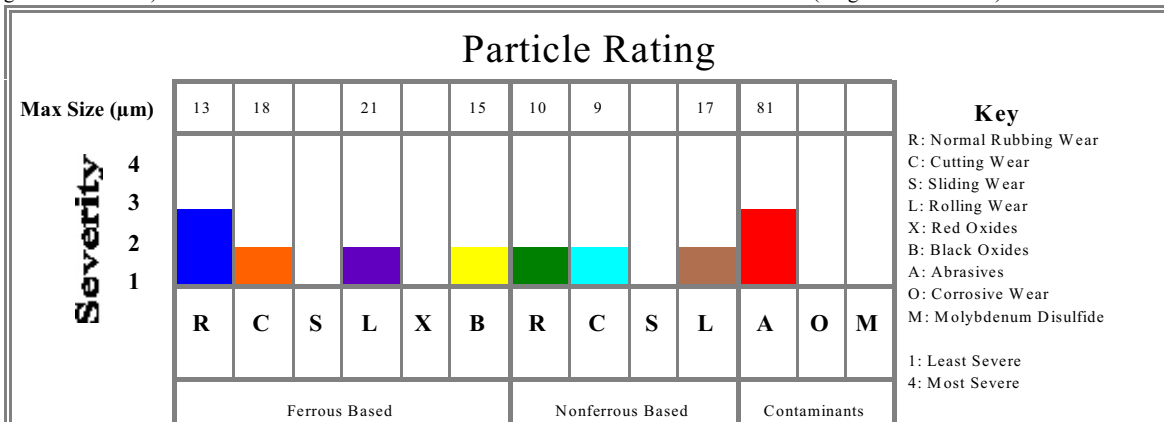
Figure 1: Nonferrous White Metal Cutting Wear Particles, Nonferrous White Metal Rubbing Wear Particles, and Abrasive/Dust/Dirt Particles at the End of the Slide (Magnification 500X).
