**PDXinspections LLC**

Portland's Used Vehicle Inspection Service

Customer	Inspection Date	Location Of Inspection	Inspection Cost
	7/16/2018		
Vehicle	Vehicle Identification Number	Manufacture Date	Exterior/Interior Color
2006 Toyota Prius Base		March 2006	Champagne/Tan
Engine type	Transmission	Drivetrain	Odometer
1.5L Inline 4 Cylinder DOHC Hybrid	CVT - Constantly Variable Transmission	Front Wheel Drive	81,794
Engine Cold Start?	Engine Temp. on Arrival	Weather/Inspection Conditions	Outside Air Temp.
No, the engine was hot on arrival	185°	Sunny	89°
License Plates/Registration			
Oregon License Plates - Current tags/registration until April 2020.

2006 Toyota Prius Inspection Prepared for

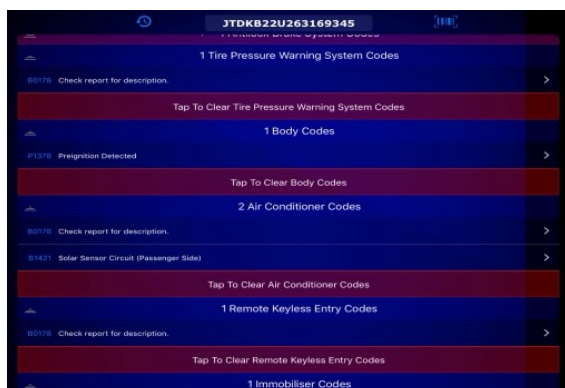
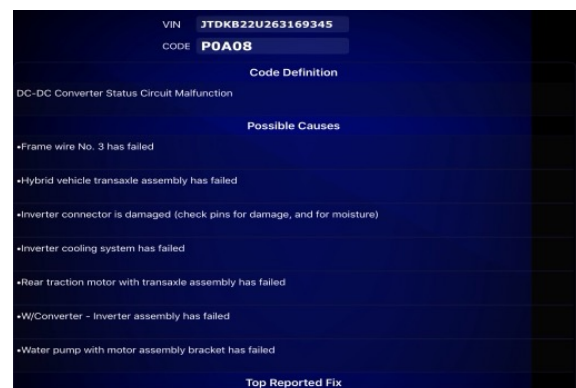
Miscellaneous history trouble codes noted. These are items that have possibly had issues in the past. They may have been addressed and/or be intermittent issues.

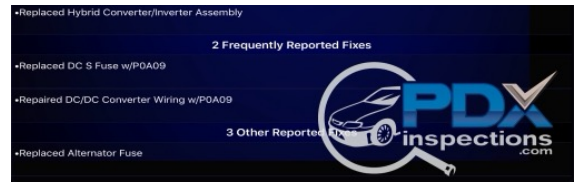
Miscellaneous history trouble codes noted. These are items that have possibly had issues in the past. They may have been addressed and/or be intermittent issues.
