## Gen3 Instrument Cluster Panel (ICP) Degradation – Blurry/Hazy/Greasy/Moldy/Damp Energy Monitor

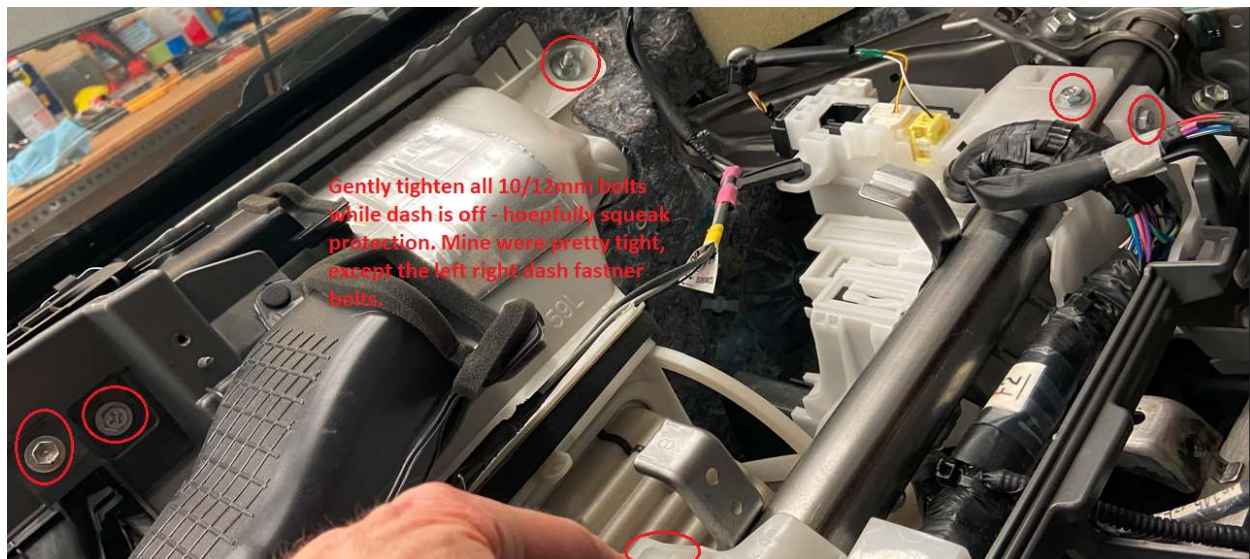
Gently tighten all 10/12mm bolts while dash is off - hopefully squeak protection. Mine were pretty tight, except the left right dash fastener bolts.
