TMS-NTC-13178
July 23, 2013

Re: Toyota Safety Recall 13V-235 Dealer Notification - Remedy

Subject: Safety Recall D0H – **Remedy Available**
Certain 2010 Model Year Prius
Brake Booster Pump Assembly (Accumulator)

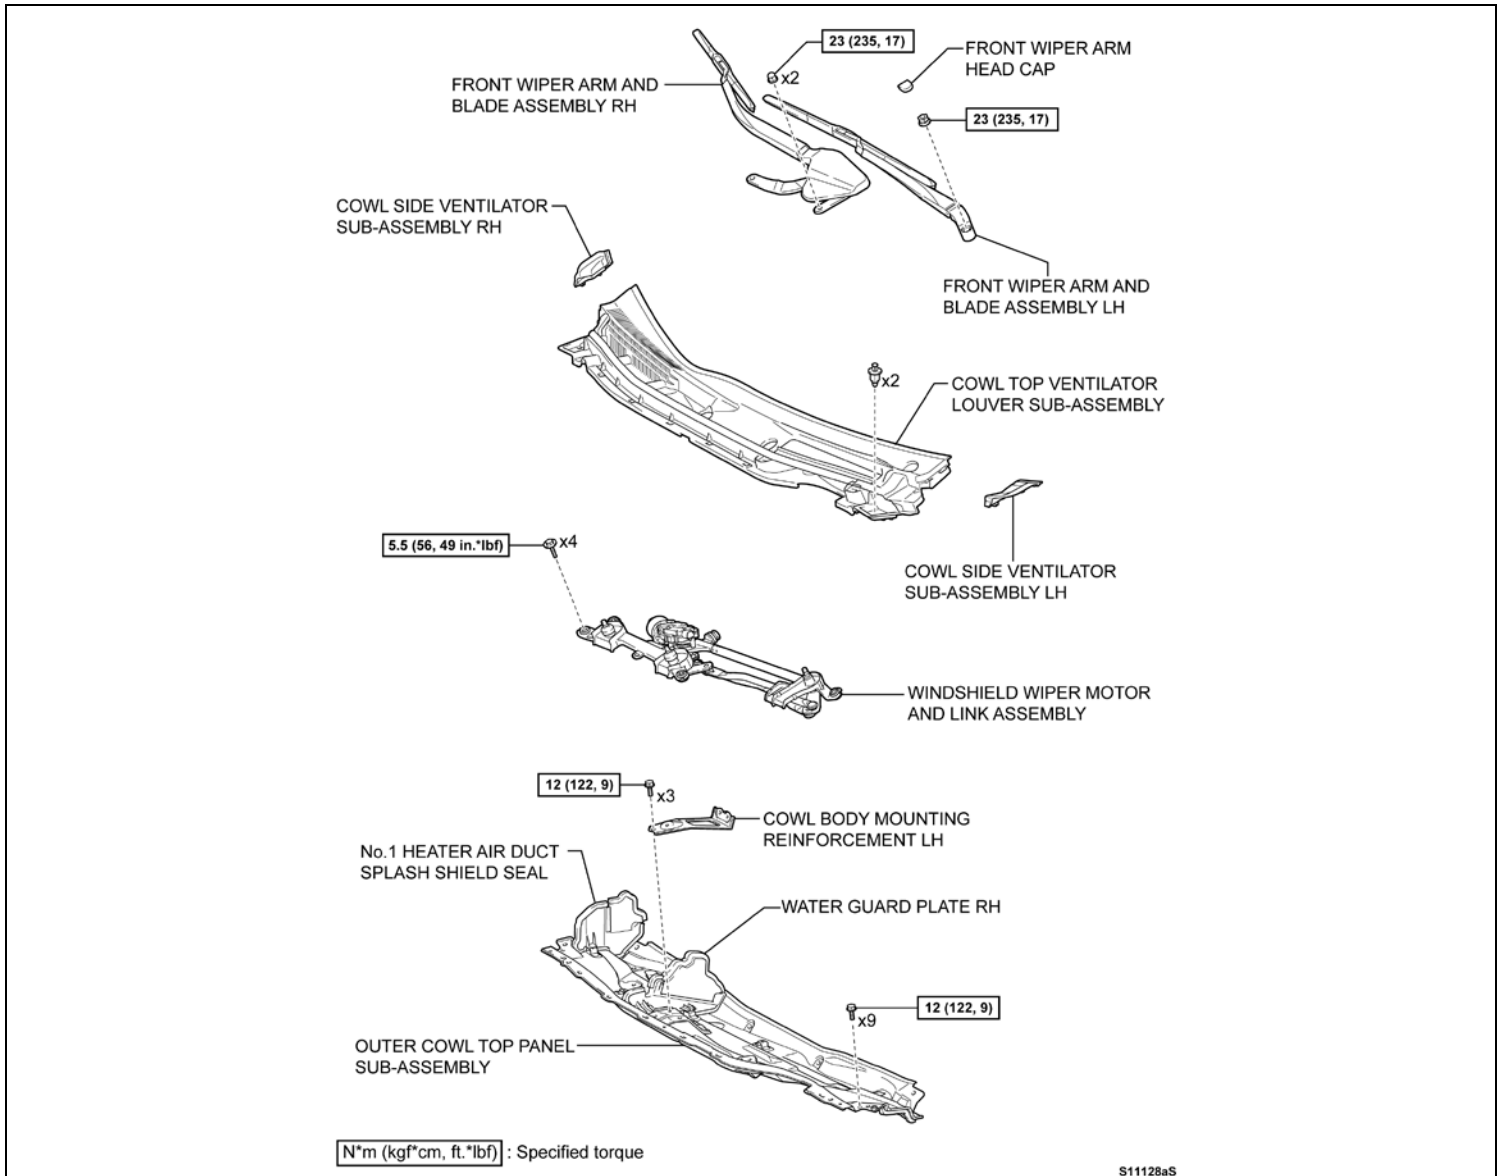
Always pull the louver down to disengage it from the windshield prior removing it. If the louver is pulled upward before disengaging it from the windshield the windshield may crack

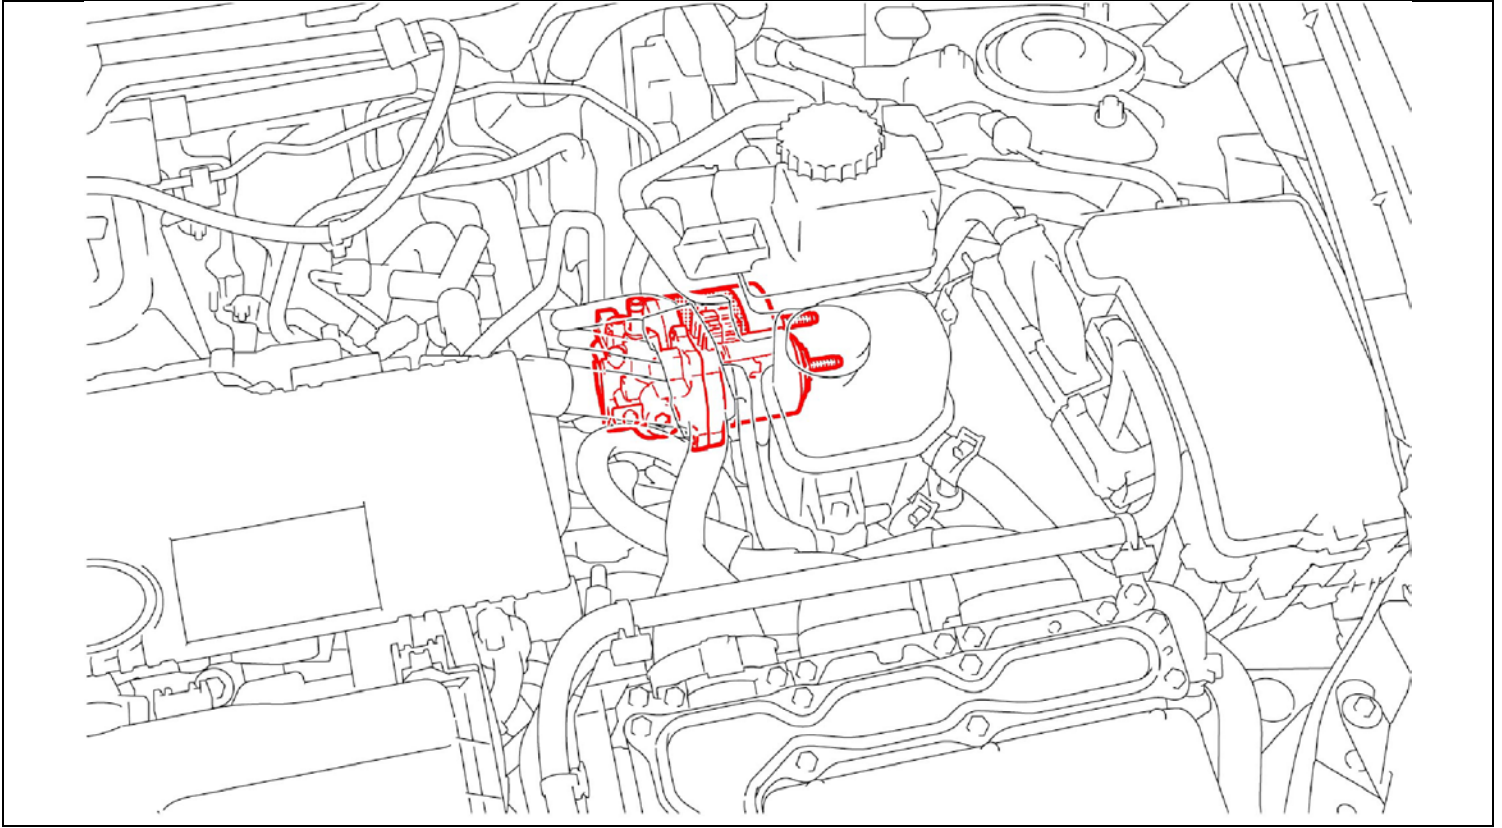
CONDITION 1

Label is **HORIZONTAL** on accumulator
Accumulator replacement **REQUIRED**

The accumulator is affected and replacement is required. Proceed to **STEP 3**. To determine if additional parts require replacement.

CONDITION 2

Label is **VERTICAL** on accumulator
NO NEED to replace accumulator

The accumulator **IS NOT** affected and **DOES NOT** need to be replaced. Reassemble the vehicle. Campaign complete.
