Techstream ECU Flash Reprogramming Procedure

Service Category Engine/Hybrid System

Section Engine Control

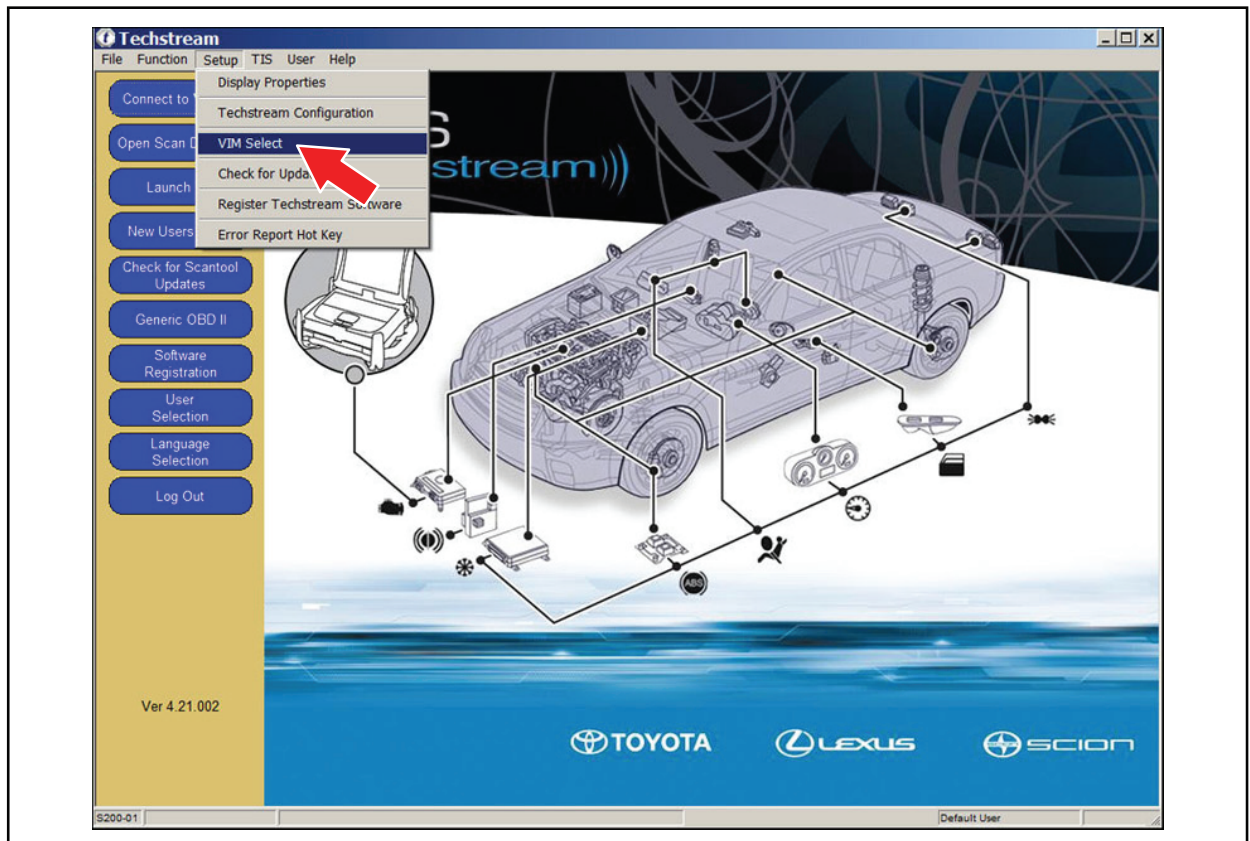
Figure 1.

1. Select *Setup* from the Techstream Main Menu screen.
2. Select *VIM Select* from the Setup drop down menu.

3. Select the correct Interface Setup from the drop down list.
 - If using Techstream 2.0, select *MongoosePro MFC*.
 - If using Techstream Lite, select *Mongoose MFC* or *MongoosePro MFC* (depending on the cable being used).

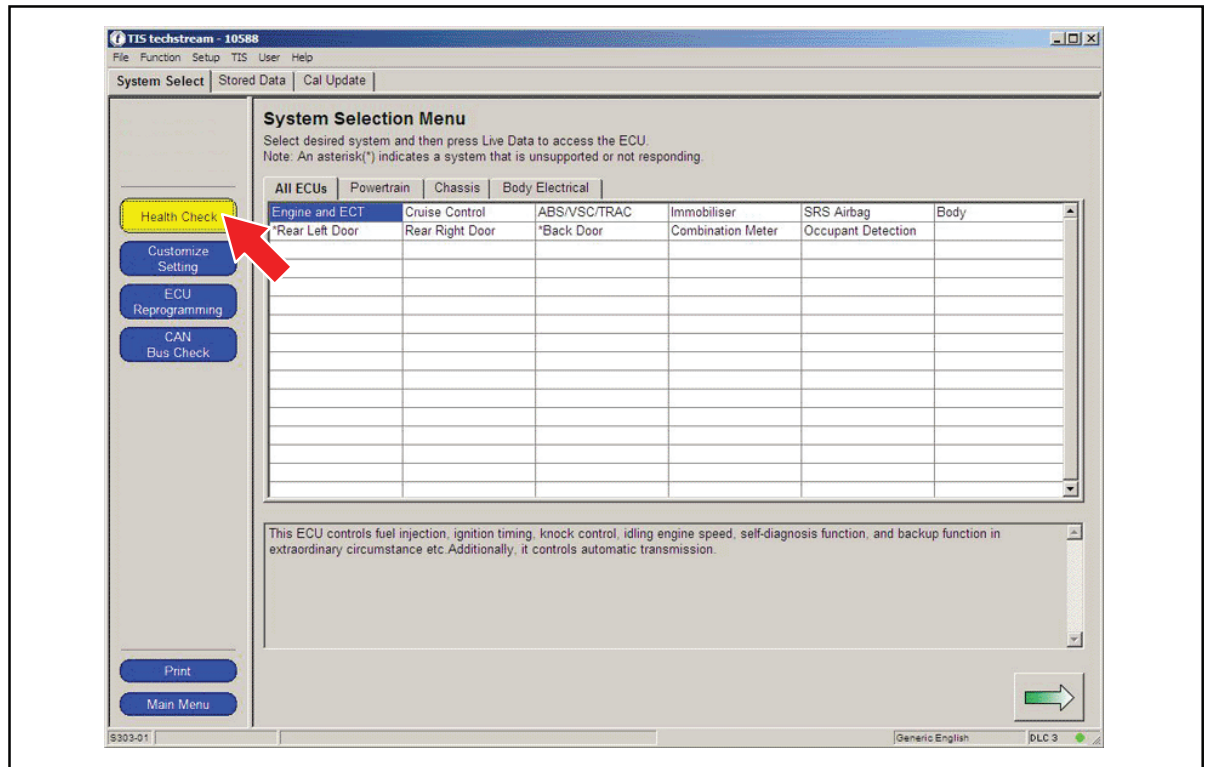
Figure 2.

1. Verify the vehicle's applicability for recalibration and locate desired calibration file.
 - A. Connect Techstream and establish a vehicle connection.
 - B. Click the *Health Check* button on the *System Select* tab.

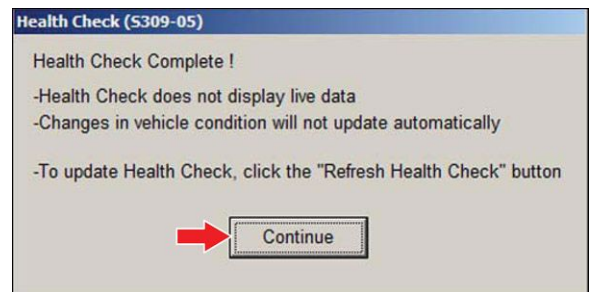
Figure 4.

E. Click *Continue* to view Health Check results.

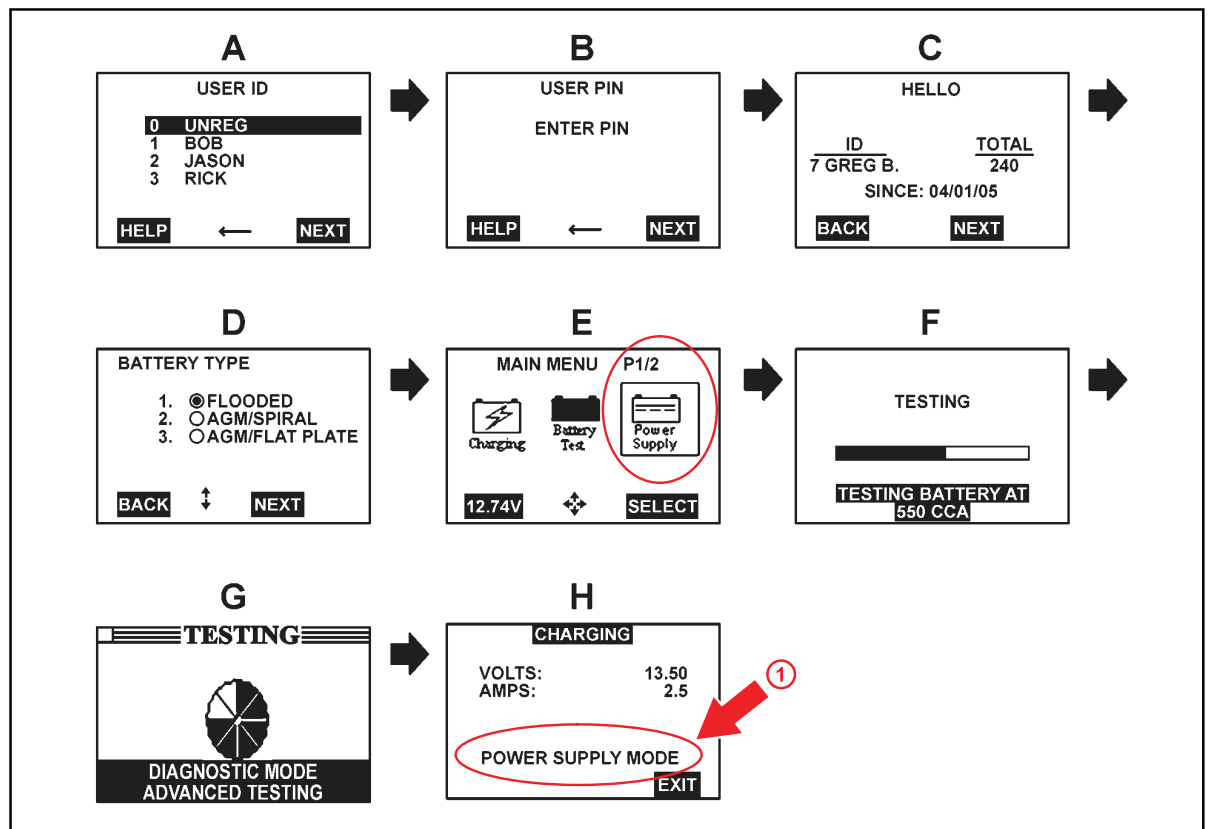
Figure 7.

2. Connect the GR8 Battery Diagnostic Station.
 - A. Connect the GR8 Battery Diagnostic Station to the vehicle and turn it ON.
 - B. Select Power Supply Mode by following the screen flow below.

1 Confirm Power Supply Mode Is Selected

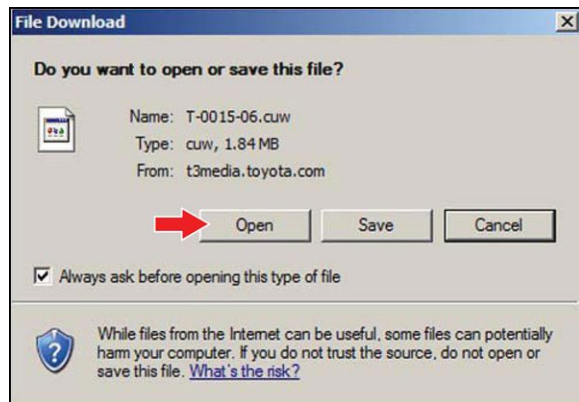
Figure 9.

- B. Click *Open* to load calibration file information.

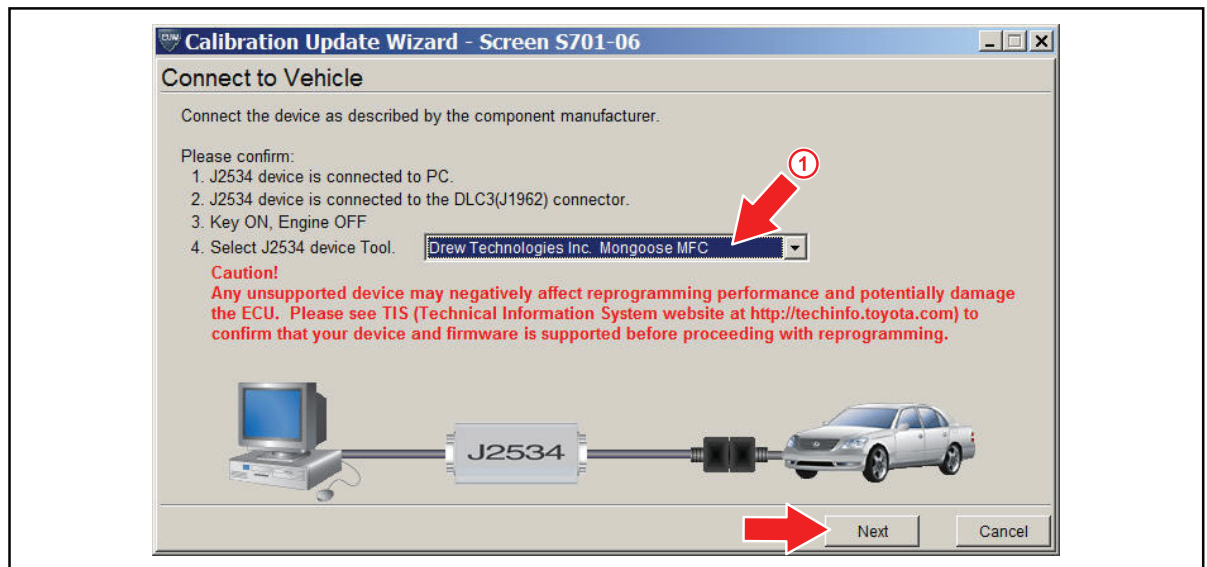
Figure 12. Using Techstream 2.0 or Techstream Lite

1 Select Correct Device Tool (“Mongoose MFC” or “MongoosePro MFC”)

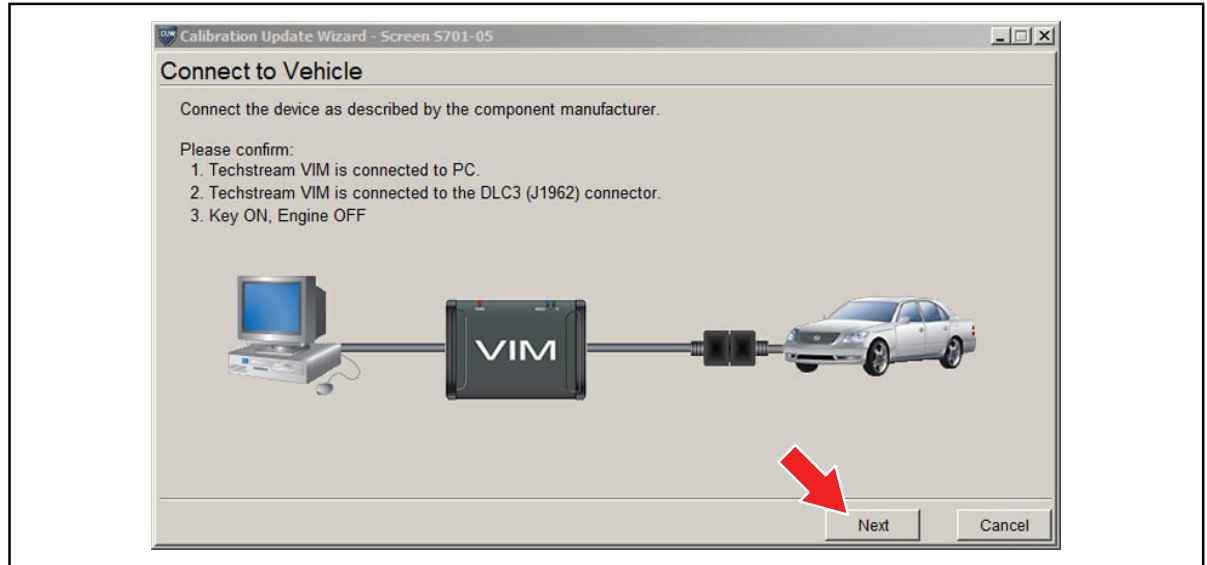
Figure 13. Using TIS Techstream

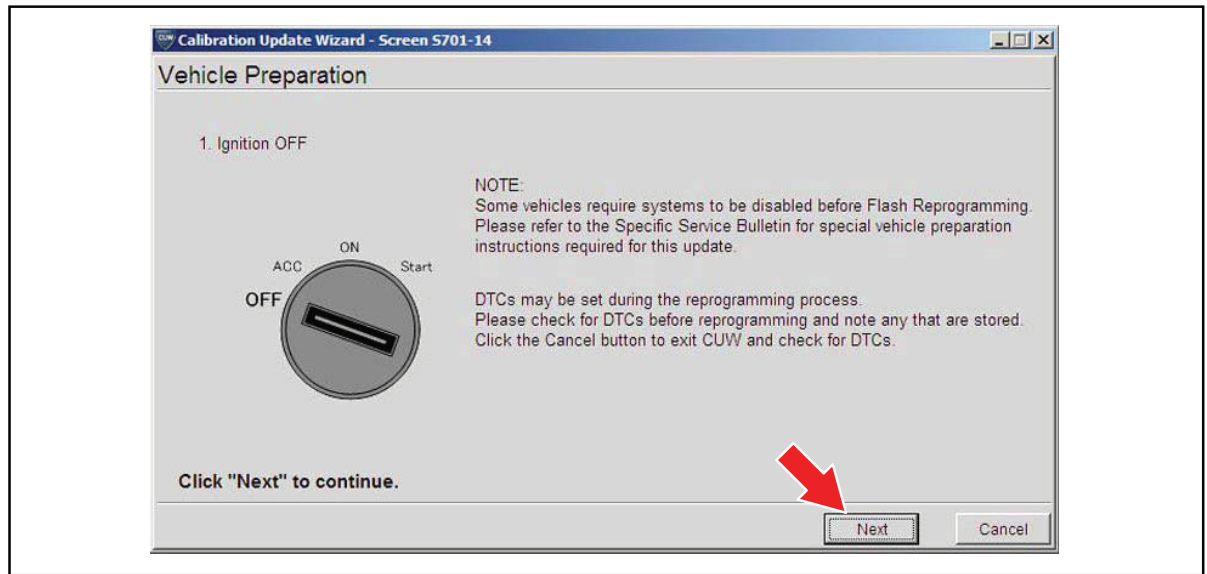
Figure 15.

G. Turn ignition OFF. Then click *Next*.

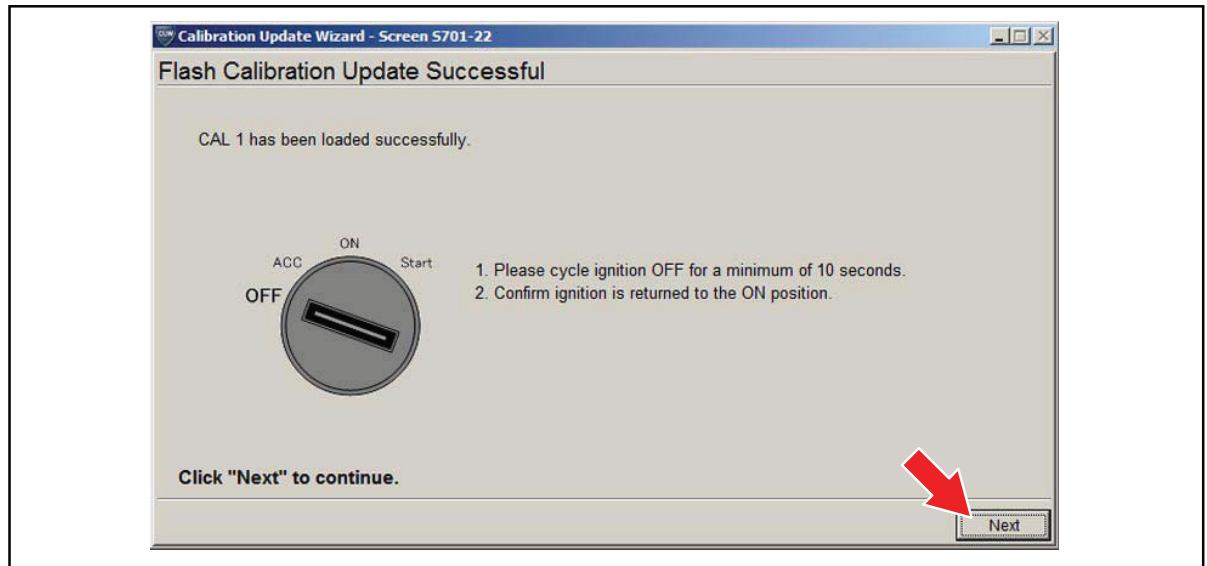
Figure 18.

- J. When Cal 1 has completed the update process, turn ignition OFF for a minimum of 10 seconds. Then click *Next*.

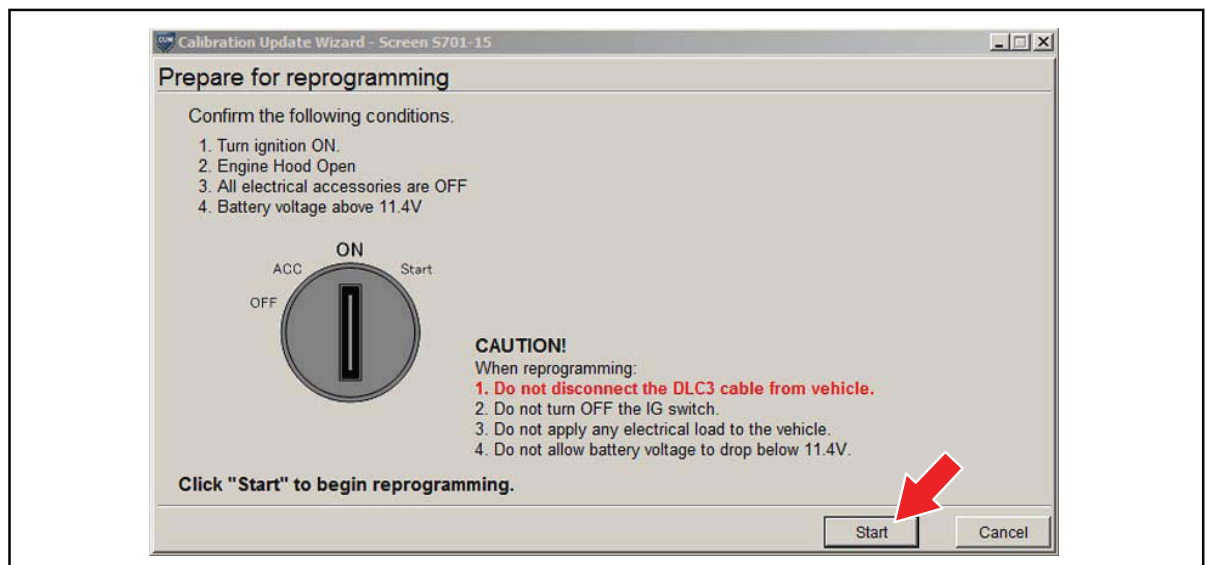
Figure 19.

- K. Turn ignition to the ON position. Then click *Start*.

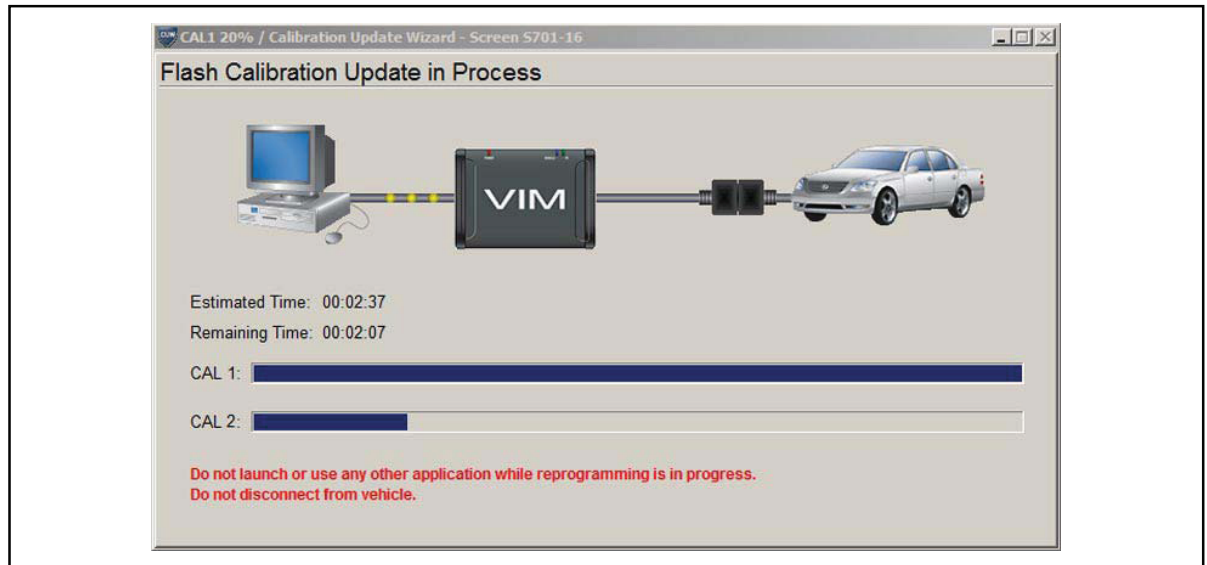
Figure 20.

- L. Do NOT disturb the vehicle during flash reprogramming.

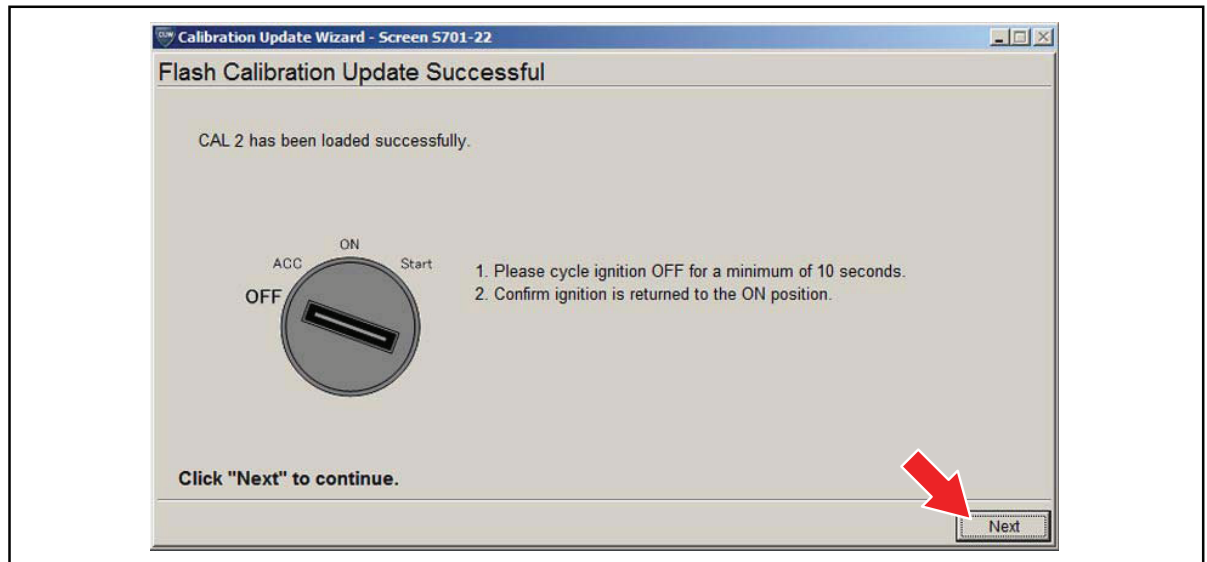
Figure 21.

- M. Turn ignition OFF for a minimum of 10 seconds. Then click *Next*.
