DTC	C1552	PIG Power Supply Voltage Malfunction
DTC	C1554	Power Supply Relay Failure
DTC	C1555	Motor Relay Welding Failure

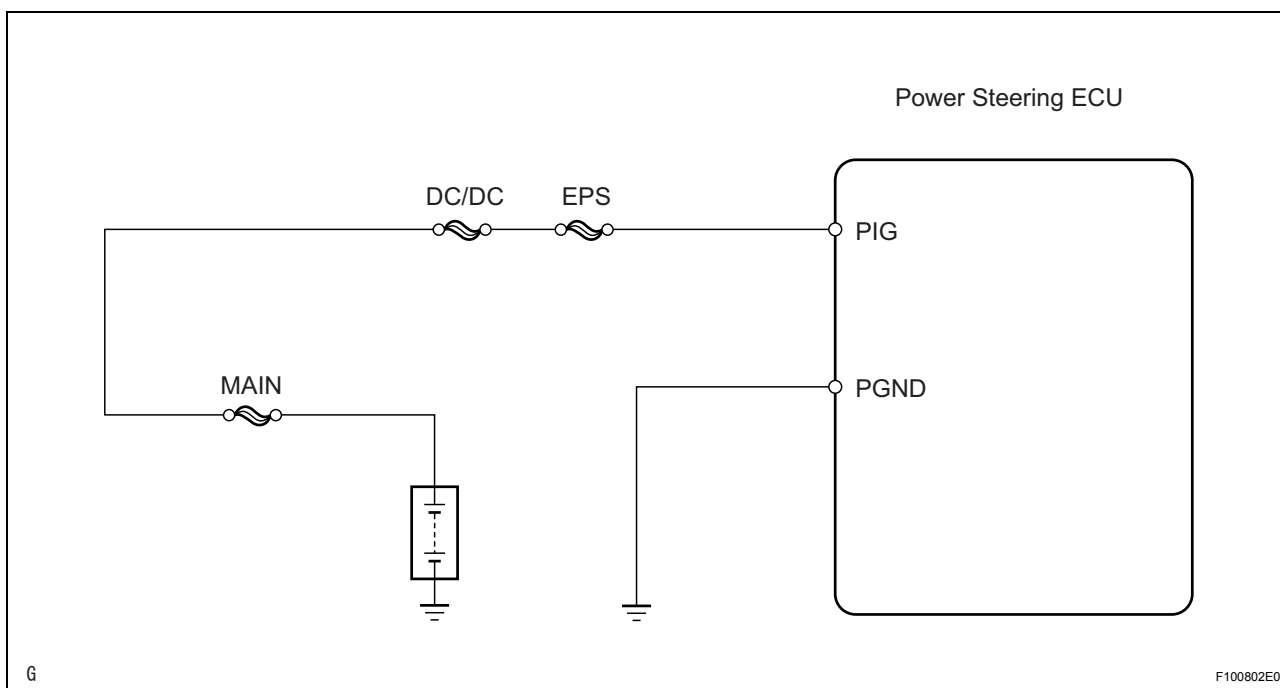
WIRING DIAGRAM

When a problem occurs in the system, the power source relay (built into the power steering ECU) circuit and the motor relay (built into the power steering ECU) circuit are shut off to stop power assist. It is necessary to replace the ECU when there is a problem in the relay because each relay is built into the ECU.

DTC No.	DTC Detection Condition	Trouble Area
C1552	PIG power source voltage error	<ul style="list-style-type: none"> • EPS H-fuse • PIG power source circuit • Power steering ECU
C1554	Power source relay malfunction	<ul style="list-style-type: none"> • EPS H-fuse • PIG power source circuit • Power steering ECU
C1555	Motor relay malfunction	<ul style="list-style-type: none"> • EPS Fuse • PIG power source circuit • Power steering ECU

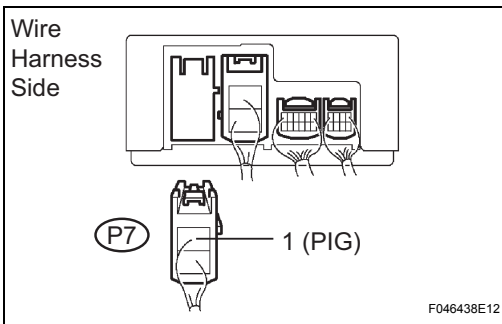
2 CHECK WIRE HARNESS (POWER STEERING ECU - BODY GROUND)

(a) Disconnect the P7 power steering ECU connector.
 (b) Measure the voltage of the wire harness side connector.
Standard voltage

Tester Connection	Specified Condition
P7-1 (PIG) - Body ground	10 to 16 V

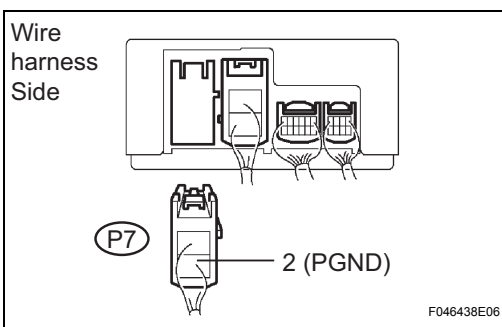
3 CHECK WIRE HARNESS (POWER STEERING ECU - BODY GROUND)

(a) Disconnect the P7 power steering ECU connector.
 (b) Measure the resistance of the wire harness side connector.

Standard resistance

Tester Connection	Specified Condition
P7-2 (PGND) - Body ground	Below 1 Ω
