DTC	P0A80-123	Replace Hybrid Battery Pack
-----	-----------	-----------------------------

DESCRIPTION

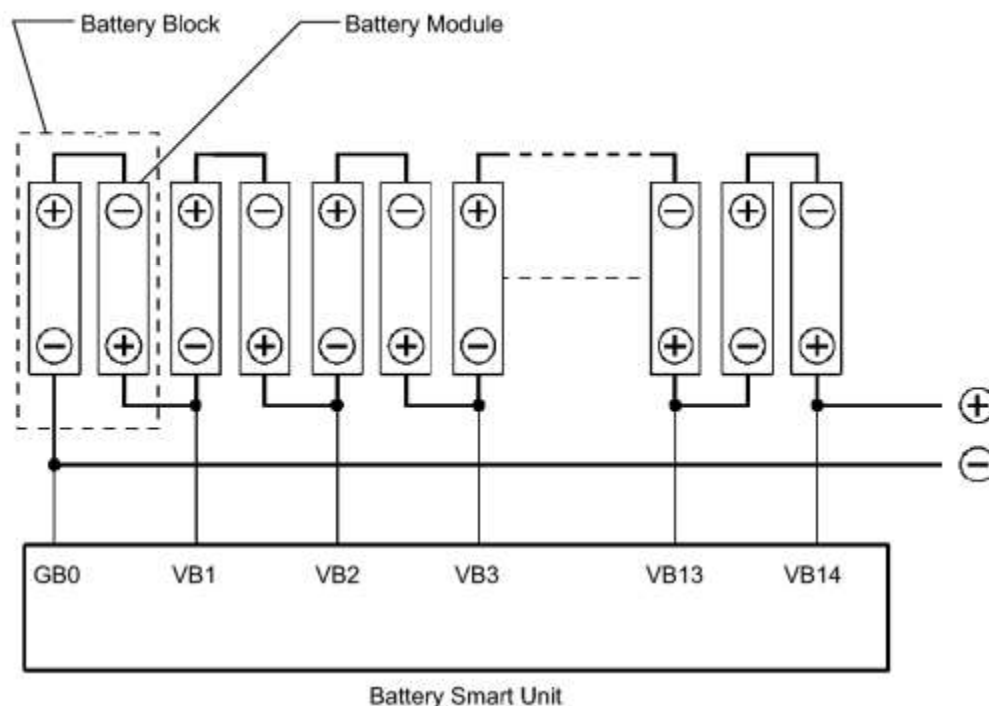
- The HV battery uses nickel metal-hydride batteries and does not require external charging. The power management control ECU controls the SOC (state of charge) of the HV battery at a constant level during driving. The HV battery is composed of 28 modules, and each module consists of eight 1.2 V cells in series. The battery smart unit monitors battery block voltage at 14 locations. Each battery block is composed of 2 modules in a set.

The battery smart unit, which monitors the voltage of the battery blocks, determines that malfunction has occurred if a voltage difference between the battery blocks exceeds the standard. When the malfunction detection condition is satisfied, the power management control ECU (HV CPU) will illuminate the MIL and set a DTC.
