# GTS+ Techstream ECU Flash Reprogramming Procedure

**Service Category** Engine/Hybrid System

**Section** Emission Control

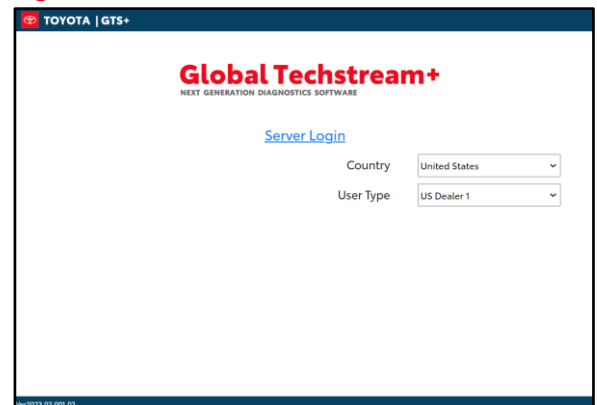
**Figure 1.**

3. Click Server Login.

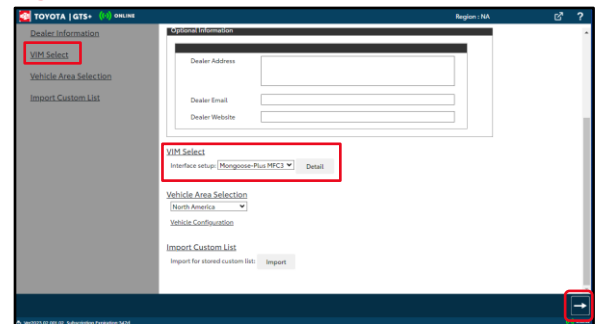
**Figure 2.**

GTS+ software requires a VIM selection before it can be used for reprogramming.

1. Select GTS+ Settings from the Main Menu screen.
2. Select VIM Select from the GTS+ Settings menu.
3. Select the correct interface setup from the dropdown list.
  - Mongoose-Plus MFC3 VIM:
    - Techstream Lite w/Blue & Black Case w/Detachable Cable
    - Techstream ADVi w/Grey Case
  - MongoosePro MFC2 VIM:
    - Techstream Lite w/Green Case
    - Techstream ADVi w/Black Case
  - MongoosePro MFC VIM:
    - Techstream Lite w/Blue Case
    - Techstream Lite w/Updated Clear Case
    - Techstream 2.0

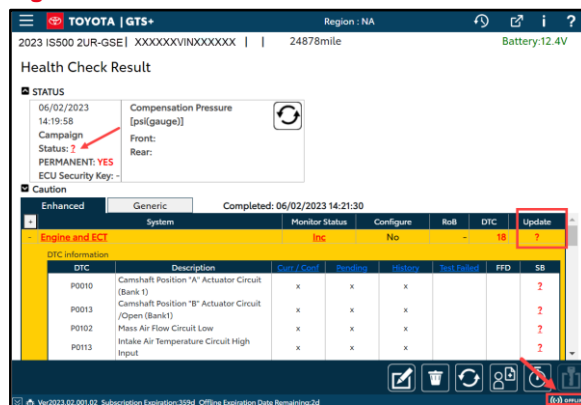
**Figure 3.**

- GTS+ will automatically search TIS for the appropriate Service Bulletin using the current calibration ID from the vehicle if the PC is connected to the network (see figures below).
- Calibration file links can be found embedded in the corresponding Service Bulletin.

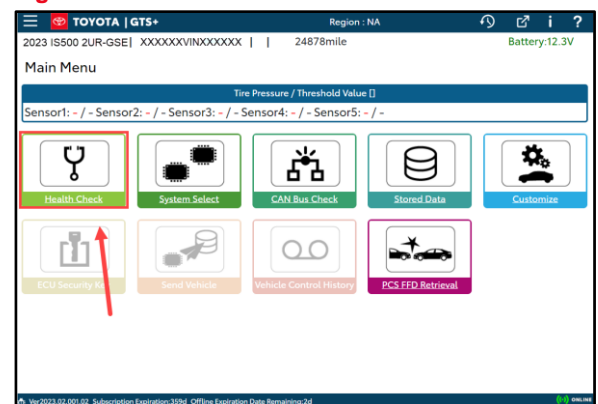
**Figure 5.**

1. Verify the vehicle's applicability for recalibration and locate the desired calibration file.
  - A. Connect GTS+ and establish a vehicle connection.
  - B. Click the Health Check button on the Main Menu.

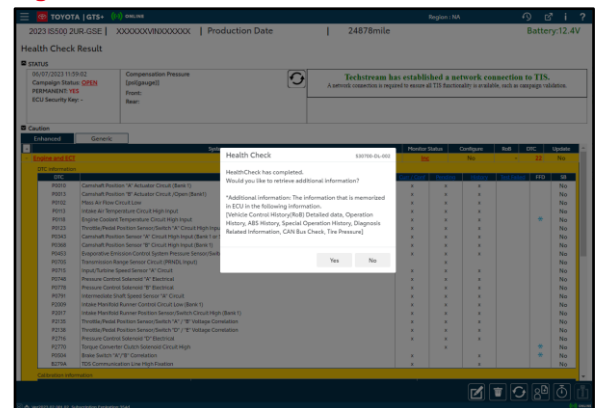
**Figure 6.**

- C. A Health Check completed window opens. To continue, click either Yes or No.
  - (1) Click Yes to include additional information in the Health Check.
  - (2) Click No if additional information is NOT desired.

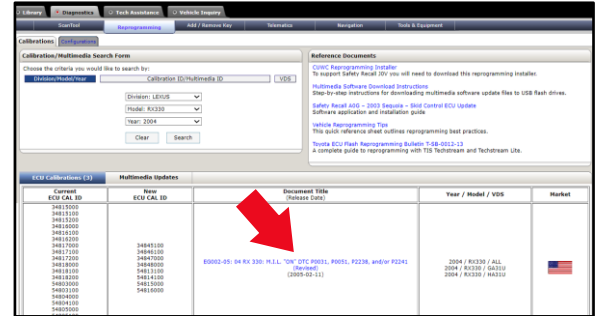
**Figure 8.**

- F. To review the Service Bulletin and access the calibration file, click the Service Bulletin link in the Document Title column of the Calibration Search Result portlet.

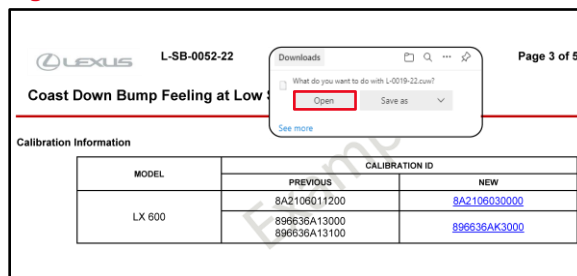
**Figure 10.**

- B. Click Open to load the calibration file information. If prompted to choose GTS or GTS+, select GTS+.

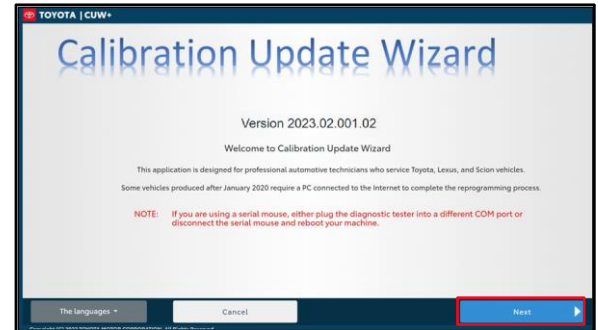
**Figure 12.**

- C. Click Next to start the calibration update process.

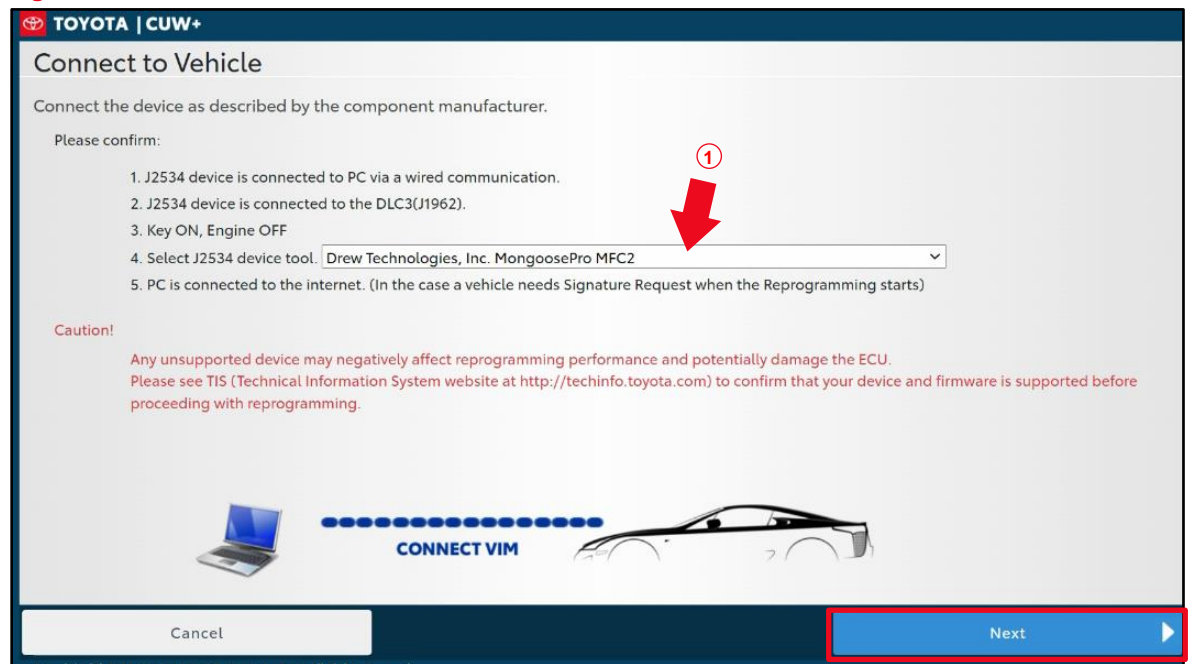
**Figure 13.**

- D. Confirm the following:

- The PC is connected to VIM.
- The VIM is connected to DLC3 connector.
- The Ignition is ON and the engine is OFF or READY-OFF (hybrid vehicles).

Then, click Next.

<b>1</b>	<b>Select the Correct Device Tool (“MongoosePro MFC,” “MongoosePro MFC2,” or “Mongoose-Plus MFC3” VIM)</b>
----------	--

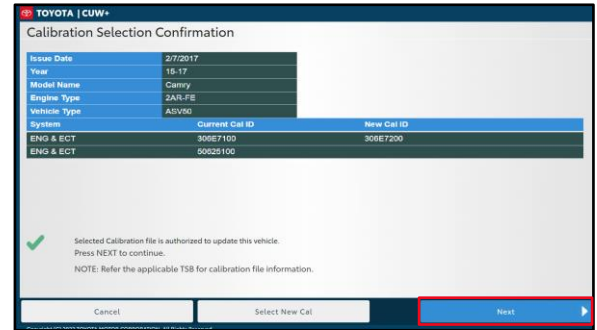
**Figure 14.**

- E. Verify the correct current and NEW calibration information, then click Next.

- The total number of calibration IDs in the calibration file corresponds to the number of reprogrammable processors in the ECU.
- The figure to the right shows an example of the update procedure for a two-processor ECU.

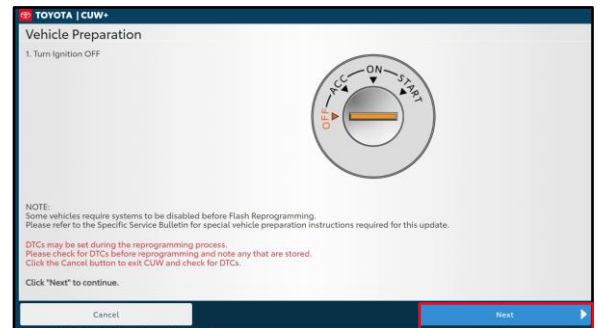
**Figure 15.**

- F. Turn the ignition OFF, click Next, and wait at least 10 seconds before proceeding.

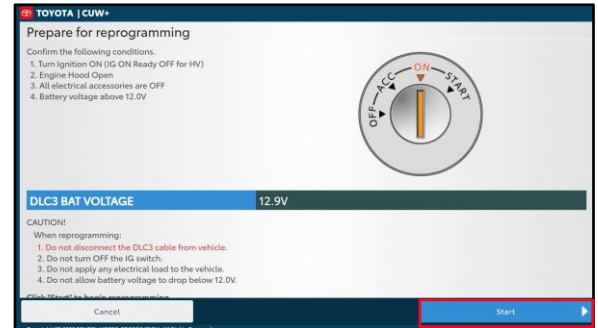
**Figure 16.**

- G. Turn the Ignition ON (IG ON Ready-OFF for hybrid vehicles).
- H. Confirm the following:
  - The PC is connected to VIM.
  - The hood is open.
  - ALL accessories are OFF.
  - Battery voltage is above 12V.

Then, click Start.

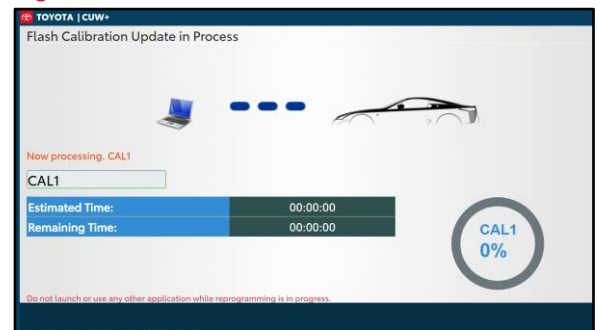
**Figure 17.**

- I. Do NOT disturb the vehicle during flash reprogramming.

- ECU flash reprogramming may take 3 – 30 minutes per calibration file.
- Reprogramming time will vary depending on model and ECU communication protocol. Vehicles using CAN communication protocol will reprogram much faster (2 – 7 minutes).

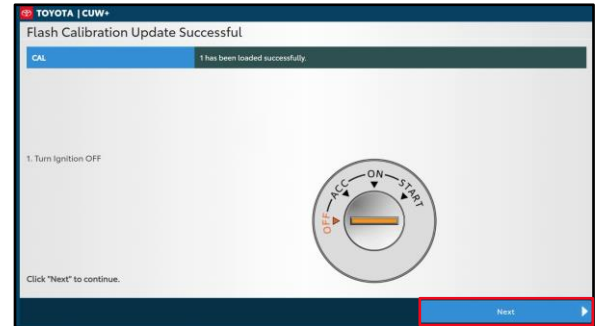
**Figure 18.**

- K. When Cal 1 completes the update process, turn the ignition OFF, click Next, and wait a MINIMUM of 10 seconds before proceeding.

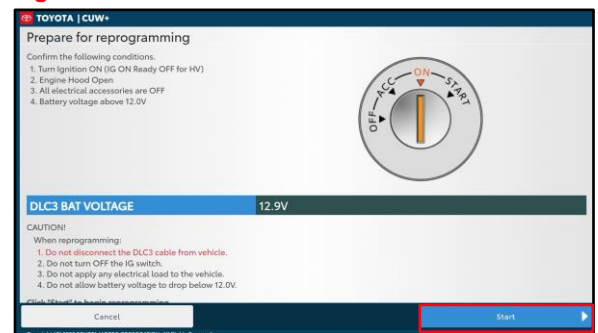
**Figure 19.**

- L. Turn the ignition to the ON position, then click Start.

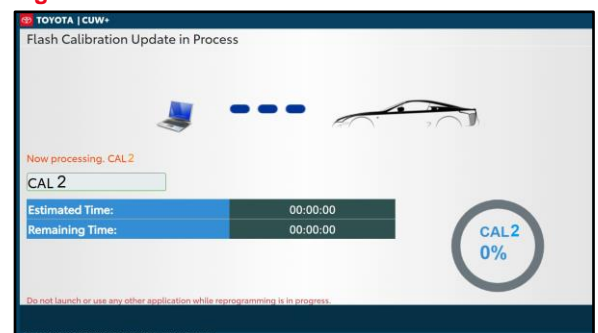
**Figure 20.**

- M. Do NOT disturb the vehicle during flash reprogramming.

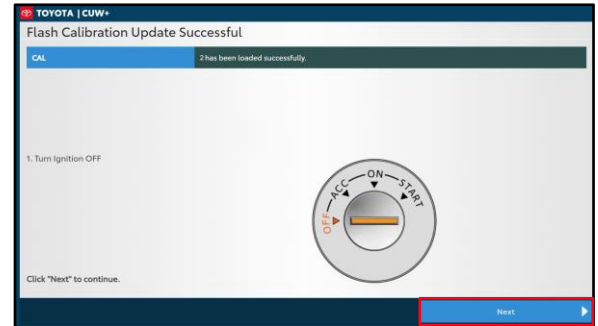
**Figure 21.**

- N. Turn the ignition OFF, click Next, and wait a MINIMUM of 10 seconds before proceeding.

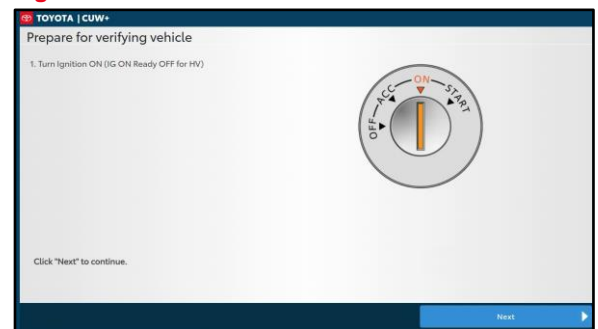
**Figure 22.**

- O. Turn the ignition to the ON position, then click Next.

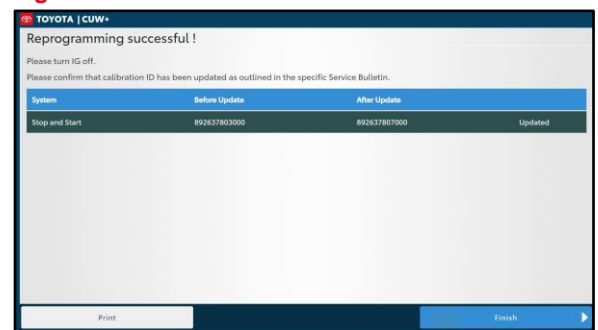
**Figure 23.**

- P. Confirm calibrations were updated and click Finish.
