# Audio Head Unit Software Update (Denso Ten)

## Applicability

YEAR(S)	MODEL(S)	ADDITIONAL INFORMATION
2023	GR Corolla, Prius, Prius Prime, RAV4, RAV4 HV, RAV4 Prime, Venza HV

## Introduction

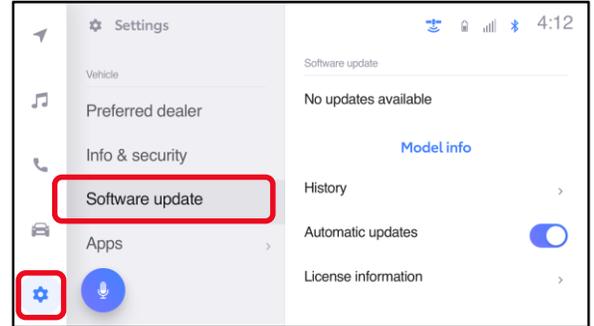
**Figure 1.**

**NOTE**  
 If it is NOT possible to perform this step due to rebooting, go to the [Continuous Head Unit Reboot Condition](#) section.

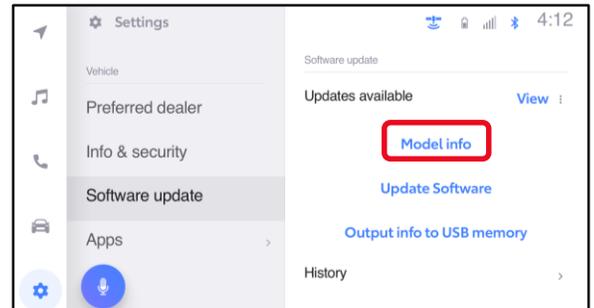
**Figure 2.**

2. Select Model Info to view the head unit version number.  
 Is the head unit software up to date?  
 (Refer to Table 1 below.)
  - **YES** — This bulletin does NOT apply, continue diagnosis using the applicable Repair Manual.
  - **NO** — Continue to step 3.

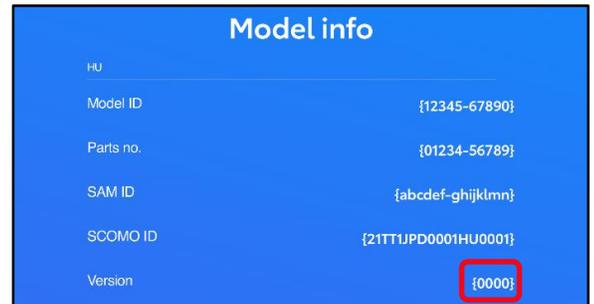
**Figure 3.**

3. Verify that the software is up to date on the Software Update screen.  
 Is the head unit software version in the vehicle one of the previous versions listed in Table 1?
  - **YES** — Continue to the [Continuous Head Unit Reboot Condition](#) section.
  - **NO** — This bulletin does NOT apply, continue diagnosis using the applicable Repair Manual.

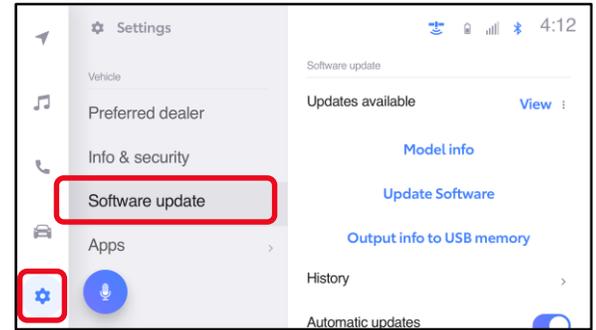
**Figure 4.**

1. Download the software from the Software Update Information section onto an empty USB flash drive.
2. Select the gear icon and scroll down to Software update.

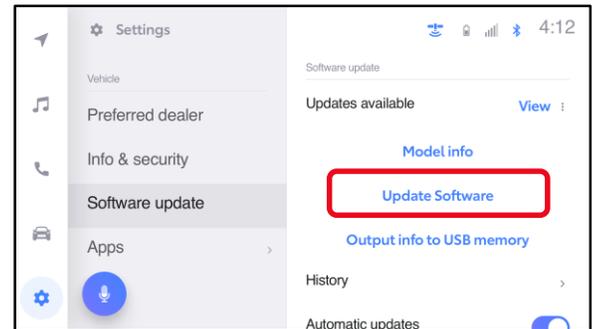
**Figure 6.**

4. Select Update Software.

- The Update Software button may not be available immediately after inserting the USB flash drive. The head unit is unzipping the software update file, and it may take up to 10 minutes for this button to become available to press.
- If the button does NOT appear within 20 minutes, refer to the Multimedia Software Update File Download notice on [page 4](#).

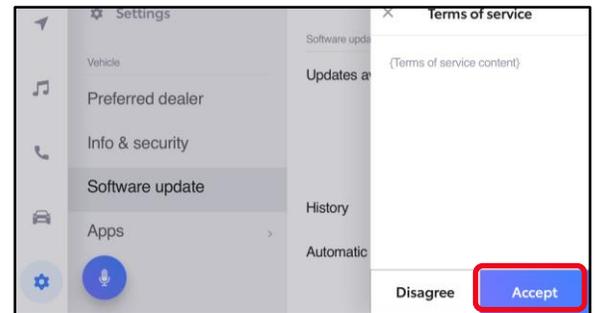
**Figure 7.**

5. Select Accept on the Terms of service screen.

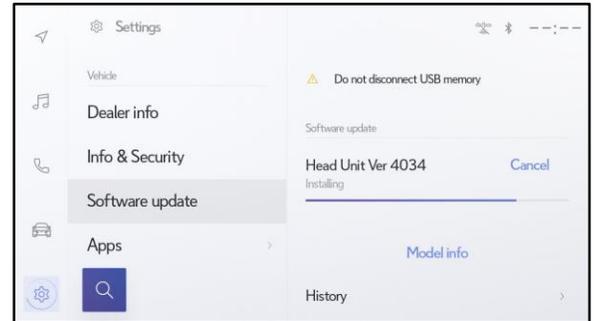
**Figure 8.**

6. Wait for the update to download. Once the head unit begins installation, the update will take about 15 minutes per update file.

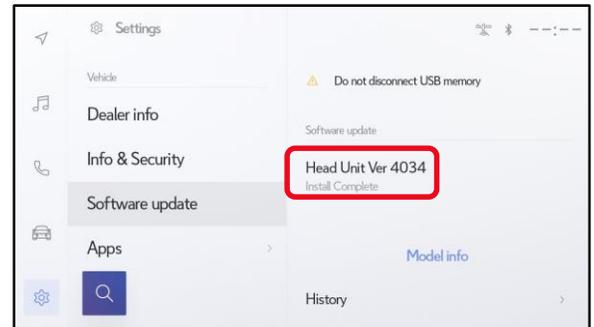
**Figure 9.**

- A. When the update is complete, “Install Complete” will show on the head unit, as shown in Figure 9.
- B. The “Software update” pop-up message may also appear, as shown in Figure 10.

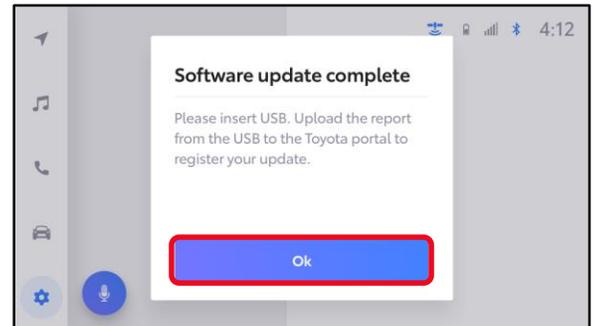
**Figure 11.**

If you are prompted to upload a report as shown in Figure 11, insert a blank USB to remove the .JSON files. These files are NOT needed.
