T-SB-0062-24 July 18, 2024

# **DCM Firmware Update (LG)**

Service

Some 2023 model year RAV4 Prime vehicles with Data Communication Module (DCM) firmware version earlier than LG-N210hh1V1V-09 may exhibit a condition in which the remote climate system is inoperative after the vehicle has been off for three hours or more.

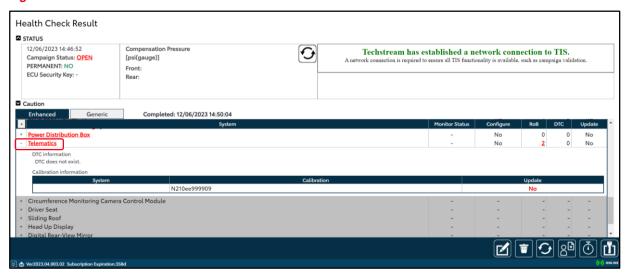
#### Figure 2.

3. Verify the current firmware version by expanding (+) the Telematics menu.

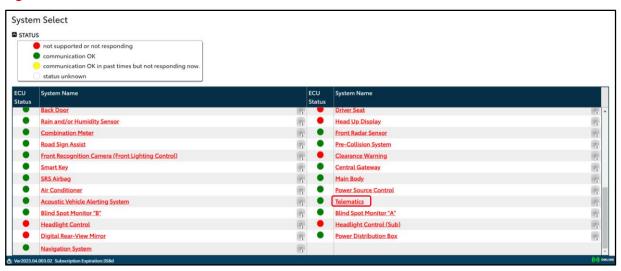
#### Figure 3.

Perform the DCM firmware update utility.
 Go to System Select – Telematics – Utility – DCM Firmware Update – Next Arrow as shown in Figures 3 and 4.

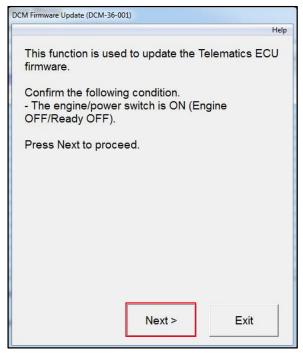
Figure 5.

6. Click Next when the DCM Firmware Update screen appears.

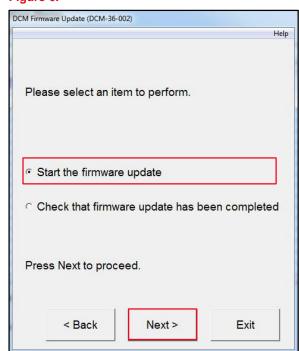
Figure 6.

7. Select Start the firmware update and click Next when the item selection screen appears.

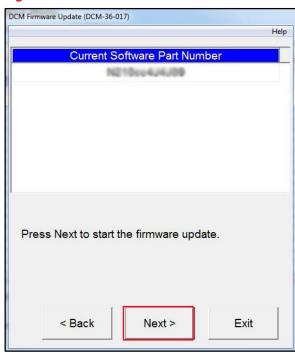
Figure 7.

8. Click Next when the Current Firmware Part Number screen appears.

If the screen in Figure 7 does NOT appear and an error message displays, begin the Firmware Update Procedure again from step 5. A battery reset MUST be performed.

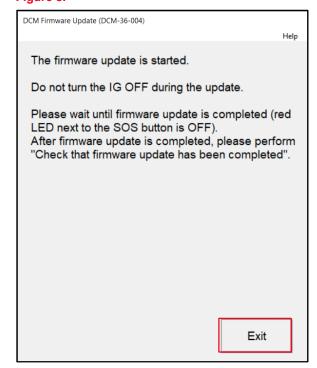
Figure 8.

- Do NOT press Exit until the update process has completed.
- During the update process, the green and red LEDs will both be ON and will reset several times resulting in the LEDs being temporarily OFF during the process. The download process will take about 5 – 10 minutes.

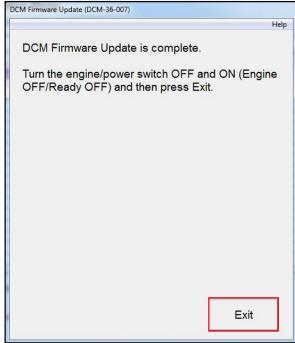
Figure 9.

- 10. The three conditions below will indicate that the firmware update process is complete:
  - The green LED will stay ON.
  - The DCM Firmware Update is complete message will appear on Techstream.
  - The service mode message will appear on the display screen.

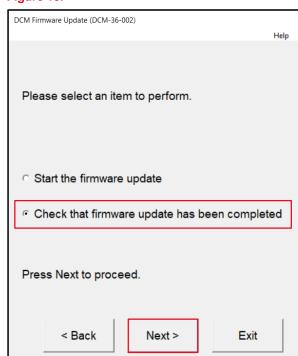
Figure 10.

11. Select Check that the firmware update has been completed and click Next.

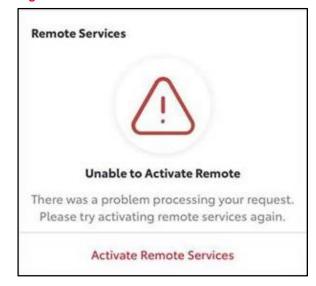
Figure 12.

14. For customers with the Unable to Activate Remote message, perform steps 14 – 16 in the Toyota app.

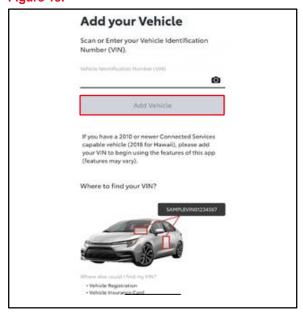
Figure 15.

17. Click Add Vehicle to perform the enrollment again.
