HV Battery Cooling Fan Maintenance for Severe Usage Vehicles

Section Hybrid/Battery Control System

YEAR(S)	MODEL(S)	ADDITIONAL INFORMATION
2010 – 2013	Prius

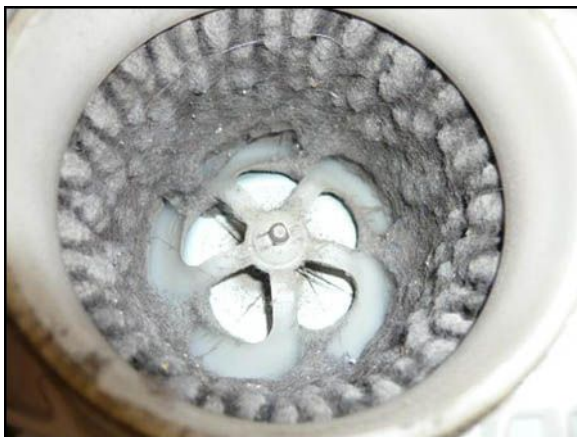
For vehicles that are used under certain severe operating conditions, the HV Battery Cooling Fan may experience an excessive buildup of dust, lint, or other debris that can reduce the efficiency of the HV Battery Cooling System. HV Battery Cooling Fan maintenance and cleaning should be performed to address this condition.

Figure 1. HV Battery Cooling Fan BEFORE Cleaning

3. Using vacuum, and compressed air, if necessary, clean any dust, lint, or debris buildup from the HV Battery Cooling Fan blades, module, and ducts.

- Do NOT attempt to clean the HV Battery Cooling Fan while it is installed in the vehicle. Doing so may cause dust or debris to enter the HV Battery Case.
- Failure to secure the fan blades while cleaning can result in electronic circuit failure due to overturning.

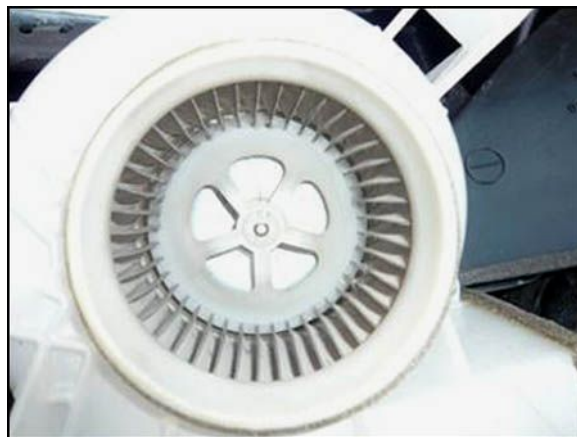
Figure 2. HV Battery Cooling Fan AFTER Cleaning
