# Fender Rattle/Tick Noise

YEAR(S)	MODEL(S)	ADDITIONAL INFORMATION
2010 – 2011	Prius

Some 2010 - 2011 model year Prius vehicles may exhibit a condition where there is a ticking/rattle type noise from the A-pillar area on either side of the vehicle. This noise has also been identified as a ticking/rattling type noise from the instrument panel. Revised upper fender retainer clips have been developed to address this condition.

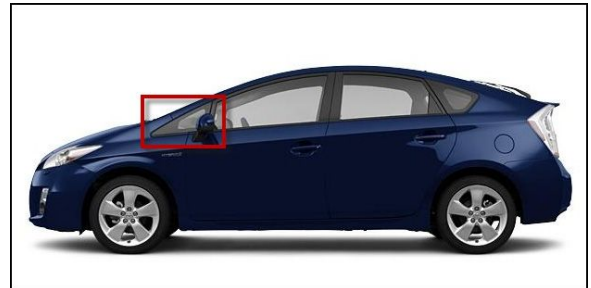
**Figure 1. Overview**

1. Confirm that the noise/rattle is coming from underneath the fixed side window. Do this by road testing the vehicle. Once the noise is duplicated, roll down the window and apply pressure with your hand to the upper portion of the fender to see if the noise stops.

- If the noise can be heard and goes away when pressure is applied, this bulletin may apply.
- If **NOT** this bulletin does not apply. Continue to diagnose the vehicle to find the source of the noise/rattle.
