Water Pump Inspection and Diagnostic Tips

Service Category Engine/Hybrid System

Section Cooling

This service bulletin contains water pump leak inspection and diagnostic tips.

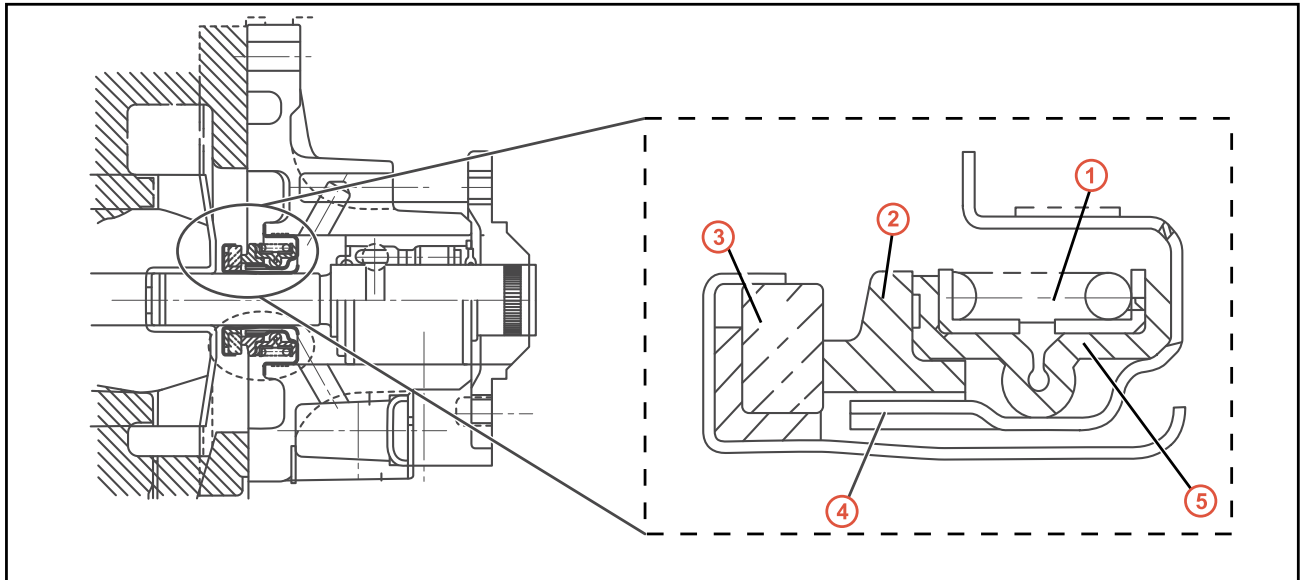
Figure 2. Mechanical Seal Components

1	Spring – Applies pressure to the seal ring to ensure the seal ring and mating ring are in constant contact.
2	Seal Ring – Stationary sealing member in the water pump housing, held in place by the cartridge.
3	Mating Ring – Rotates with the water pump shaft and provides sealing surface for the seal ring.

4	Cartridge – Locates the seal ring and bellows in the water pump housing.
5	Bellows – Seals the cartridge and the seal ring.

NOTE
 The seal and mating rings are lubricated by the surrounding coolant; a small amount of coolant leakage is normal.

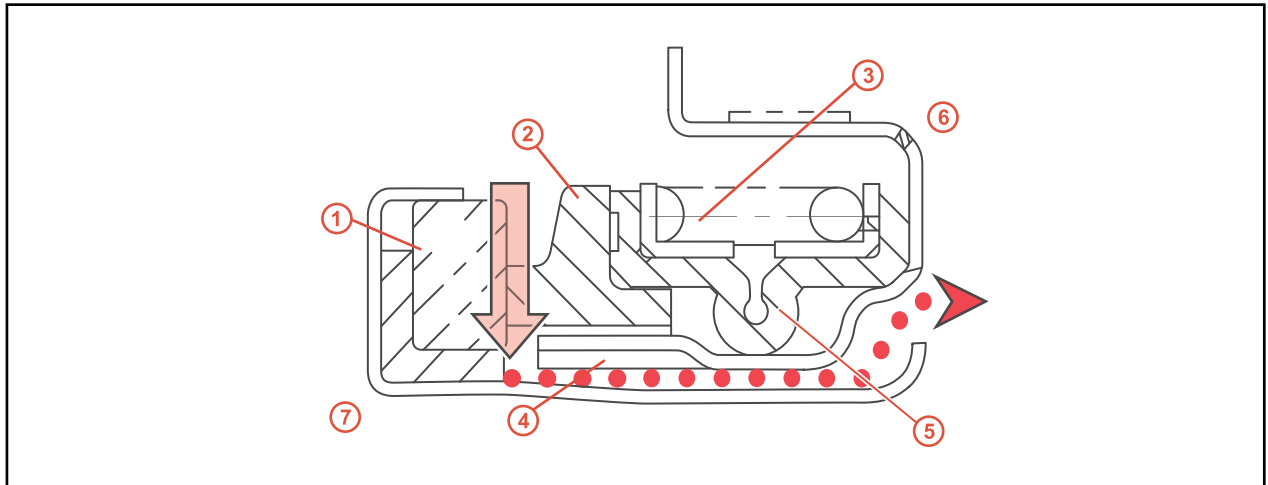
Figure 3. Debris in Mechanical Seal

If debris becomes trapped between the mating ring and seal ring a small gap is formed. This allows coolant to bypass the mechanical seal, flow into the fluid catch pocket, and drain out of the weep hole. This condition is temporary and will no longer be present once the debris is crushed or works its way out of the seal. **Water pump replacement is not necessary.**

1	Mating Ring
2	Seal Ring: gap formed by debris
3	Spring
4	Cartridge

5	Bellows
6	Housing Side
7	Impeller Side

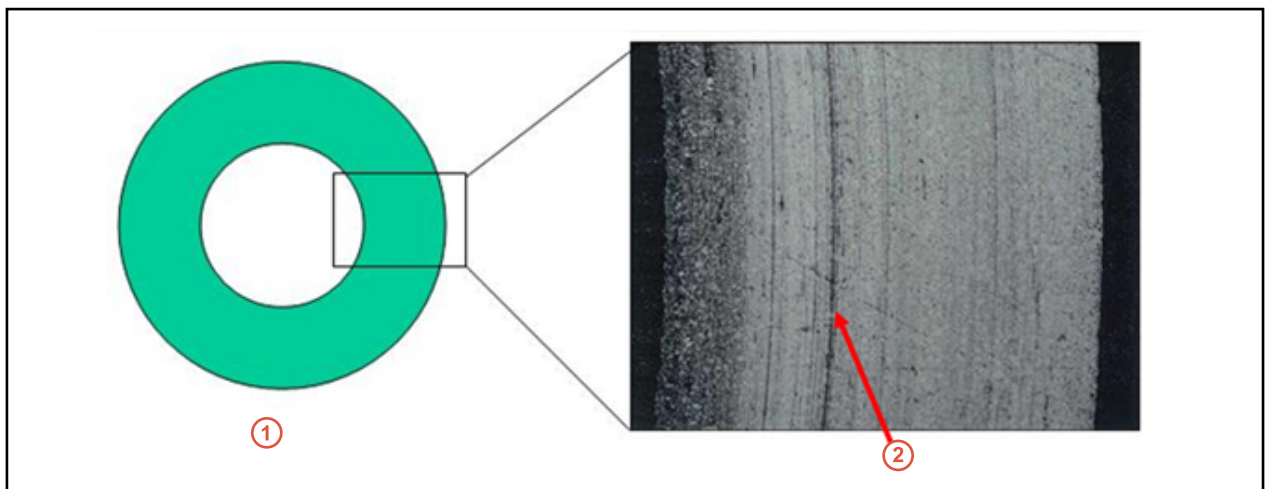
Figure 4. Mechanical Seal Mating Ring Sealing Surface

If debris was trapped between the seal ring and mating ring an abrasion mark may have been left on the mating ring surface. This abrasion mark does not affect sealing performance due to the large sealing surface of the mating ring. Once the debris is no longer present the mechanical seal performance will return to normal operation. **Water pump replacement is not necessary.**

1	Mating Ring
---	-------------

2	Debris Abrasion Mark
---	----------------------

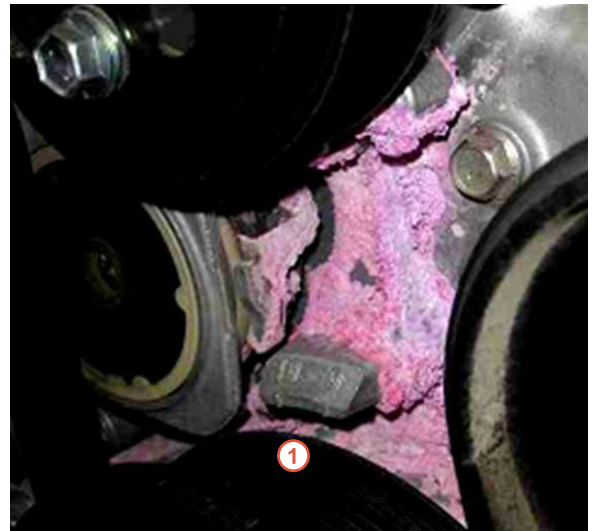
Figure 5. Current Leak – Replace Water Pump

1	Heavy coolant deposits present on water pump and all surrounding components
----------	---

1. Visually inspect the water pump and coolant level in the coolant reservoir. Replace the water pump if any of the following conditions exist:
 - A. The coolant level is below the “low” level and the water pump appears to be leaking.
 - B. Water pump pulley/bearing has excessive free play or does not turn smoothly.
 - C. Heavy coolant deposits are present on both the water pump and surrounding components (i.e. pulleys, engine block, timing cover, under hood).

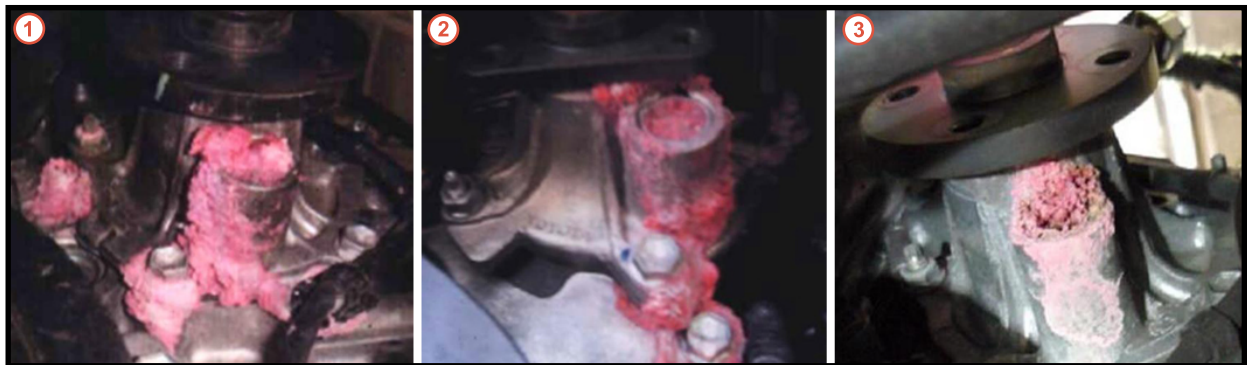
Figure 6. Possible Temporary Leaks – Inspect Water Pump

If the above conditions do not apply or amount of deposits are in question, the leak may have been temporary and additional inspection is necessary.

1	Thick coolant deposits present on water pump only
2	Moderate coolant deposits present on water pump only
3	Light coolant deposits present on water pump only

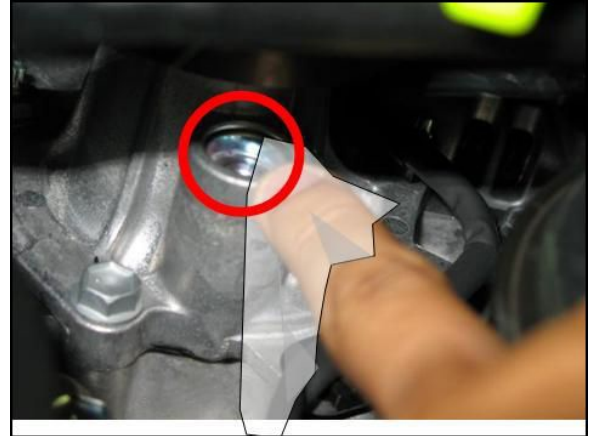
Figure 7.

2. A paper towel should be used to determine if a leak is current, or was temporary due to debris that has now cleared.

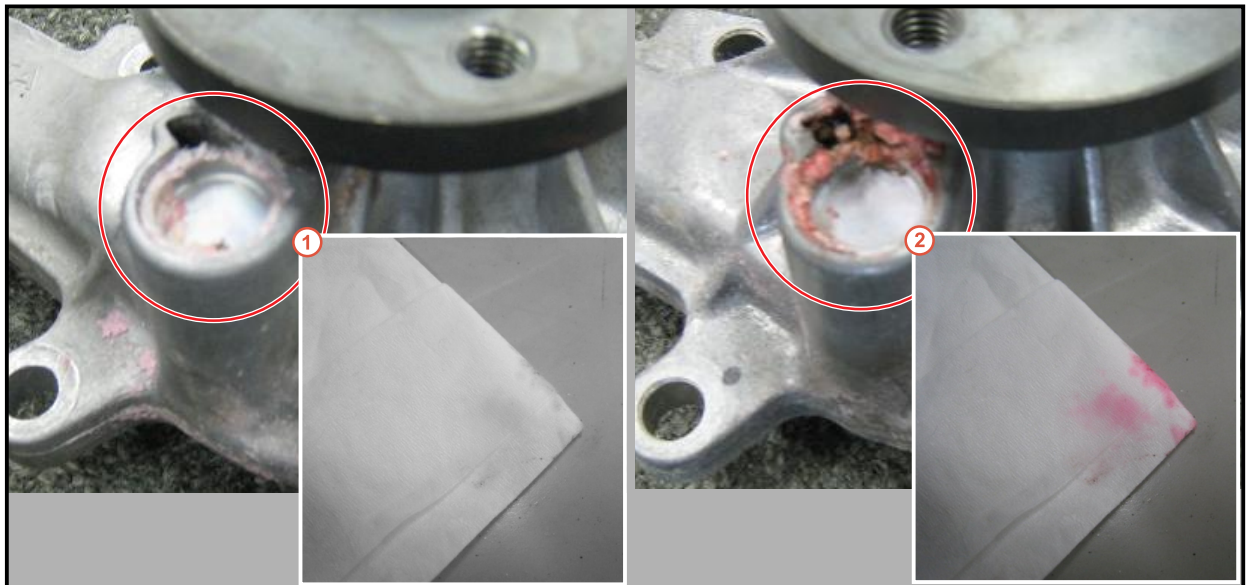
Figure 8.

3. Apply a dry paper towel to the coolant deposits around the weep hole. If the paper towel remains dry the leak was temporary and the water pump does not need to be replaced. If the paper towel becomes wet the leak is current and the water pump should be replaced.

1 Dry Paper Towel DO NOT Replace Water Pump

2 Wet Paper Towel Replace Water Pump
