2ZR-FXE Engine Oil Consumption Repair Procedure

Service Category Engine/Hybrid System

Section Engine Mechanical

Some 2010 – 2014 model year Prius PHV, Prius V, and Prius vehicles equipped with the 2ZZ-FXE engine may exhibit engine oil consumption. The piston and piston ring assembly have been changed to reduce the potential for oil consumption. Follow the Repair Procedure in this bulletin to address this condition.

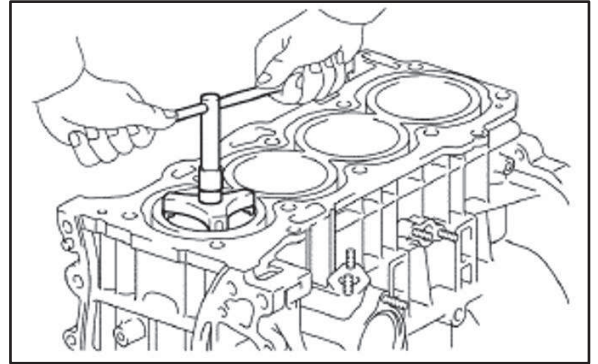
Figure 1.

5. Remove the pistons from the connecting rods.
 - A. Remove the piston sub-assemblies with connecting rod.
 - (1) Using a ridge reamer, remove ALL the carbon from the top of the cylinder.

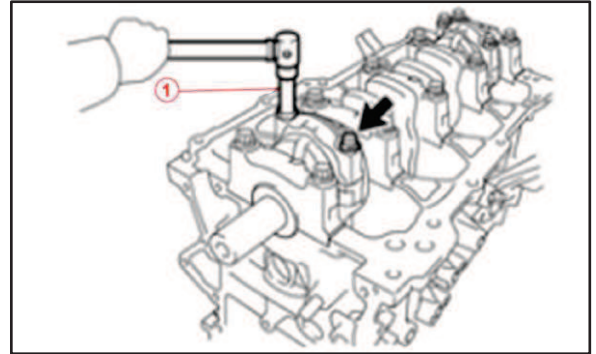
Figure 3.

- (3) Using SST 09205-16011, uniformly loosen the 2 bolts.

1	SST
----------	-----

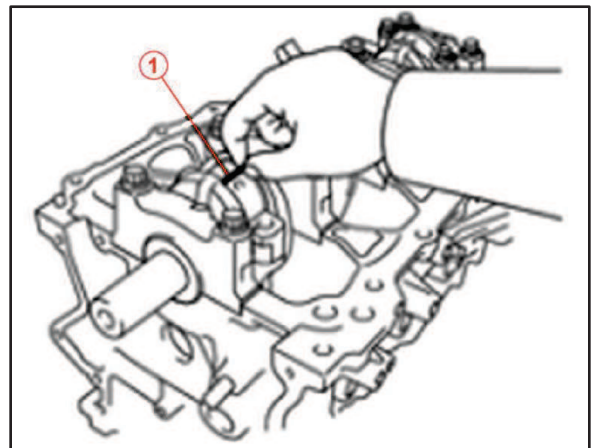
Figure 4.

- (5) Inspect the connecting rod oil clearance.
- a. Clean the crank pin and bearing.
 - b. Check the crank pin and bearing for pitting and scratches.
 - c. Lay a strip of Plastigage™ on the crank pin.

1	Plastigage™
----------	-------------

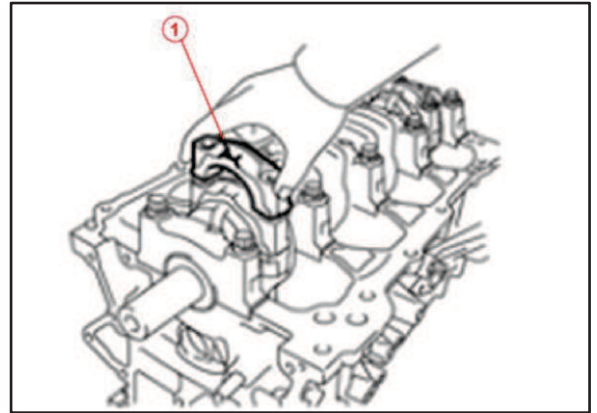
Figure 5.

- d. Check that the front mark of the connecting rod cap is facing forward.

1	Front Mark
----------	------------

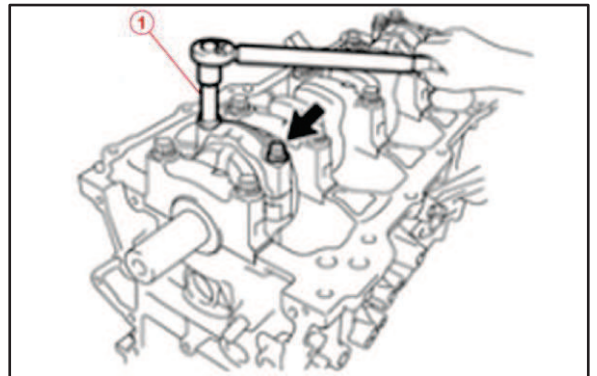
Figure 6.

- e. Install and alternately tighten the bolts of the connecting rod cap in several steps.
Torque: 20 N*m (204 kgf*cm, 15 ft*lbf)
SST: 09205-16011

The connecting cap bolts should be tightened in 2 progressive steps.

1	SST
----------	-----

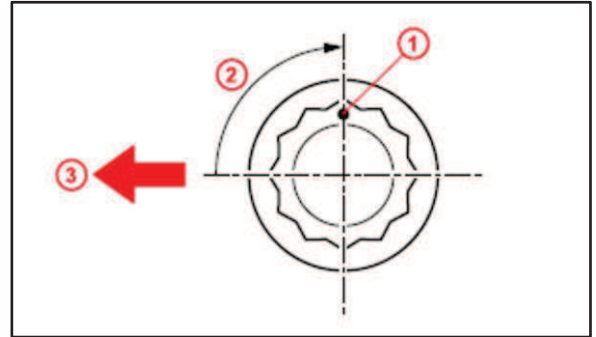
Figure 7.

- f. Mark the front of the connecting rod cap bolts with paint.
Retighten the cap bolts by 90° as shown.

1	Paint Mark
2	90°
3	Engine Front

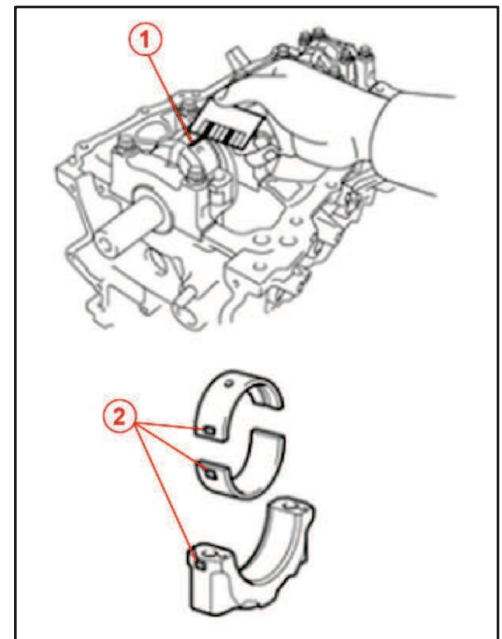
Figure 8.

- h. Measure the Plastigage™ at its widest point.

Standard Oil Clearance: 0.014 to 0.038 mm (0.000551 to 0.00150 in.)

Maximum Oil Clearance: 0.070 mm (0.00276 in.)

If the oil clearance is greater than the maximum, replace the connecting rod bearings. If necessary, inspect the crankshaft.

If replacing a bearing, replace it with one that has the same number as its respective connecting rod cap. Each bearing's standard thickness is indicated by a 1, 2, or 3 mark on its surface.

1	Plastigage™
2	1, 2, or 3 Mark

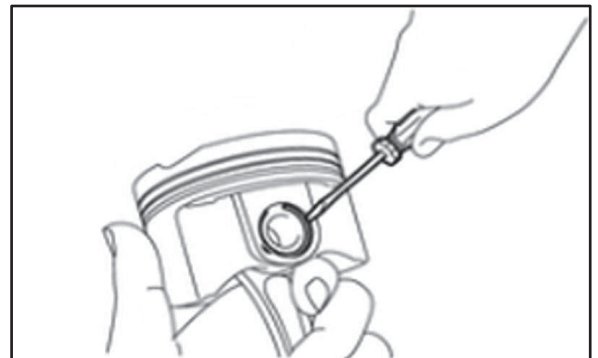
Figure 9.

- D. Using a screwdriver, pry out the 2 piston pin snap rings.

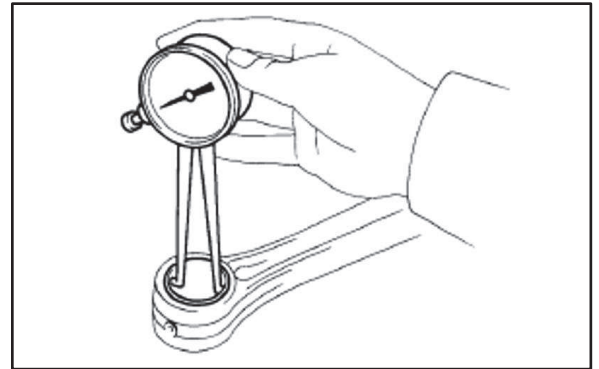
Figure 12.

- A. Using a caliper gauge, measure the connecting rod small end bore diameter.

Standard Connecting Rod Small End Bore Diameter: 20.012 to 20.021 mm (0.78787 to 0.78823 in.)

Ensure the connecting rod small end bore diameter measurement is within specification for the piston bore diameter.

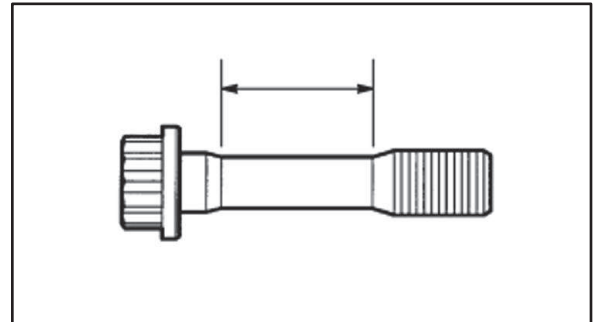
Figure 13.

Using vernier calipers, measure the tension portion diameter of the bolt.

Standard diameter: 6.6 to 6.7 mm (0.260 to 0.264 in.)

Minimum diameter: 6.4 mm (0.252 in.)

If the diameter is less than the minimum, replace the connecting rod bolt.

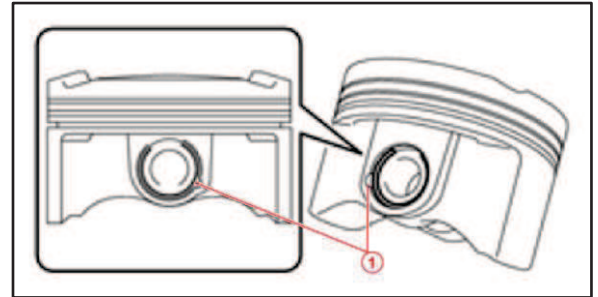
Figure 14.

- Using a screwdriver, install a NEW snap ring at one end of the piston pin hole.

Make sure that the end gap of the snap ring is NOT aligned with the pin hole cutout portion of the piston.

1 Service Hole

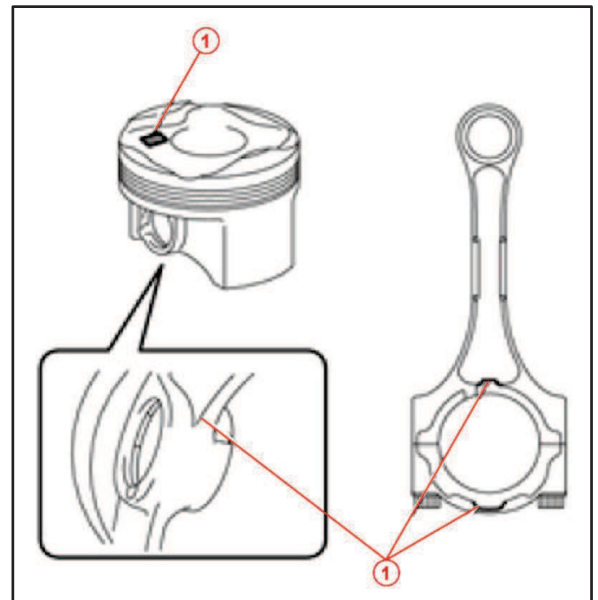
Figure 15.

- Gradually heat the piston to approximately 80° to 90°C (176° to 194°F).
- Align the front marks of the piston and connecting rod, insert the connecting rod into the piston, and then push in the piston pin with your thumb until the pin comes into contact with the snap ring.

The piston and pin are a matched set.

1 Front Mark

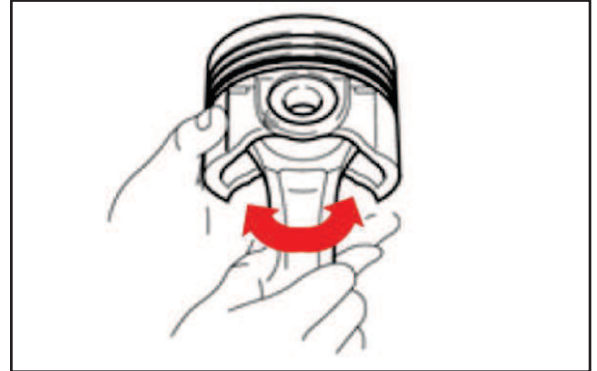
Figure 16.

11. Check the fitting condition between the piston and piston pin by trying to move the piston back and forth on the piston pin.

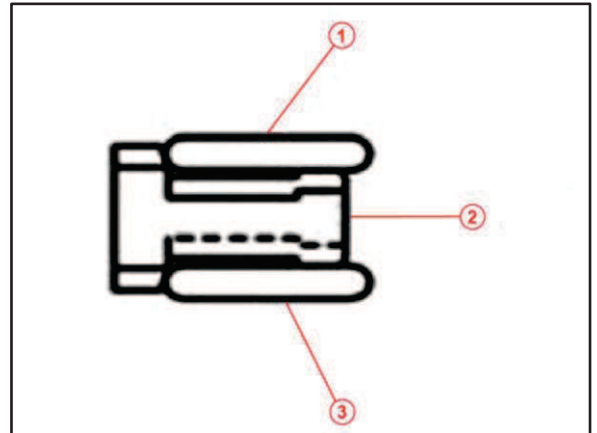
Figure 17.

12. Install the NEW Piston Rings Set.

3 piece oil control ring installation procedure is NOT included in the Repair Manual. Follow the steps below to install the piston rings and refer to the Repair Manual for ALL other reassembly steps.

1	Upper Oil Ring Side Rail
2	Oil Ring Expander
3	Lower Oil Ring Side Rail

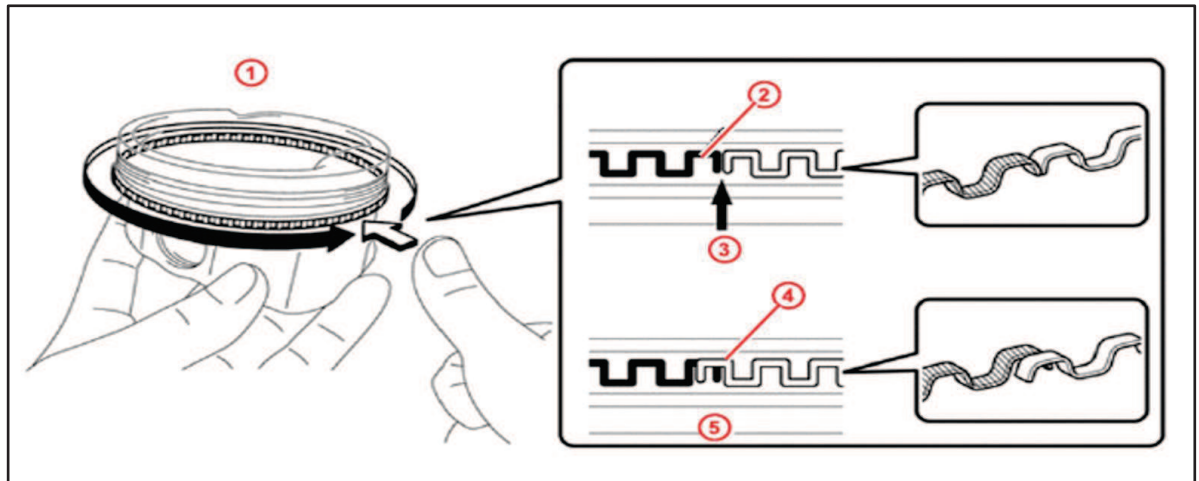
Figure 18.

- A. Install the oil ring expander and 2 oil ring side rails by hand.

When installing the oil expander ring, do NOT overlap the ends.

1	Push Oil Ring Expander Surface Into Piston With Thumb
2	Normal Condition
3	Align End of Ring

4	NG Condition
5	Do NOT Overlap

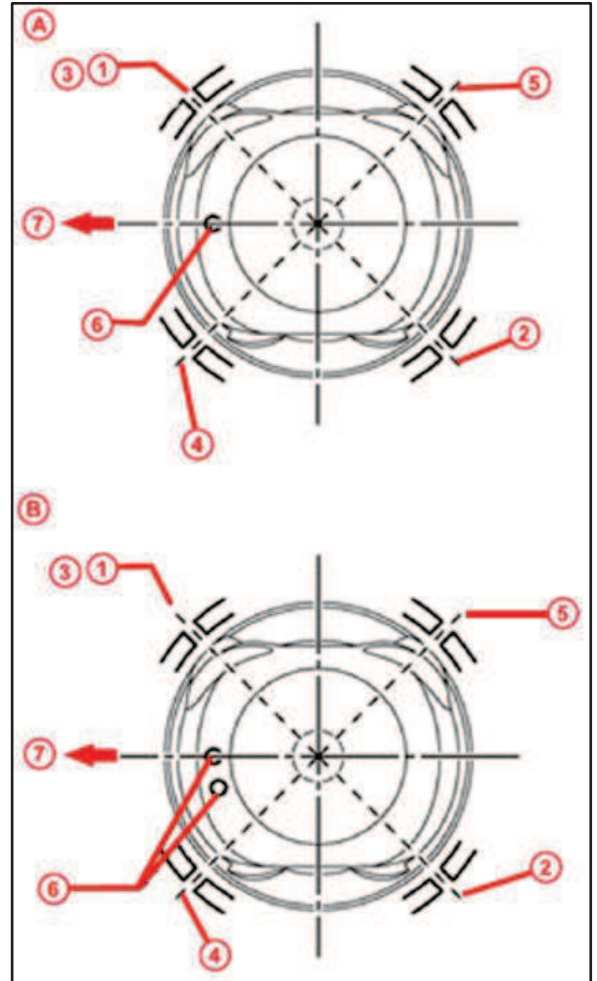
Figure 20.

- C. Position the piston rings so that the ends are as shown.

A	TMC Made
B	TMMK Made
1	No. 1 Compression Ring
2	No. 2 Compression Ring
3	Oil Ring Expander
4	Upper Side Rail – Oil Control Ring
5	Lower Side Rail – Oil Control Ring
6	Front Mark
7	Front Side
