Pre-Purchase Inspection

2016 Toyota Aqua

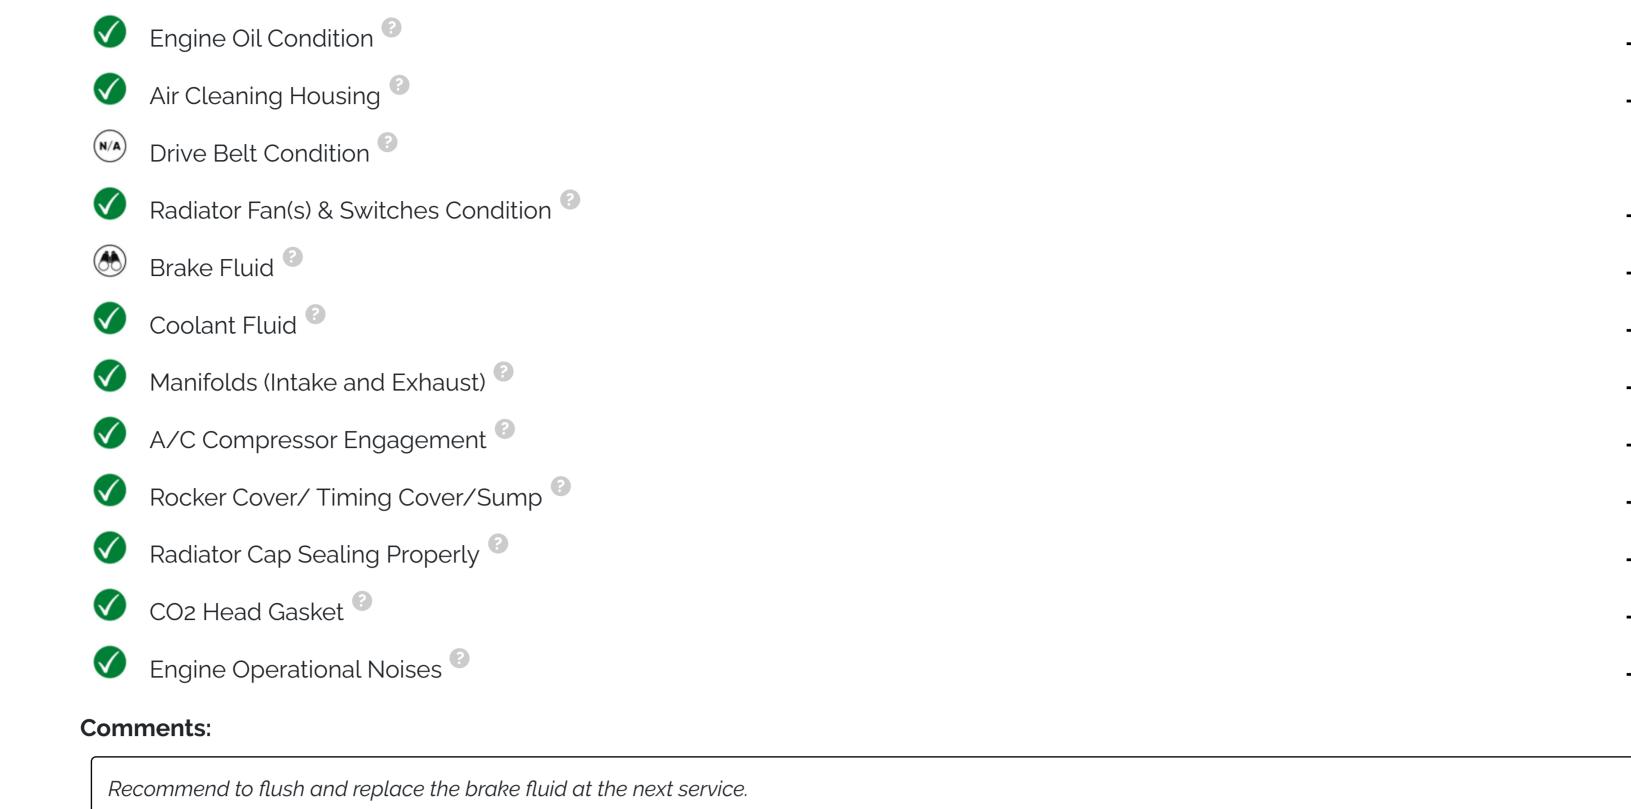
Starter Test ^② Alternator ?

Load Test Pass

Battery

Fail Voltage 12.06 V

Weak Pass Fail Voltage 14.16 V

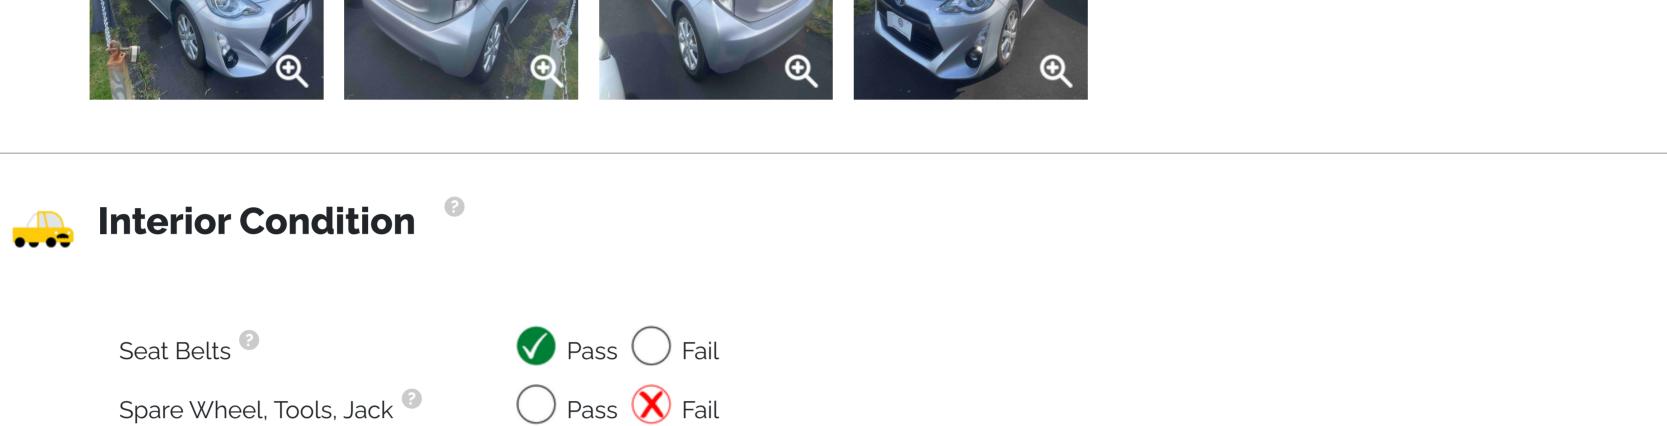
```
There are numerous, minor scratches and stone chips around the body of the vehicle, but overall it is in a reasonably good condition for its age and milage. See
photos for details.
```

Recommend to replace the flat tyre kit.

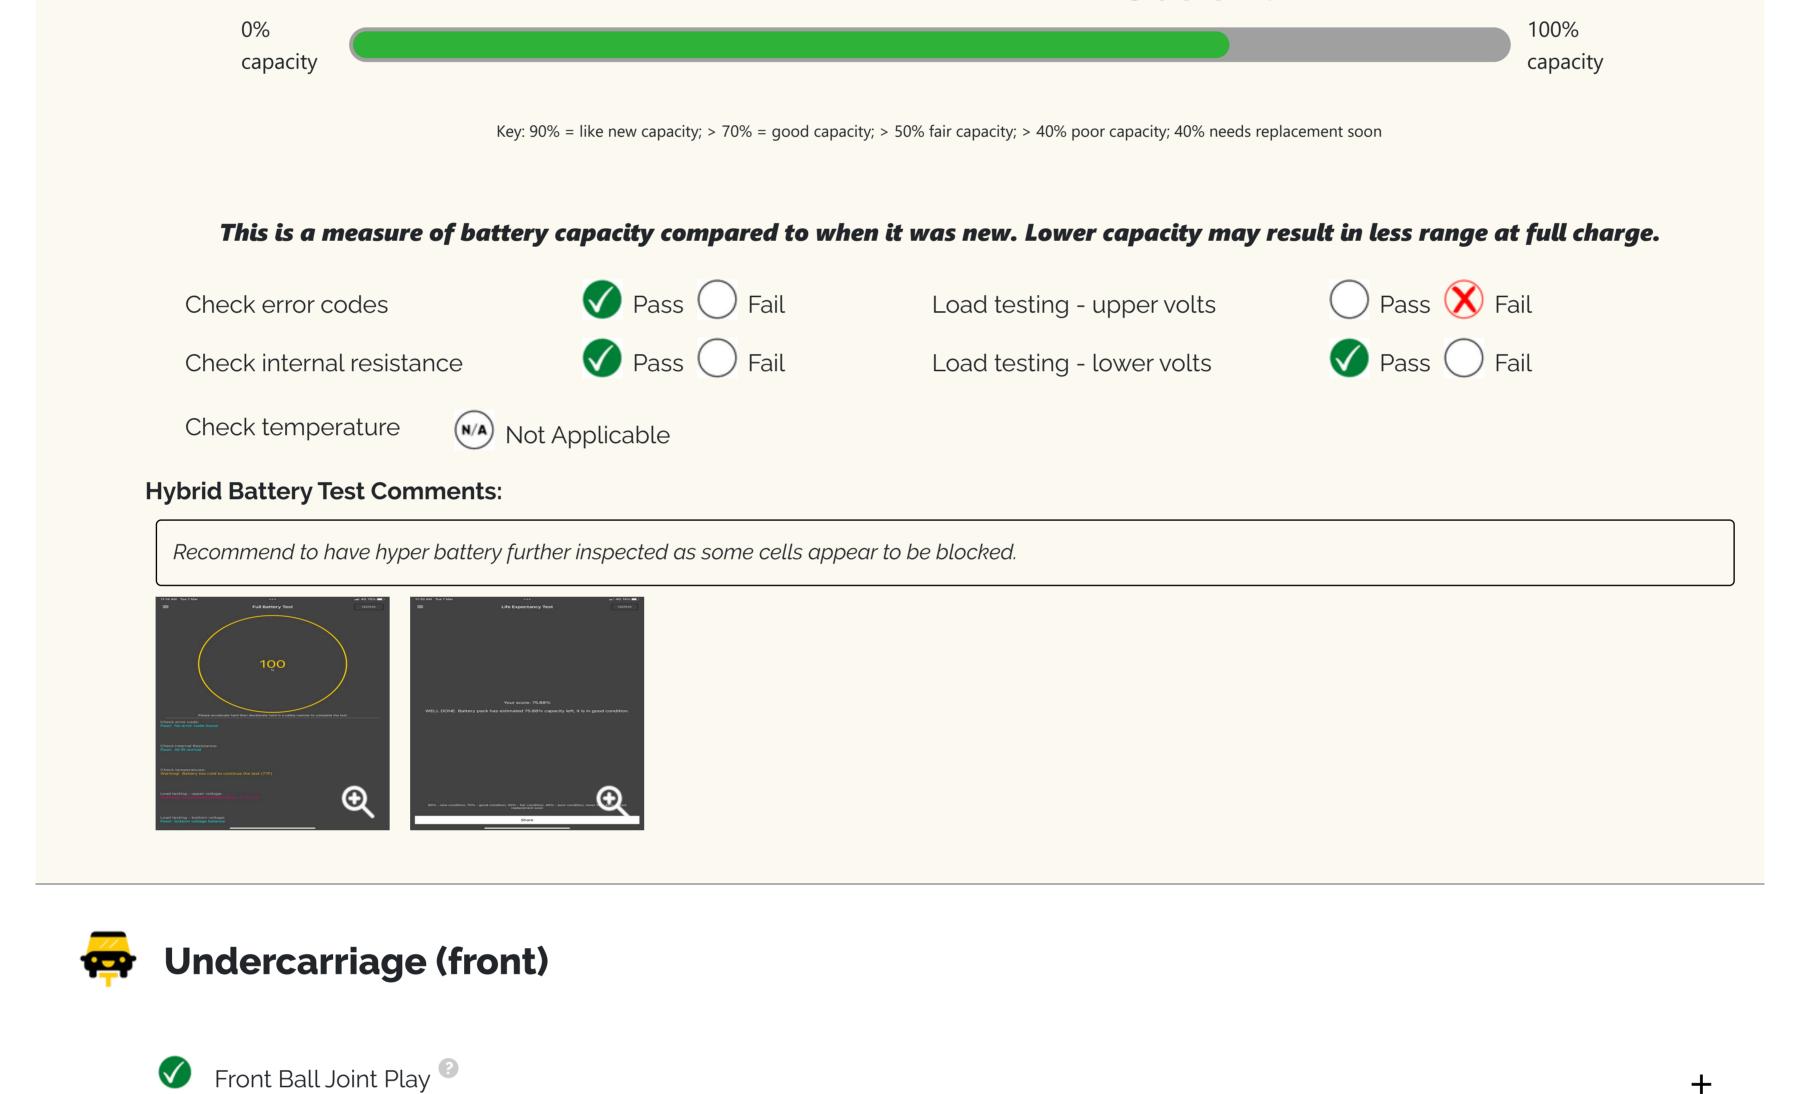
Front Brake Hoses (including under pressure) Front Suspension Bushes Front Shocks Front Bump stops/ Gaiters Front Axles CV Joint Boots & Hangers Front Engine Mounts Steering Rack Mounts Front Sway Bar Links Front Bushes Front Visible Engine Oil & Transmission Leaks Front General Damage or Corrosion (including check sills/ chassis) **Undercarriage (rear)**

```
Rear Brake Pad Outer (if possible)
 Rear Brake Callipers 
    Rear Brake Hoses (including under pressure)
 Rear Suspension Bushes
 Rear Shocks 
     Rear Bump stops/ Gaiters
 Rear Axles CV Joint Boots & Hangers
 Rear Sway Bar Links
 Rear Bushes
 Rear Differential
 Rear Visible Engine Oil & Transmission Leaks
     Rear Tow Bar Mounts (incl. Bolt Connections)
    Rear General Damage or Corrosion (including check sills/chassis)
                                                                                                                        +
Key: Pass X Fail Not applicable
                                                                  Defects requiring further investigation or repair
 Tyres
```
