Last Modified: 5-3-2010	6.4 A	From: 200904
Model Year: 2010	Model: Prius	Doc ID: RM000000UX402XX
Title: SUPPLEMENTAL RESTRAINT SYSTEMS: KNEE AIRBAG ASSEMBLY: REMOVAL (2010 Prius)

31. REMOVE DRIVER SIDE KNEE AIRBAG ASSEMBLY

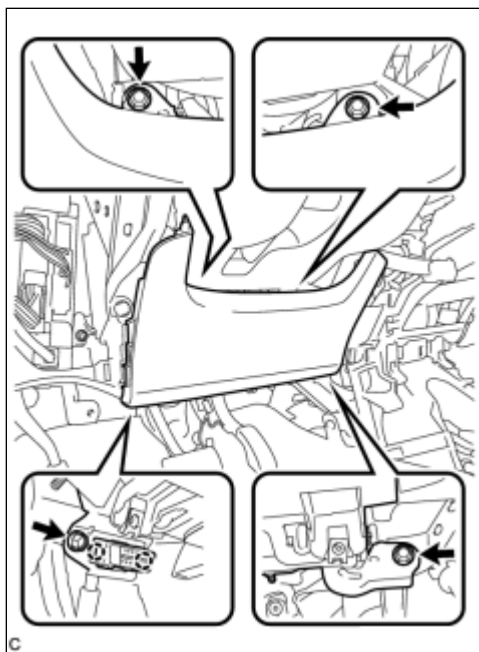
(c) Remove the 4 bolts.

(d) Disengage the 2 claws to separate the DLC3.

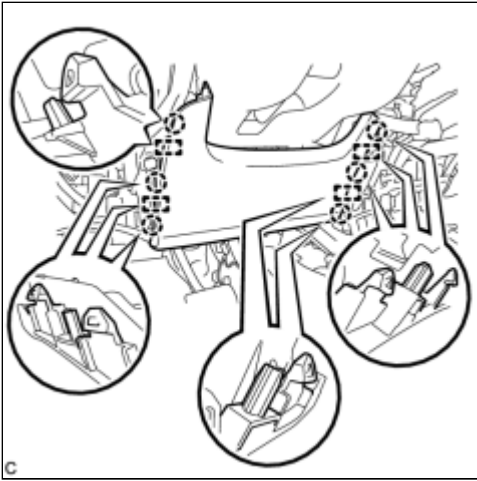
(e) Disengage the 6 claws and 4 guides to separate the driver side knee airbag assembly.

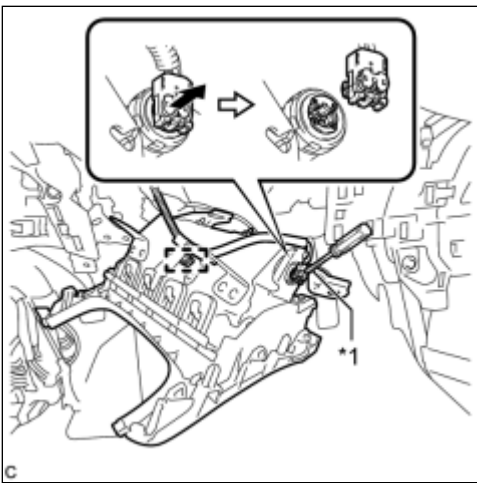
(f) Disengage the clamp to separate the wire harness.

(g) Using a screwdriver with the tip wrapped with protective tape, release the airbag connector lock.

Text in Illustration

*1	Protective Tape
----	-----------------

(h) Disconnect the airbag connector to remove the driver side knee airbag assembly.
