Antenna

Showing Genuine Parts that fit your: 2012 Toyota Prius V 1800CC 16-VALVE DOHC EFI, AUTOMATIC, ATM STEPLESS

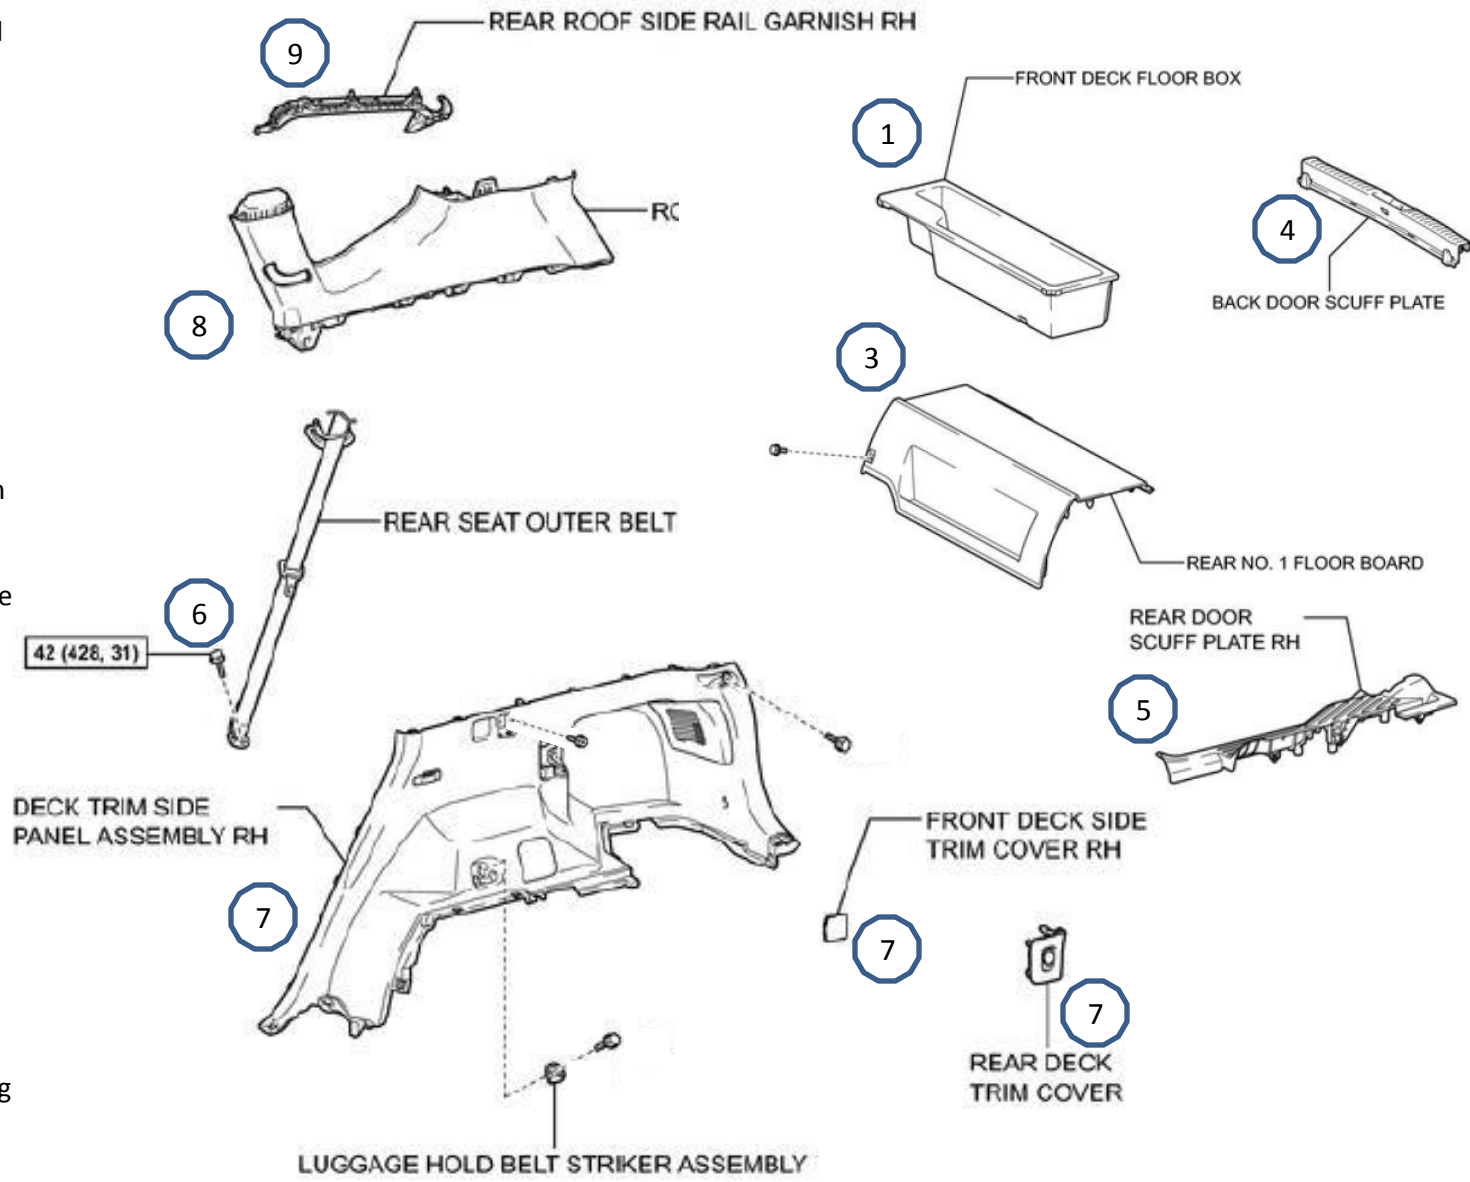
1'm (kgf*cm, ft.*lbf): Specified torque

1. Remove all Back Foam Panels
2. Remove 12v Battery Cover Panel (not shown here)
3. Remove Panel over HV Battery to Back Seat "Rear #1 Floor Board" (One 10mm bolt and Clips)

4. Remove "Back Door Scuff Plate" at Rear Hatch
5. Remove Right Rear Door Scuff Plate
6. Remove Rear "Right Seat Outer Belt" 22mm on Floor
7. Remove Lower Right "Deck Trim Side Panel" and "Trim Panels" on same (two – one covers bolt and the other is the 12v outlet) (Two 10mm bolts –and Clips) (Remove Third 10 mm bolt if equipped with Cargo Net)

8. Remove Upper Right Panel with Clips
9. Remove Upper Right Small Window Panel "Rear Roof Side Rail" with Clips
10. Remove three Exposed Push Clips holding Headliner in back

11. Partially Pull Headliner Down until Antenna Base Nut and Cables are Accessible
12. Remove Antenna Connectors first then Cable Retainers starting at Connector End.

13. Remove Base Nut and depress built in retainer hooks to remove. (See new part for clarity)

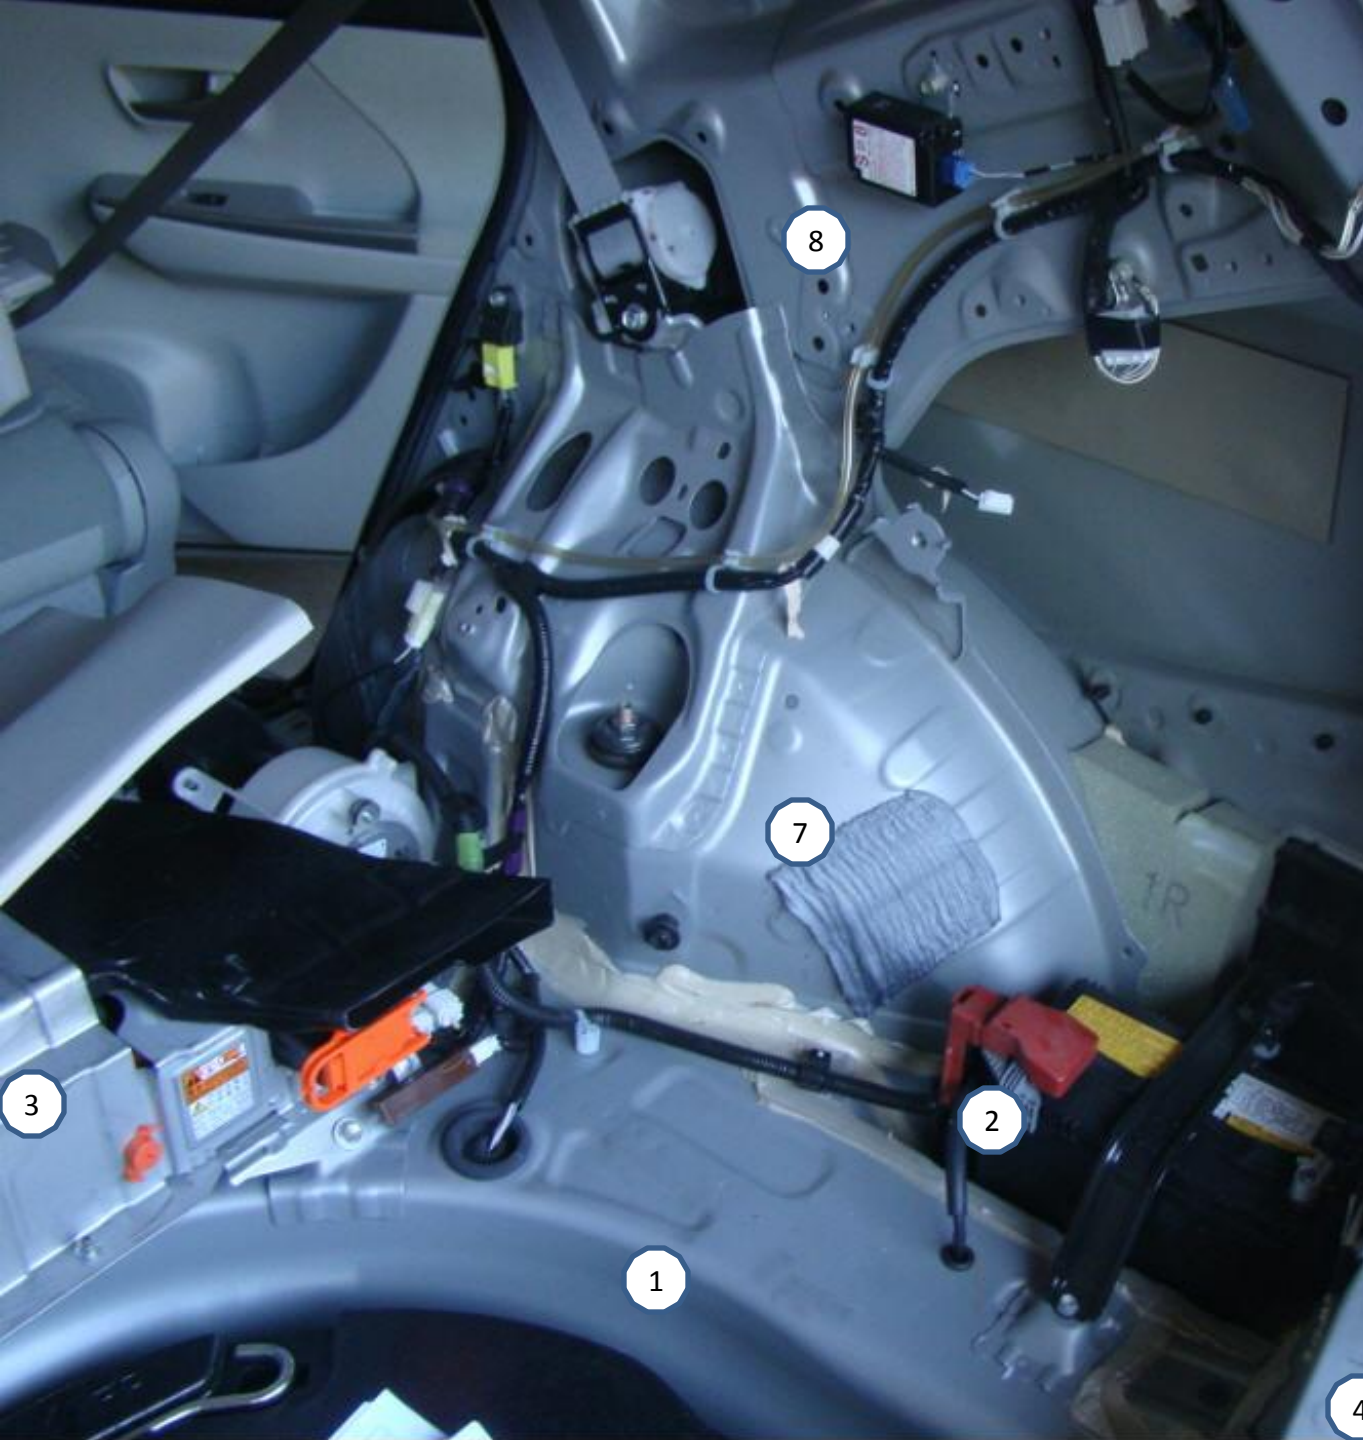
Headliner Pulled Down on
Right Corner

Two Antenna Connectors
to Body Wiring Harness
(Bottom)

12v Power Outlet Plug
Removed Prior to Lower
Panel

Panels Removed in this Picture

1. Remove all Back Foam Panels
2. Remove 12v Battery Cover Panel
3. Remove Panel over HV Battery to Back Seat "Rear #1 Floor Board" (One 10mm bolt and Clips)

4. Remove "Back Door Scuff Plate" at Rear Hatch
5. Remove Right Rear Door Scuff Plate (pic next page)
6. Remove Rear "Right Seat Outer Belt" 22mm on Floor (next page)

7. Remove Lower Right "Deck Trim Side Panel" and "Trim Panels" on same (two – one covers bolt and the other is the 12v outlet) (Two 10mm bolts – and Clips) (Remove Third 10 mm bolt if equipped with Cargo Net)

8. Remove Upper Right Panel with Clips
9. Remove Upper Right Small Window Panel "Rear Roof Side Rail" with Clips (next page)
10. Remove three Exposed Push Clips holding Headliner in back (next page)

11. Partially Pull Headliner Down until Antenna Base Nut and Cables are Accessible (next page)
12. Remove Antenna Connectors first then Cable Retainers starting at Connector End (next page).

13. Remove Base Nut and depress built in retainer hooks to remove. (See new part for clarity)

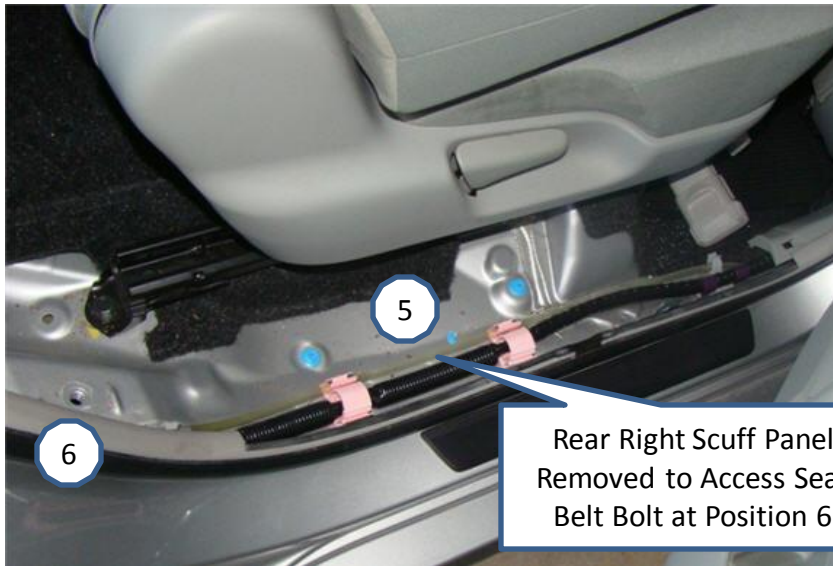
Rear Right Scuff Panel Removed to Access Seat Belt Bolt at Position 6

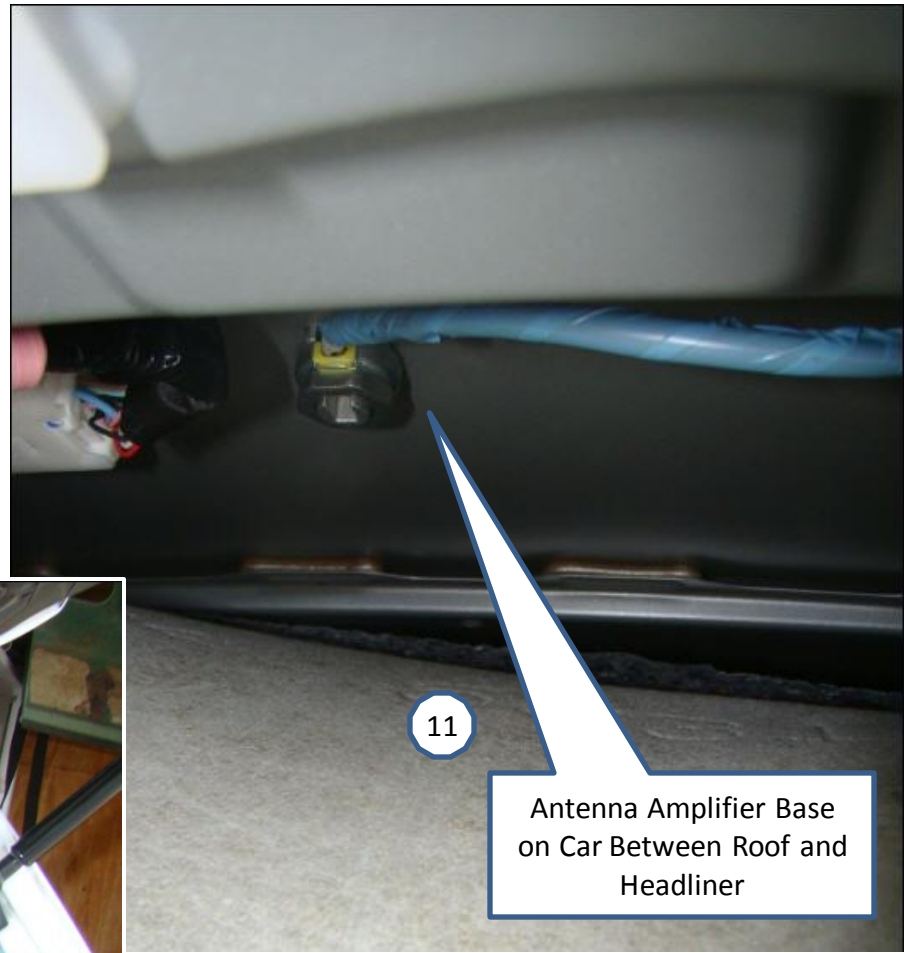
Antenna Amplifier Base on Car Between Roof and Headliner

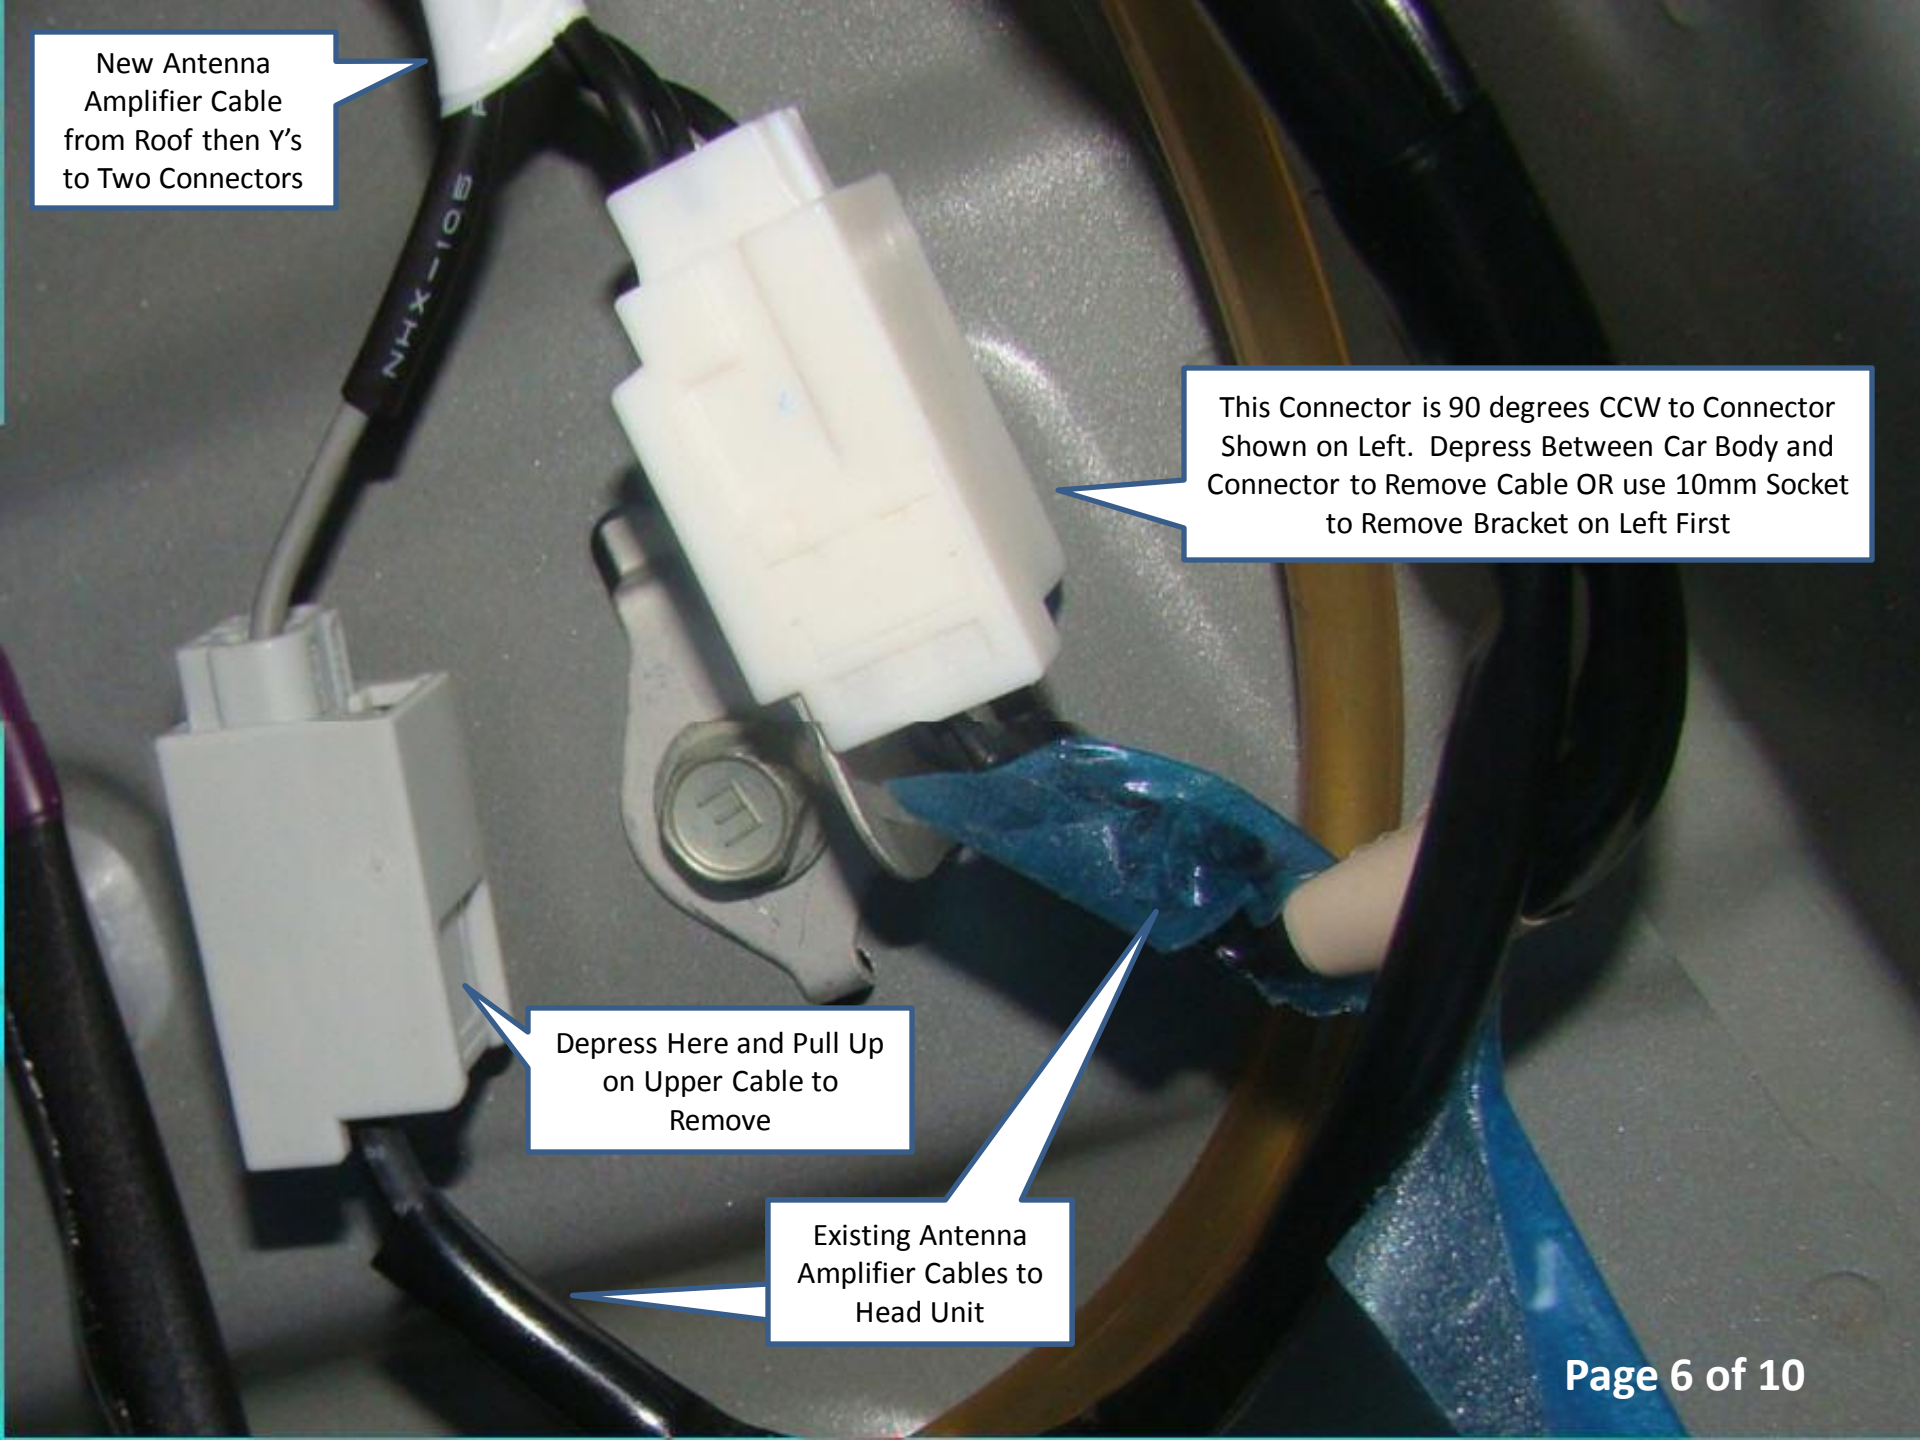
New Antenna
Amplifier Cable
from Roof then Y's
to Two Connectors

This Connector is 90 degrees CCW to Connector
Shown on Left. Depress Between Car Body and
Connector to Remove Cable OR use 10mm Socket
to Remove Bracket on Left First

Depress Here and Pull Up
on Upper Cable to
Remove

Existing Antenna
Amplifier Cables to
Head Unit

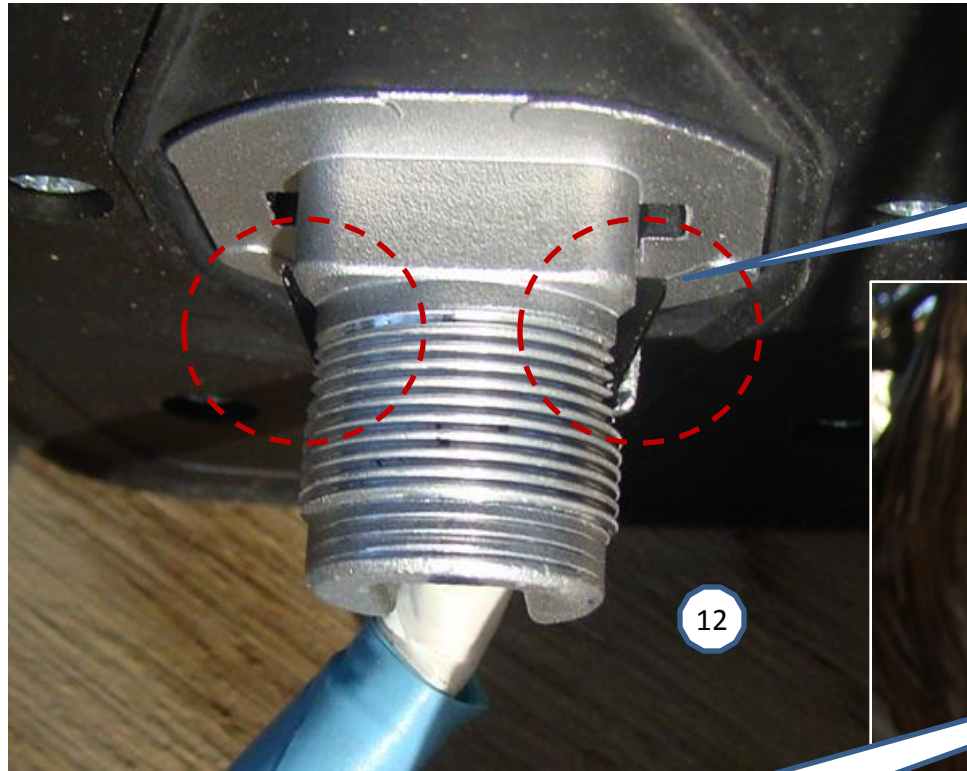
Two Spring Loaded Black Retainer Latches

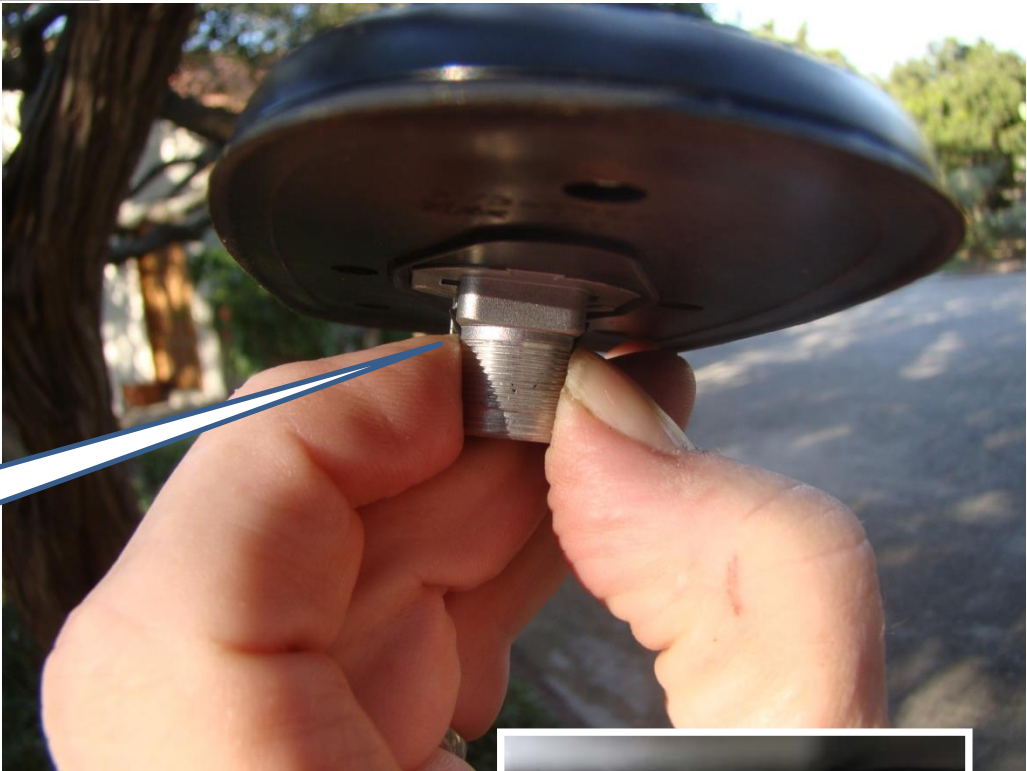
Press at Top of Threads after Nut Removed and Push Up Through Roof

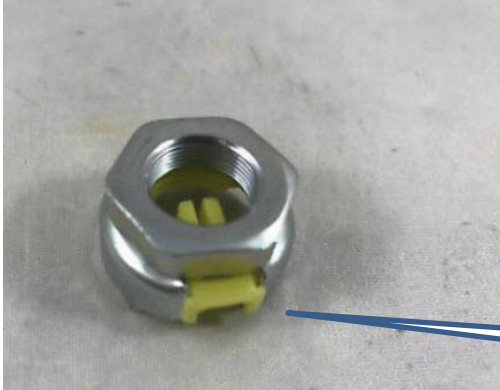
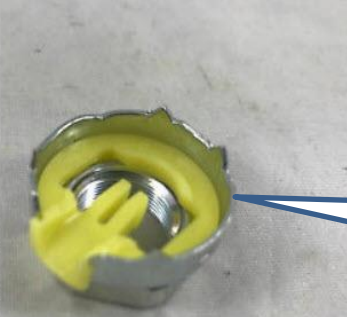
Antenna Nut Installed This End Up

The Cable Exits through the Yellow Plastic Channel – Only the Nut Rotates

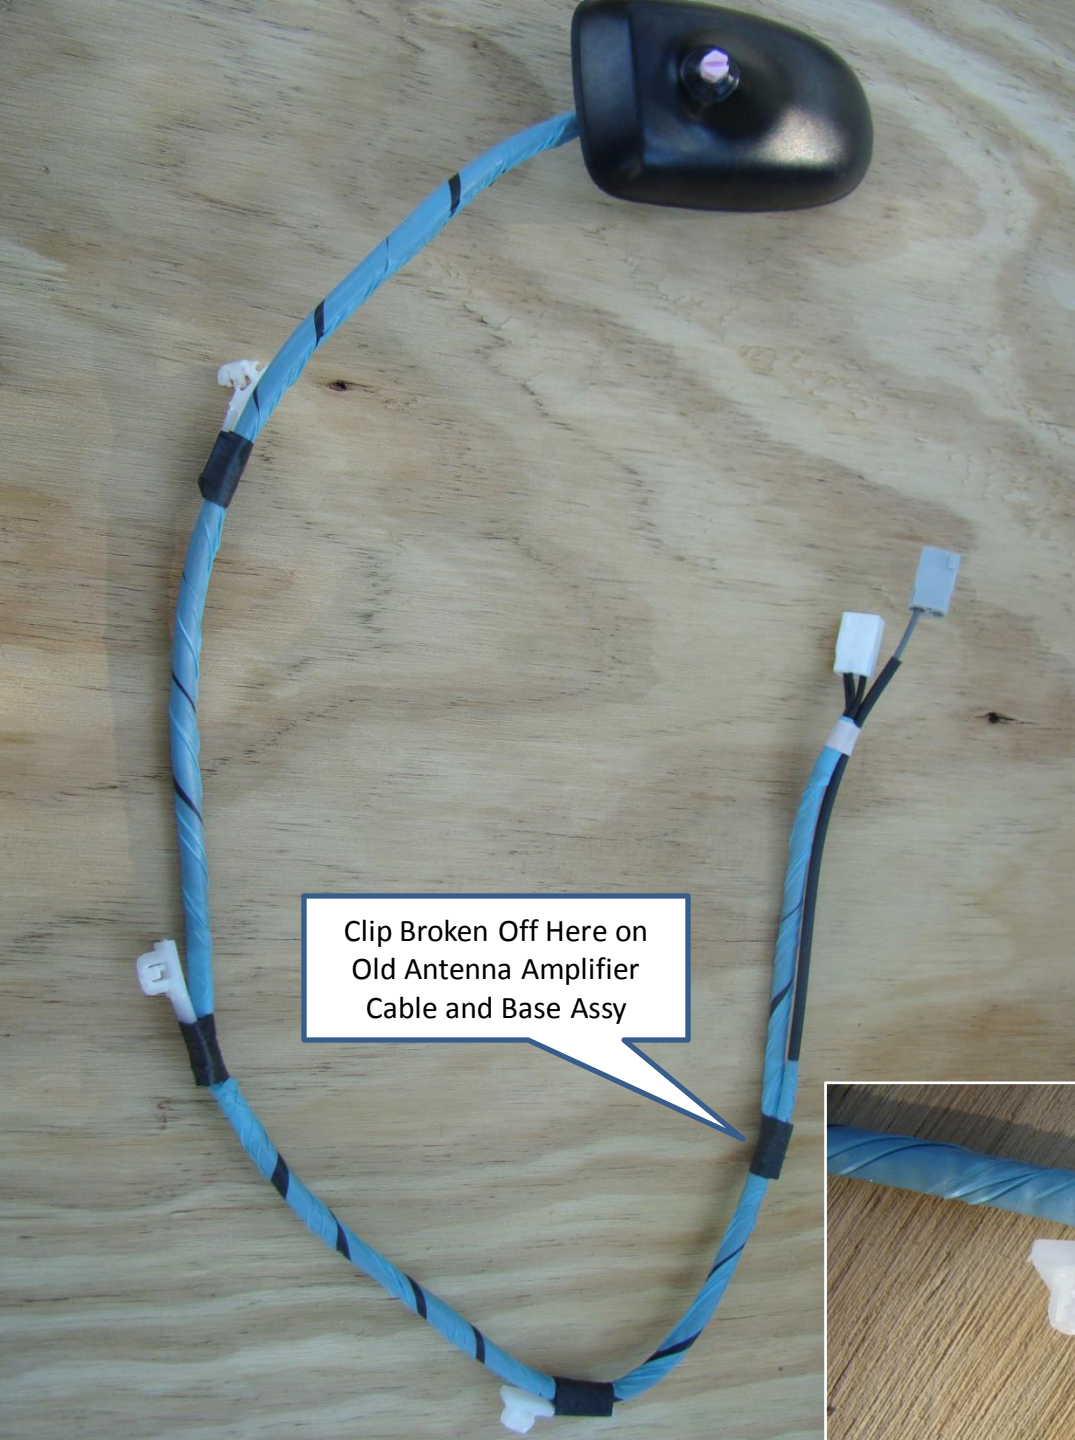
Clip Broken Off Here on Old Antenna Amplifier Cable and Base Assy

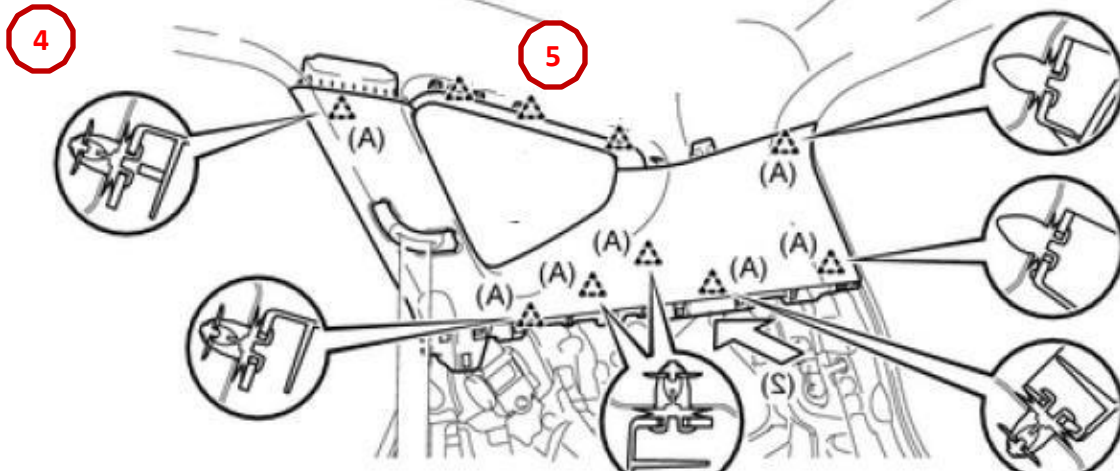
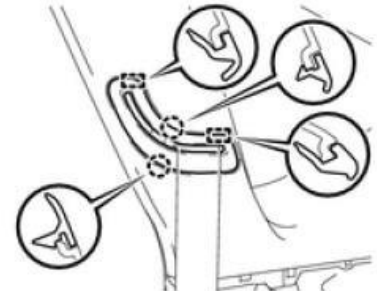
Circled Numbers on this page represent the sequence of panel removal

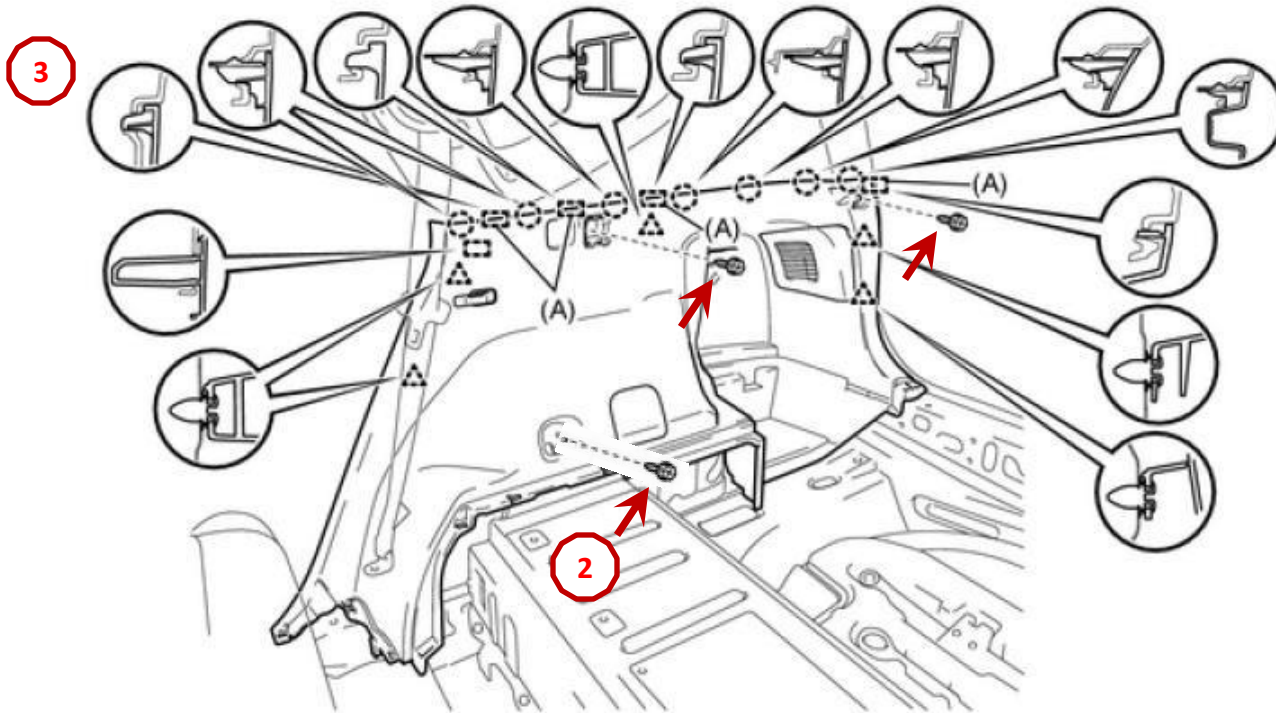
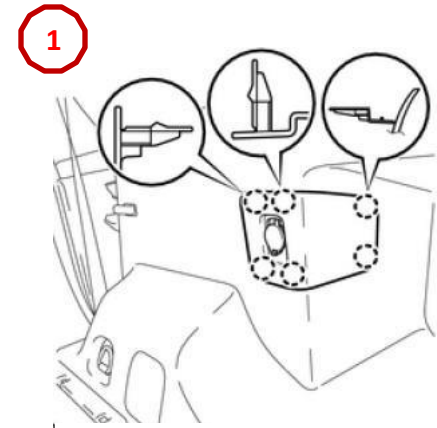
Seat Belt Guide (Left In Panel but could be removed)

12v Power Outlet Panel Removed and Disconnected
